A. VEHICLE INSPECTION PROCEDURE

B. CROSS MEMBER INSPECTION PROCEDURE 2009-2013 MAZDA6

On certain subject vehicles in salt belt states, it is possible that the front cross member may be corroded due to possible insufficient paint coating. Corrosion may be more severe on the portion just under the air conditioner drain, causing a perforation.

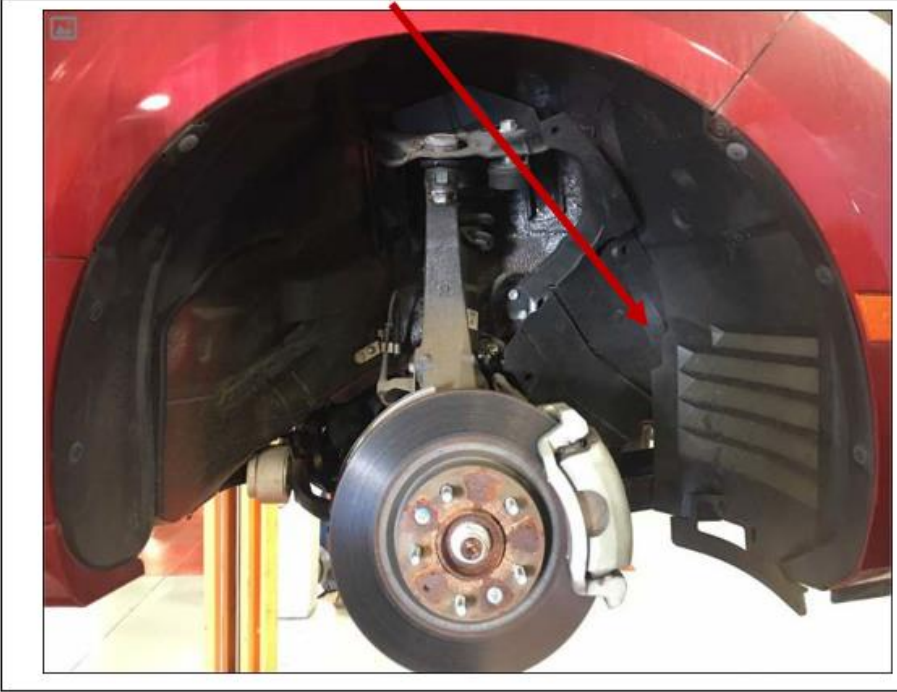
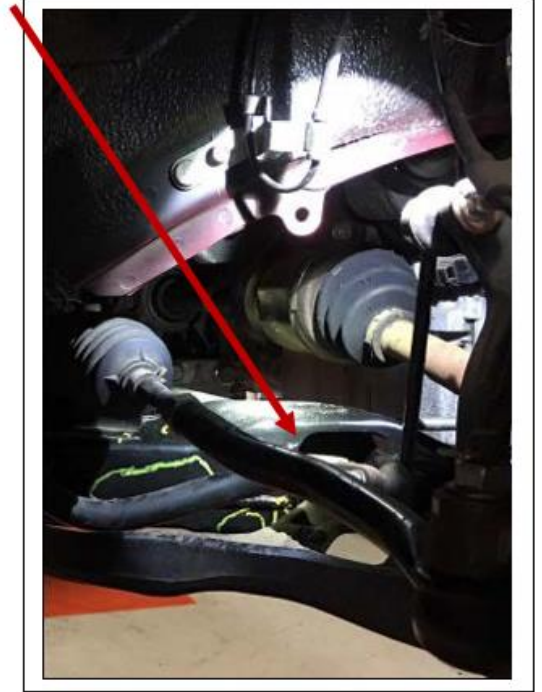
Then bend the side cover so that Inspection point Zone No.1: Upper surface of the cross member can be seen

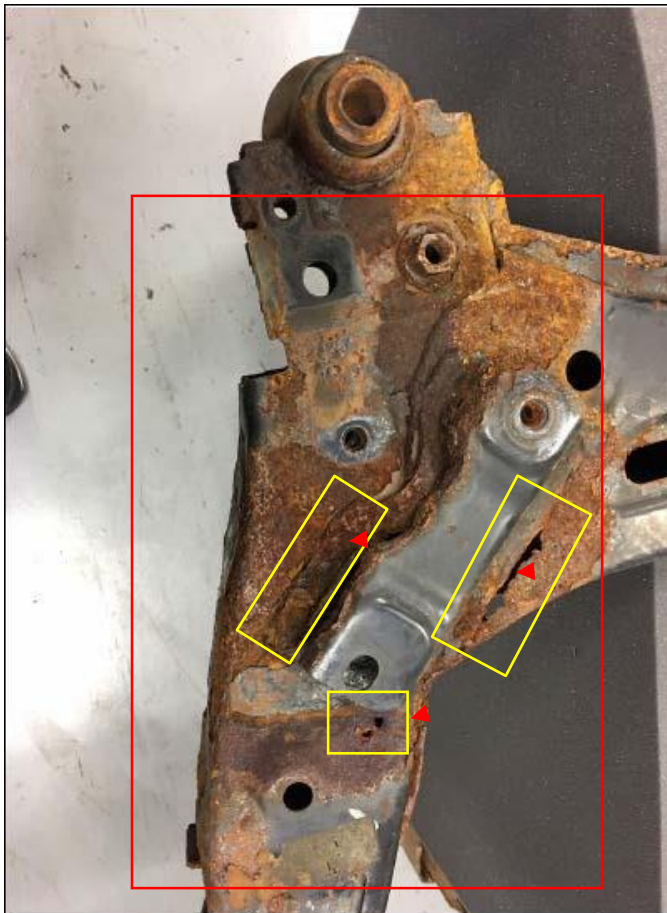
Top View: Used Cross member

Zone 1 inspection Area: Top Surface

Look for holes or cracks along the top surface in these areas. If a hole or crack is present, the cross member needs to be replaced. This cross member fails inspection as there is perforation

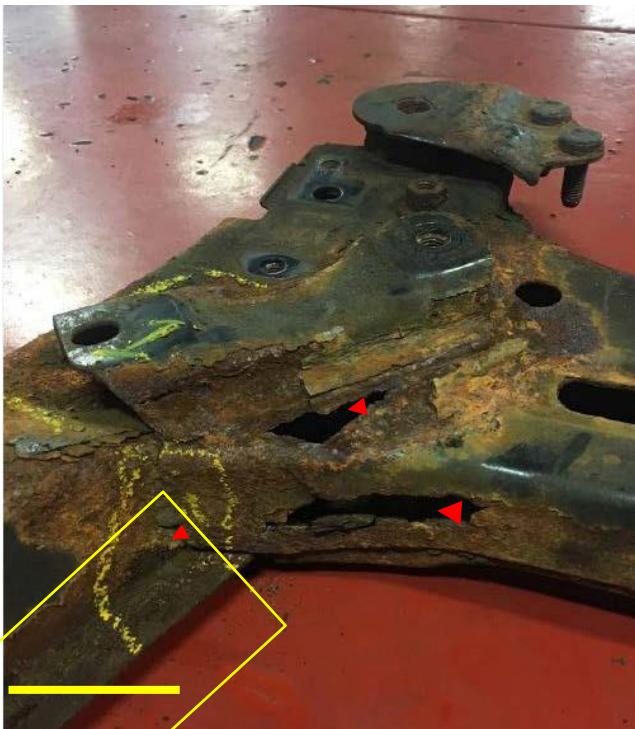
Inside Top View: Damaged Cross member

Zone 2 inspection Area:

Look for perforation or crack along the flange in this area. If a crack or perforation is present, replace the cross member.

Top side Zone 1 Failure due to perforation. Replace

Corrosion or a hole in this area does not compromise the structural integrity of the cross member, however this cross member will fail a state safety inspection due to perforation, so we need to replace the cross member

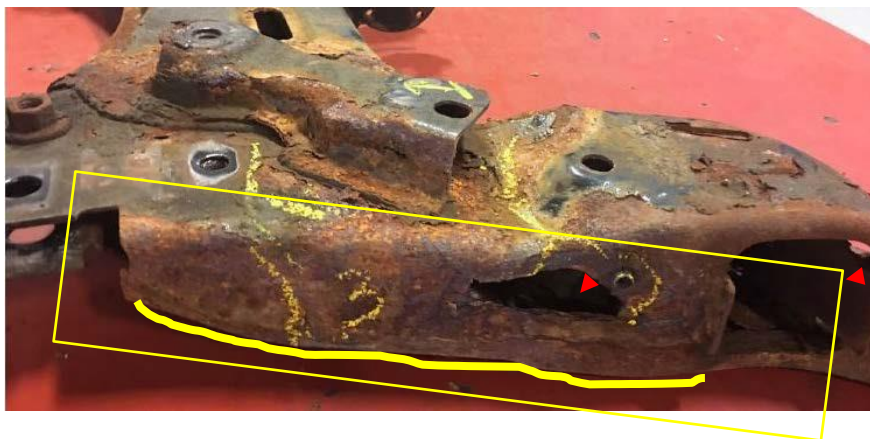
Top Side View: Damaged Cross member

This cross member passes inspection even with the perforation as the bracket supports and covers the hole. If perforation is visible beyond what the bracket covers, the cross member must be replaced as it will fail a state safety inspection for perforation.

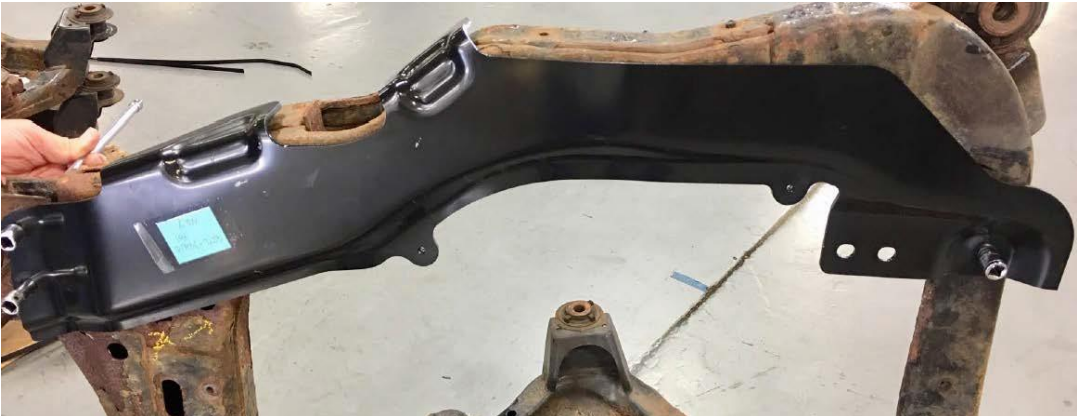
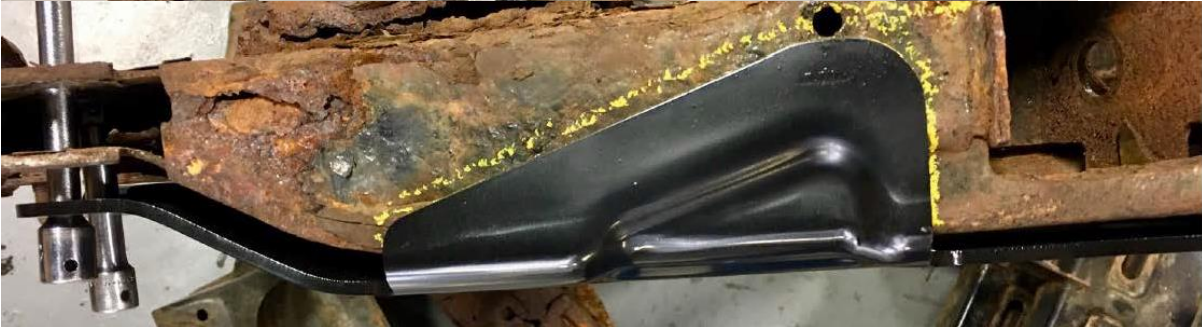
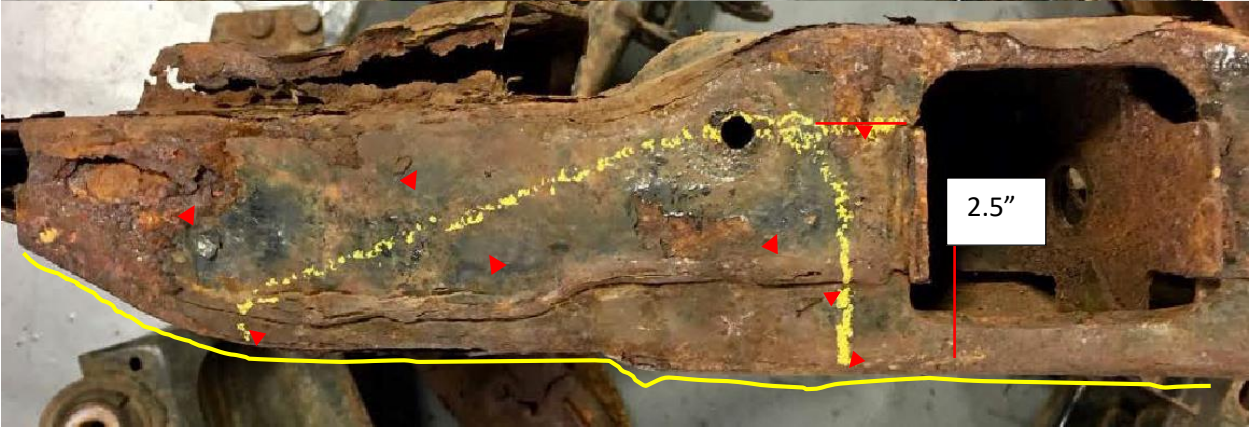
Photos of the bracket installation

Perforation in this area is not covered by the bracket and will fail State Inspection.

6.5 " Perforation in this area is covered by the bracket and is ok to use the cross member.
