SAFETY BULLETIN

Communication #: I-19-02-A/B

SUBJECT: 2014 INDIAN MOTORCYCLE - FORWARD LIGHTING PURPOSE

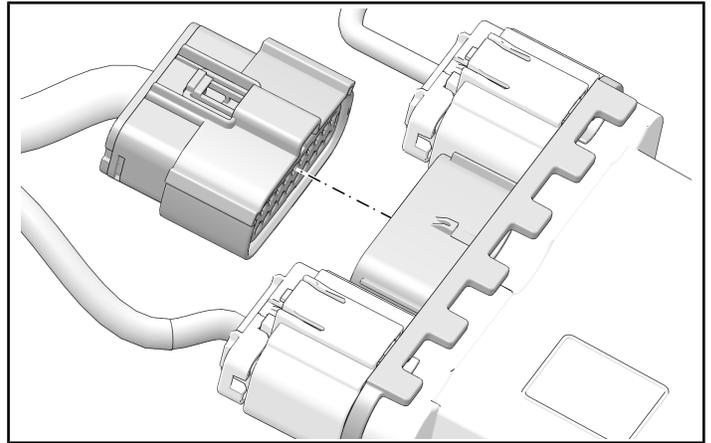
10. Disconnect the center connector on the VCM. Locate Pin 11 of the VCM1 (center) connector and check for any discoloration.

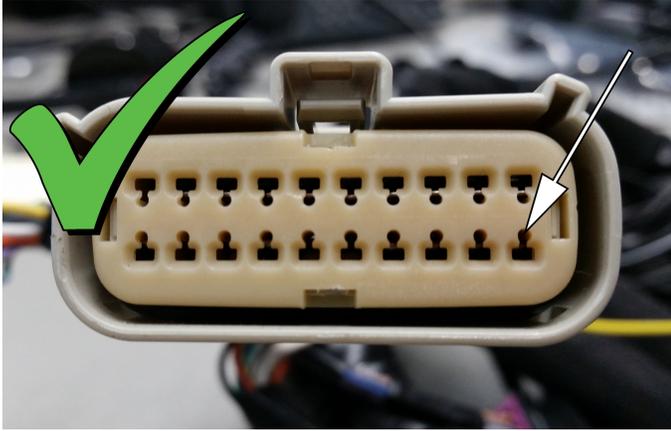
Pay special attention to the white terminal lock plate during inspection. If damage is present, a dark halo will be present around pin 11 of the VCM connector. Refer to the pictures below for examples.

DAMAGE IS NOT PRESENT	DAMAGE IS PRESENT
<p>VCM connector, pin 11</p>

- If damage **IS** present, take pictures of the damage and proceed to I-19-02-B.
 US/CAN: Submit an Ask Polaris Service & Warranty Question > All Vehicle Diagnostic case.
 INT'L: Contact your Country Service Department.
- If damage is **NOT** present, proceed to step 11 to complete I-19-02-A.

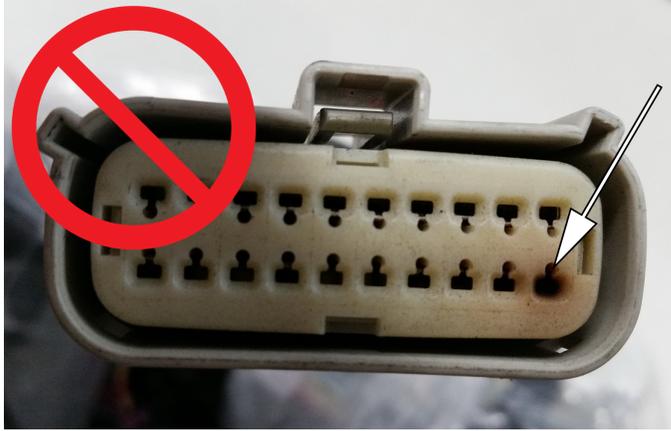
<p>VCM connector, pin 11</p>

Damage = Any sign of heat or thermal damage in or around pin 11 of the center VCM connector (e.g. the dark halo shown in the right image above).

Submit photos of the dark halo present around VCM pin 11 on the white terminal lock plate and wait for further instructions from Indian Motorcycle Technical Service.
