## SAFETY RECALL CAMPAIGN 2010 - 2013 Front Passenger Seat OCS Campaign 4016 for all Kizashi vehicles (A6B424)

<b>Affected Models:</b>	All 2010 - 2013 Suzuki Kizashi vehicles (A6B424)
<b>Affected Departments:</b>	Management, Service, Warranty, Parts
<b>Attachment:</b>	Customer notification letter
<b>Reference:</b>	Safety Recall Campaign 4015 Bulletin SC-85 (April 3, 2020), & Safety Recall Campaign 4015 Update SC-86 (October 8, 2021) & Campaign 4016 VIN-Parts Support Document (October 22, 2021)

The front passenger seat occupant classification system (OCS) may misclassify adult occupants as child occupants and suppress the front air bag due to the seating posture/position of the adult occupant. In a crash necessitating air bag deployment, the front air bag may not deploy with an adult occupant in the front passenger seat, increasing the risk of injury to the adult occupant.

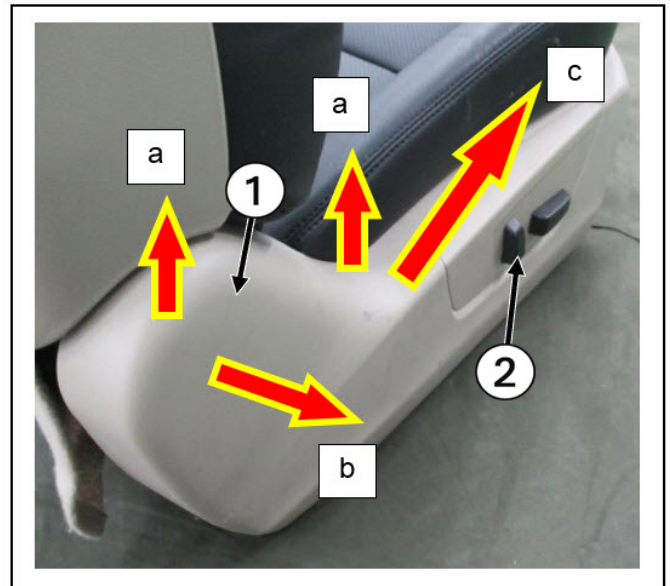
The power seat switch ② is connected to a wire harness. If the reclining mechanism outside cover ① is removed too aggressively, the harness can be damaged.

21. Remove the reclining outside cover ① in the direction of the arrows as shown in alphabetical order (a – c).

Carefully and slowly remove the reclining mechanism outside cover ① to avoid damaging the harness.

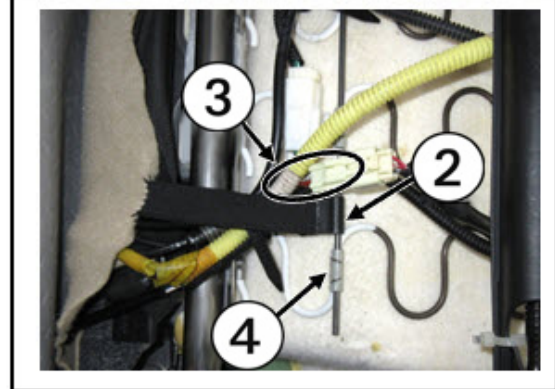
The OCS harness ③ can be damaged if it comes in contact with the edge of the clasp ④.

14. Pull the hooks ① of the cushion trim sub-assembly in the direction of the arrows, and connect the hooks ① of the cushion trim sub-assembly to the cushion frame assembly.

To prevent this, hang the hook ② in the space between the OCS harness ③ and the clasp ④.
