SERVICE BULLETIN

TCE-SB014 | October 1, 2019

THUNDER CREEK EQUIPMENT

Subject: Wheel and Wheel Center Cap Replacement

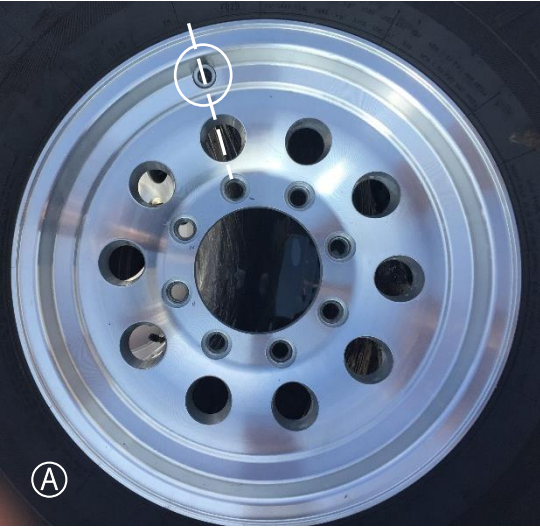
Sendel (ST20)

Ⓐ Affected wheels are the brand “Sendel” and have a valve stem (circled) that is lined up with the wheel hole.

Issue Description: The wheel center caps on affected trailers could cause the wheels to come off the trailer.

Required Action: The wheels must immediately be removed and inspected. The inspection results will determine which of the two procedures below you need to follow:

If the lug nut bore holes are undamaged and do not show any wear or threading problems, the wheels may be put back on the trailer and lug nuts re-tightened. However, the affected wheel cap should be immediately removed and cannot be used again. Since the wheel center caps are for appearances only, you may use the trailer after the wheels have been securely fastened, without the center cap. Tighten the lug nuts in stages, per the axle Owner's Manual, to 130 ft./lbs. And, contact Thunder Creek Equipment to get new wheel center caps.

The trailer cannot be used until the damaged wheels are replaced. Contact Thunder Creek Equipment for new wheels and new center caps. Install the new wheels and center caps before using the trailer.

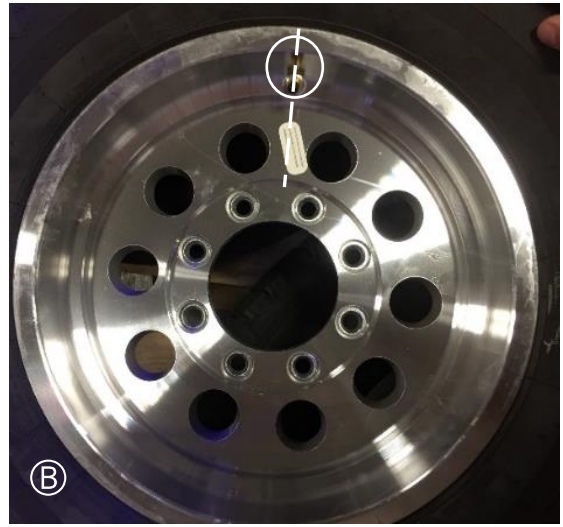
Other Brand

Ⓑ Other Brands have a valve stem (circled) that is between two wheel holes and are not included in this service bulletin.
