Compliance Recall **Code: 94L9**

Headlight Adjusting Screw Caps

June 11, 2019

U.S.A.: 2012-2020 MY Volkswagen Passat & 2018-2019 MY Volkswagen Atlas

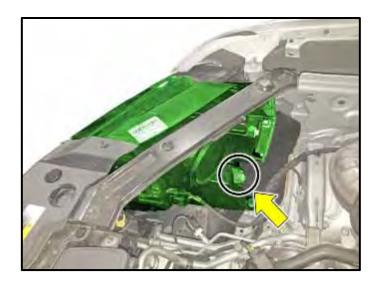
- Inspect horizontal adjustment screws on both headlights and install a cap, if necessary.
- Atlas shown.

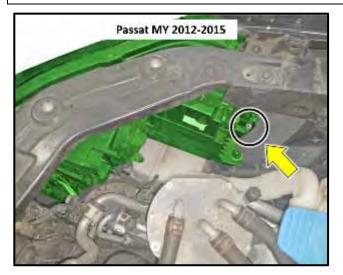
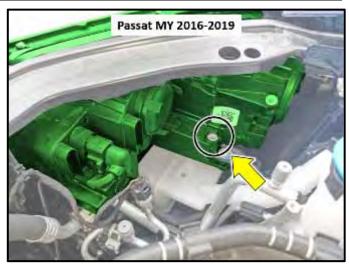
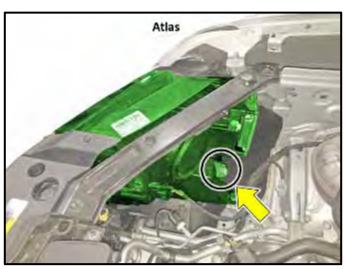
- Both headlights must be inspected.
- Inspect for the presence of a cap on the horizontal adjustment screws.
- If the cap is missing (as shown in the photos), install a new cap into the horizontal adjustment screw.
- Ensure the cap is fully seated into the horizontal adjustment screw.

- DO NOT install caps on any other adjustment screws.
- The factory installed caps may be either black or white.
- Right side shown, left side is similar.
