Thor Motor Coach Recall Repair Instructions

Recall #	19V-417 2019-266		
Description/Title:	BB35/BH35 Junction Box		
Affected Product Line(s):	Certain MY 2019/2020 Magnitude & Omni motorhomes		
Service Campaign # :	RC000169	Released Date:	07/01/2019
Repair Code:	Inspect: TMCRC80483Y Repair: TMCRC80483V	Document Date:	07/01/2019
Time Allowed:	Inspect: 0.1 Repair: 0.4	Document Revision:	A

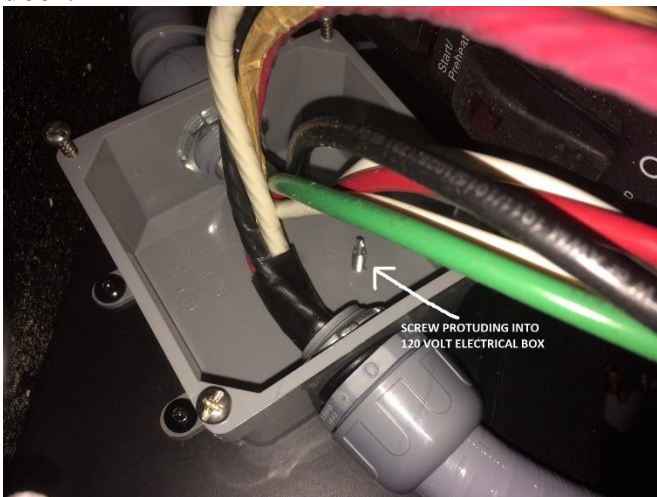
It has been discovered that on certain model year 2019/2020 Magnitude & Omni motorhomes, an extra screw had been inserted into the center of the junction box that makes connection to the generator and secures the junction box to the compartment wall. While the motorhome is in motion, the wires located in the junction box move around and the screw point has the potential to start rubbing the insulation off the wires. If the screw point starts rubbing the insulation off the wires located in the junction box, this could potentially lead to a short or fire, which could result in property damage, injury, or death.

3. Inspect inside for extra screw through middle of box as show in picture below.
If there is no extra screw, you are done with recall.
If screw is present, please remove by accessing back of box via 1st compartment door.

6. Caulk the hole in the junction box that was left from removing the screw to prevent any water intrusion.
