## STEERING BOX SLIP SHAFT BOLT TORQUE

<b>Bulletin Type:</b>	UPCOMING RECALL
<b>Bulletin #:</b>	YET TO BE ASSIGNED
<b>Job Code:</b>	9803435 <i>Please hold claims until Recall number is assigned.</i>
<b>Flat Rate:</b>	RC024 Inspect only NO repair required .1hr RC025 Inspect and repair .3 hr

<b>Publication Date:</b>	Pre notification 6-6-2019
<b>Make:</b>	Entegra
<b>Model(s):</b>	Anthem Cornerstone
<b>Model Year:</b>	2020

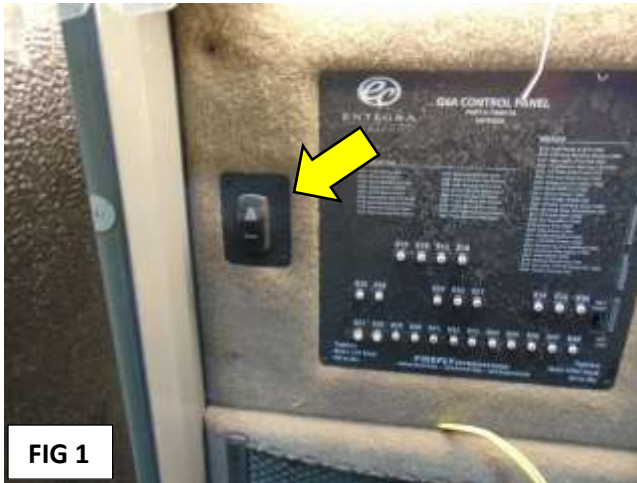
**FIG 1:** Open the generator compartment using the switch (arrow) inside the driver side front electrical compartment.

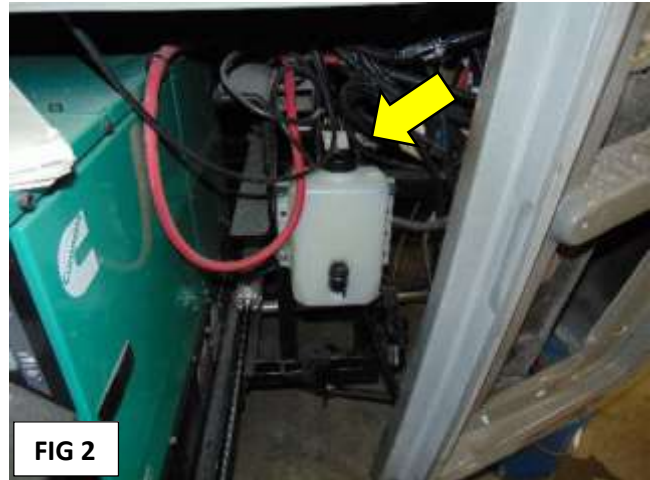
**FIG 2:** Bolt is located on the right side of the generator behind the washer fluid bottle (arrow).

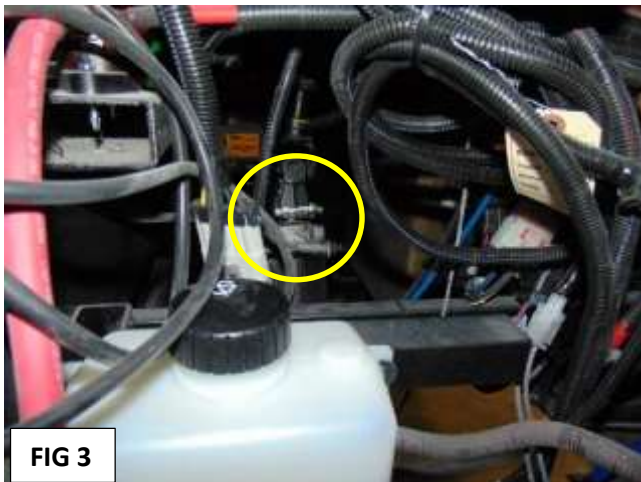
**FIG 3:** Bolt location is circled in this photo.

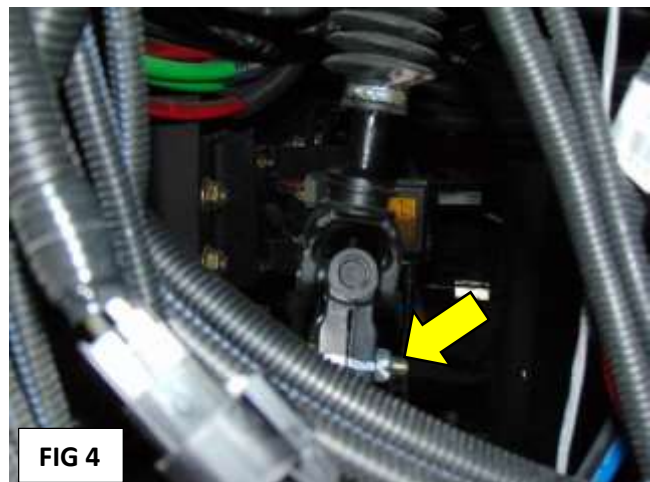
**FIG 4:** Arrow is pointing to the Steering Slip Shaft bolt.

- Move wiring out of the way to see it.
- **IF WHITE LINE RUNNING FROM BOLT HEAD TO THE NUT – NO REPAIR IS REQUIRED – BOLT WAS TORQUED TO 55FT LBS PRIOR TO SHIPPING.**

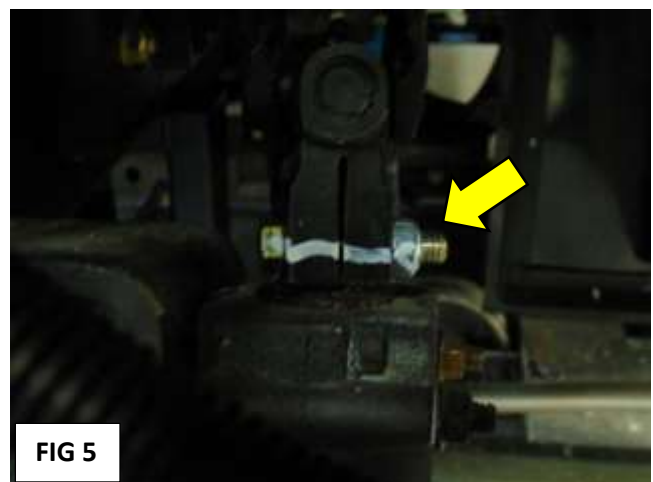
**FIG 5: IF WHITE LINE IS NOT VISIBLE PROCEED TO NEXT STEP TO COMPLETE REMEDY.**

Bolt head size takes a 5/8" socket or wrench.

- Nut size takes an 11/16" socket
- Use a torque wrench and torque the nut to 55 ft./lbs.
- Mark the bolt with a white line as shown in photo to indicate the bolt has been torqued properly.
