# Recall Campaign

Daimler Trucks  
North America LLC

NHTSA #19V-444

## Subject: TBB Bendix Air Disc Brake Calipers

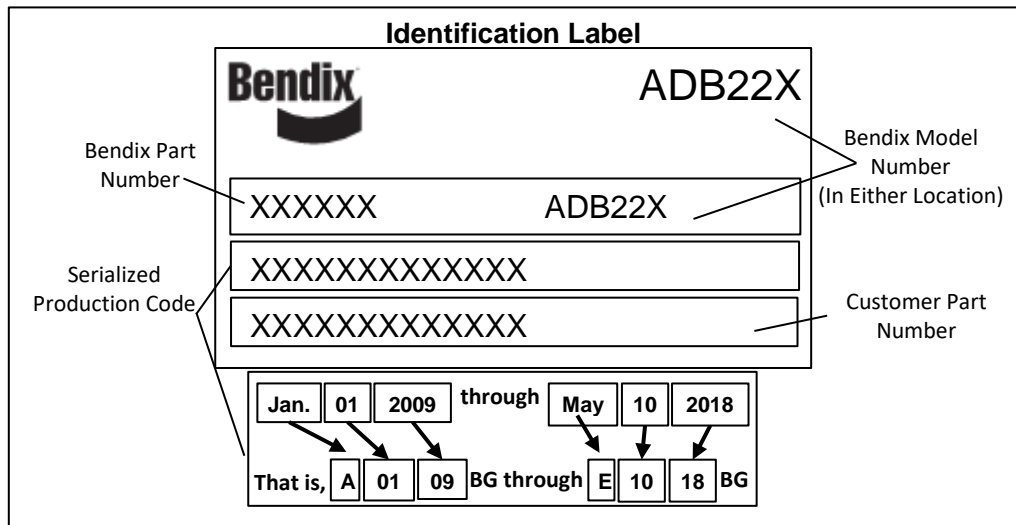
Figure 2: Bendix Label and Date Code Range

If the manufacturing date code is January 2, 2009, through May 10, 2018, replace the caliper. The majority of buses will require a caliper replacement.

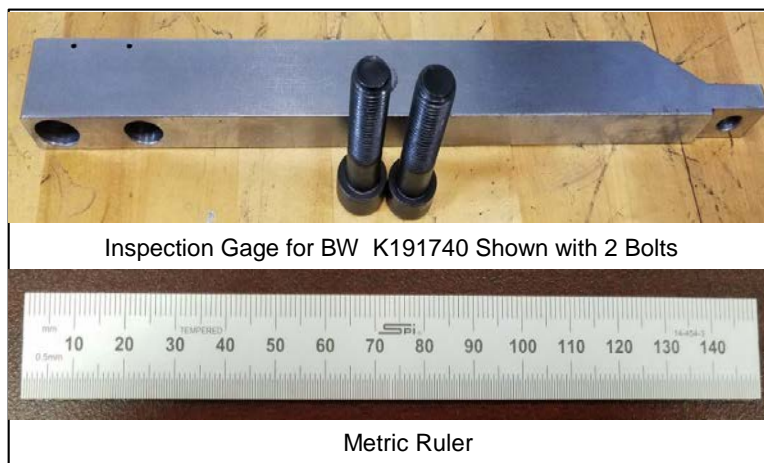
**Figure 4: Items Needed for Inspection**

NOTE: A small number of replacement calipers for FL818B may have a defect and should not be used. Calipers that pass this inspection are good and may be used for the FL818 repair. Calipers that fail this inspection should not be used, return them to your facing PDC as defective and use a caliper that passes this inspection.

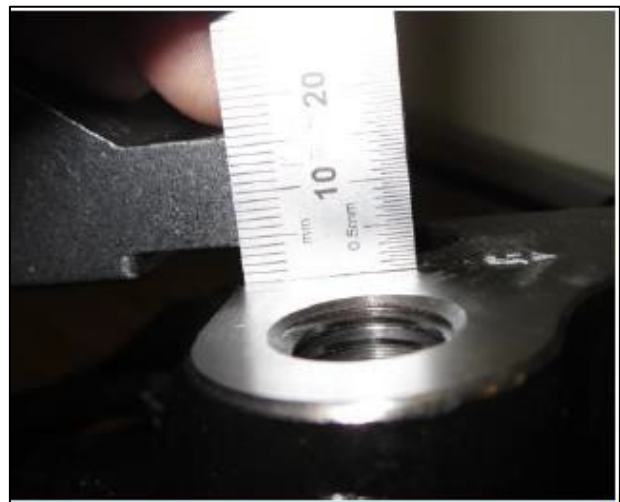
Figure 7: Measuring the Gap

If the average is **less than 5 mm**, the caliper passes the inspection. Continue with the caliper replacement.

If the average is **5 mm or more**, the caliper fails the inspection. Return the caliper to your facing PDC as defective. Get a new caliper and repeat the inspection. Continue the replacement with a caliper that passes this inspection.
