Product Safety Recall

N192263640 Steering Knuckle Stopper Bolt – US Only

Release Date: July 2019

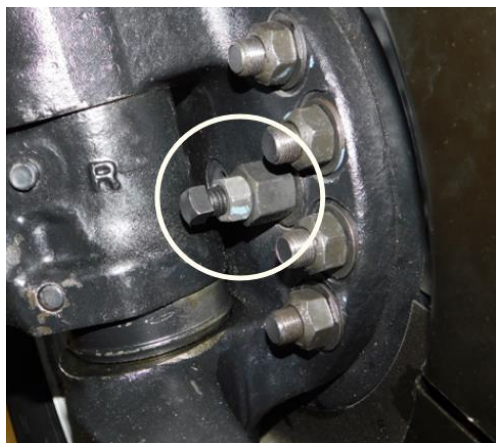
Right Front Stop Bolt

1) Stop Bolt 2) Jam Nut 3) Adapter Base

2. Start the engine and turn the steering wheel all the way to the left in order to access the right (passenger side) stop screw, as shown. Shut the engine off after turning the steering wheel.

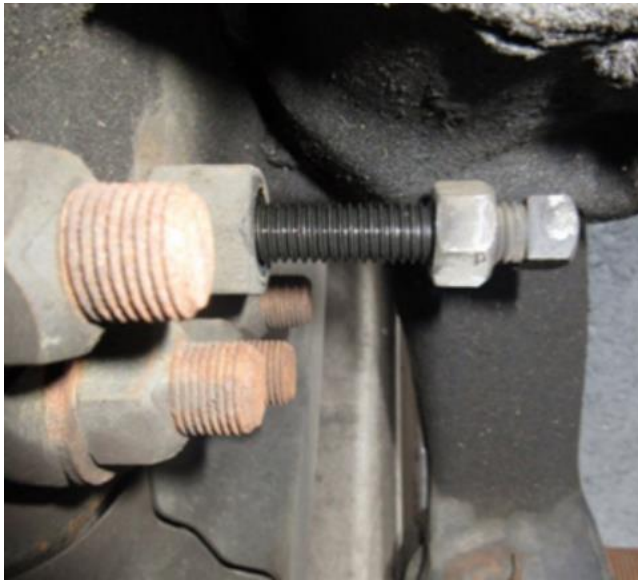
5360552

10. Inspect the stop bolt jam nut to determine whether it is loose, or if the stop bolt has backed out of position, become bent (as shown), or is missing completely.
- If the assembly is not tight, or is damaged in any way, print the template on the next page for steering bolt adjustment and proceed directly to step 11 in this procedure to replace the stop bolt adapter assembly.
 - If the stop bolt and jam nut are in place and tight, go to step 3 and repeat this service procedure through Step 8 for the left (driver's) side.
 - Once both sides have been completed, go to step 26.
