# Safety Recall

## Code: 69Z4

**Subject** Passenger Occupant Detection System (PODS)

**Release Date** September 12, 2019

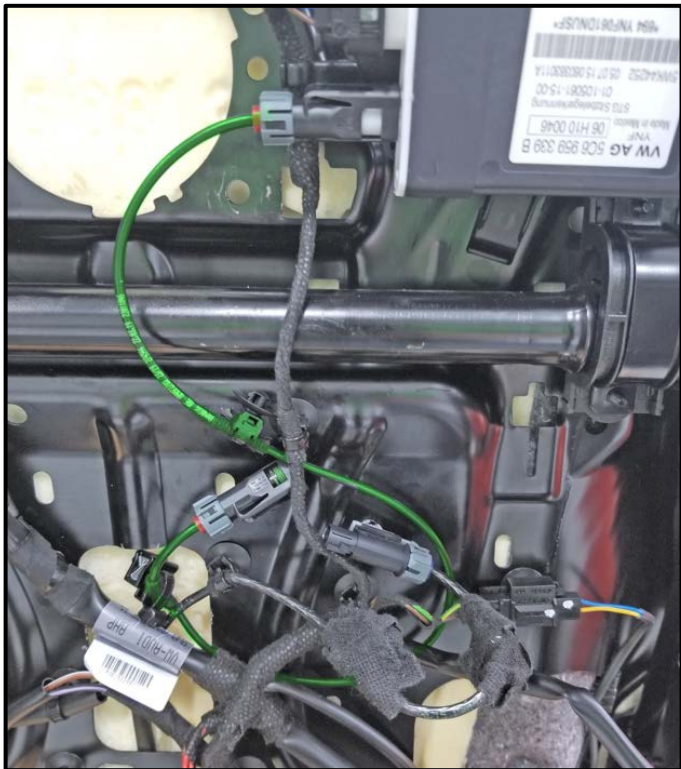
**Repair Overview**

**Problem Description** Due to a mostly temporary loose contact at the connector, the passenger occupant detection system (PODS) may detect an error and switch off the passenger airbag even though the seat may be occupied. As designed, a warning light in the instrument panel comes on together with an acoustic warning sound and an error message is displayed in the instrument cluster. The airbag indicator light shows "passenger airbag off". In the event of a crash there would be an increased risk of injury to the occupant seated in the front passenger seat if the passenger airbag is switched off/not working.

- Install new PODS control module wiring harness.
  - The new wiring harness will plug into the PODS control module.
  - The existing connector to the PODS control module must also be replaced.

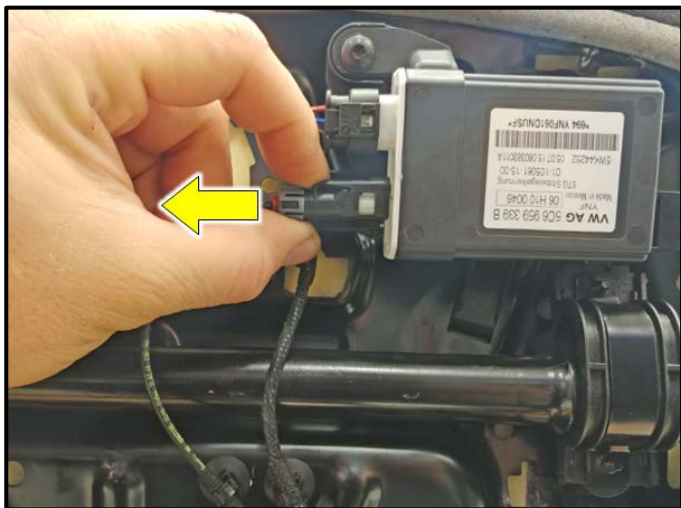
### Disconnect PODS control module:

The connector must be removed exactly parallel with the PODS control module. The center pin in the PODS control module is fragile and must not be bent during removal. A damaged center pin will cause PODS faults. Damage to the PODS control module is not covered under this action.

- For vehicles with Criteria 01, there are two versions of PODS control module installation position depending on if the seat is equipped with a storage compartment.
- Press the locking tab and disconnect PODS control module connector.

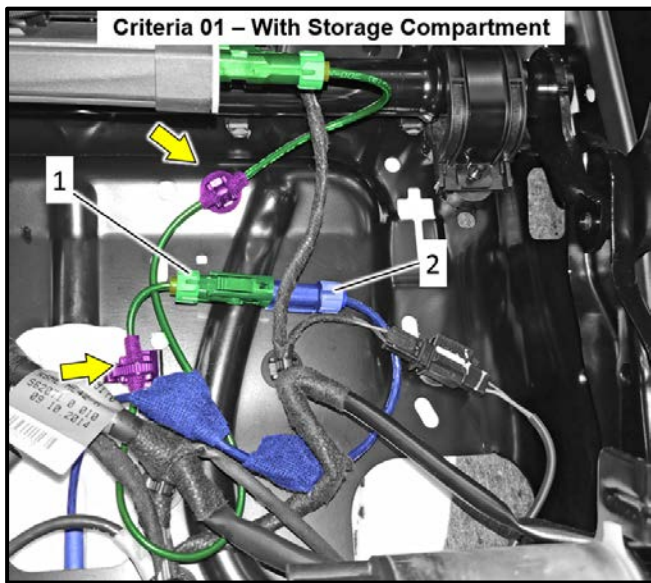
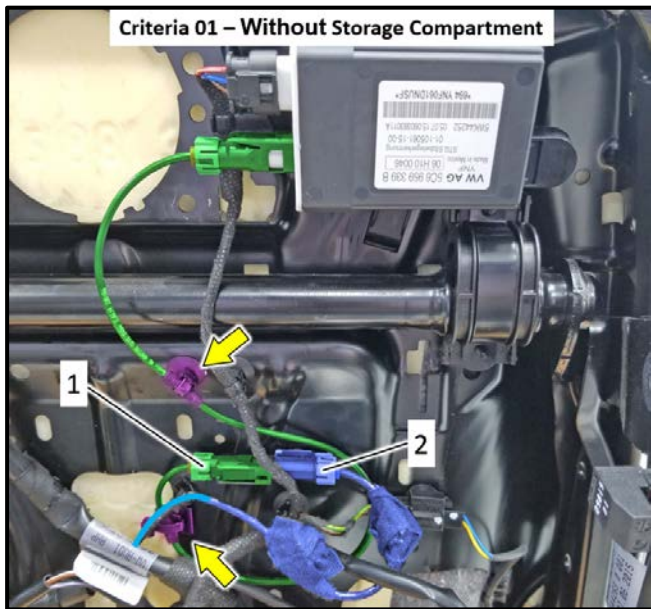
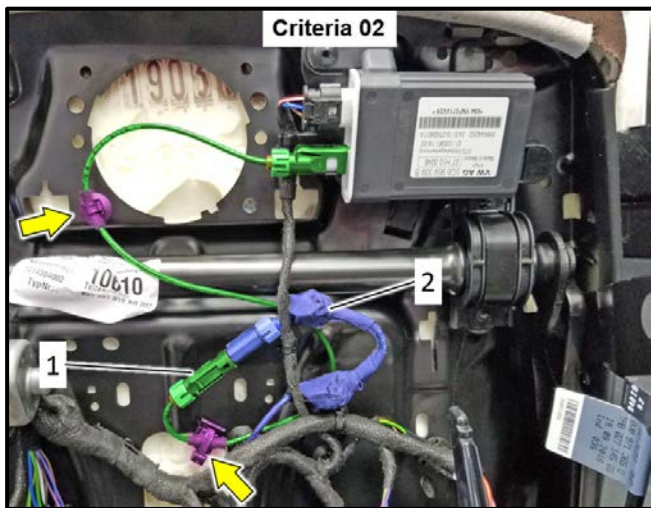
## Installing wiring harness:

The connector must be installed exactly parallel with the PODS control module. The center pin in the PODS control module is fragile and must not be bent during installation. A damaged center pin will cause PODS faults. Damage to PODS control module is not covered under this action.

- Route the new harness under the existing seat wiring in an “S” pattern.
- Plug the new wiring harness into the PODS control module.
- The harness should not have any kinks.
- The harness bends should have a minimum radius of 2 cm.
- Secure clips <arrows> to seat frame.
- Connect new harness <1> to modified seat harness <2>.
