Vehicle Safety Recall - Technical Service Bulletin

Attention: McNeilus Product Owner
Subject: Battery Cables Rerouted to Avoid Rubbing
Models Affected: Front End Loader
Model Year: 2019
Date: June 2019

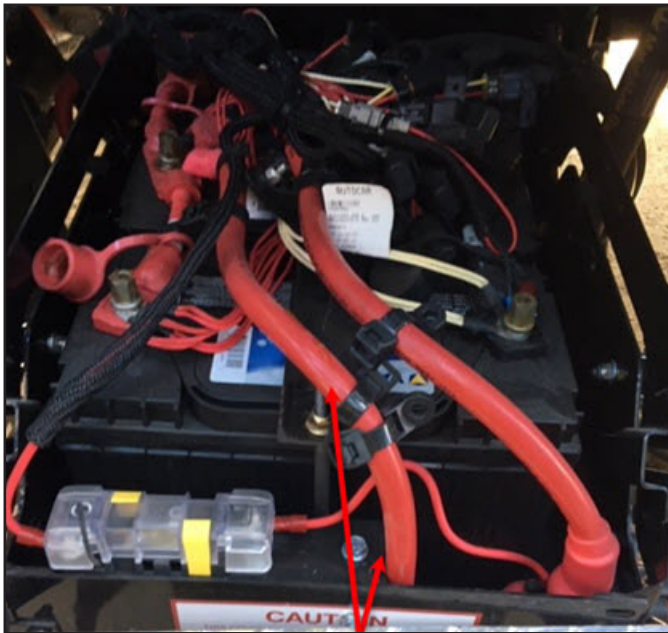
Figure 1 Incorrect routing. Battery cables are rubbing on bolts and the fuse box bracket.

3. Reroute the battery cables so that they do not touch or rub on against bolts or the fuse box bracket. Figure 1 shows incorrectly routed battery cables (page 4). Figure 2 shows correctly routed battery cables that are not rubbing (page 4).
4. When the cables are rerouted, this procedure is complete. Reconnect the battery switch or cables.
5. Remove your company's Lockout/Tagout procedure. If your company does not have a Lockout/Tagout procedure, follow OSHA 1910.147 and 1910.146 Confined Space as appropriate. Remove the wheel chocks, remove the truck from PARK, and disengage the parking brake.

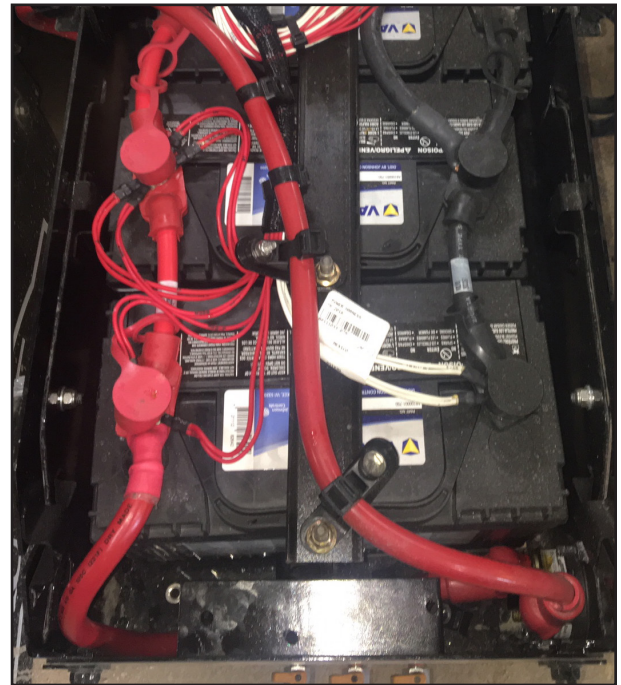
Figure 2 Correct routing. Battery cables are routed away from bolts and the fuse box bracket.
