VSR-TSB-026

NHTSA Campaign Number: 19V-486

Subject: Hydraulic Steering Pump Hoses Routing Inspection

Models Affected: Oshkosh S-Series Front Discharge Mixer

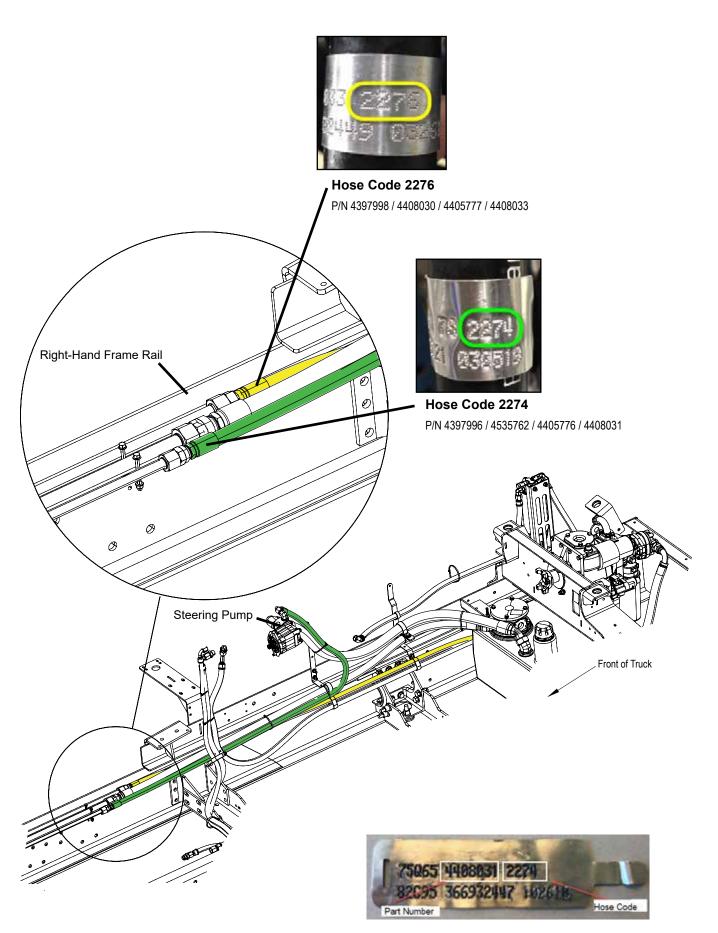
Figure 1

- 3. Locate the three hardline to hose connections located on the right-hand side frame rail next to the transmission bell housing. See Figure 1. Use the aluminum code identification tags affixed to the hose to identify the hoses.
- 4. Check that the hose <u>closest to the right-hand frame rail</u> has a "2276" hose code identification tag. Hose "2276" is shown in yellow in Figure 1.
- 5. Check that the hose <u>closest to the transmission bell housing</u> has a "2274" hose code identification tag. Hose "2274" is shown in green in Figure 1.

- A. If hoses 2274 and 2276 are installed correctly, this procedure is complete and no further action is required. Remove your company's Lockout/Tagout procedure. If your company does not have a Lockout/Tagout procedure, follow OSHA 1910.147 and 1910.146 Confined Space as appropriate. Remove the wheel chocks. Return the vehicle to service.
- B. If the hoses are incorrectly installed, **Do not run or use the vehicle**, maintain your company's Lockout/ Tagout on the vehicle, and contact S-Series Service Support at 888-686-7278 immediately.
