PRODUCT CAMPAIGN BULLETIN

APPLICABILITY: 2019MY Legacy and Outback
SUBJECT: Front Duct Panel Spot Weld

NUMBER: WUH-93R
DATE: 06/26/19
NHTSA: 19V493
REVISED: 07/17/19

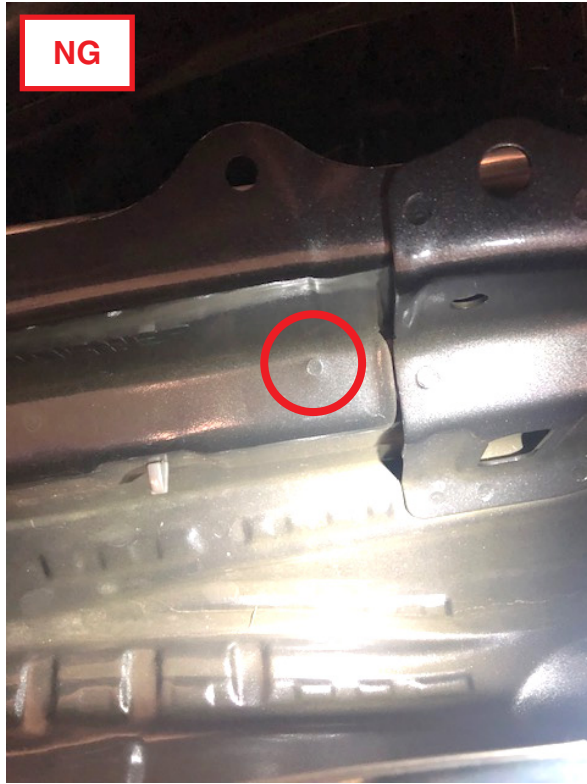
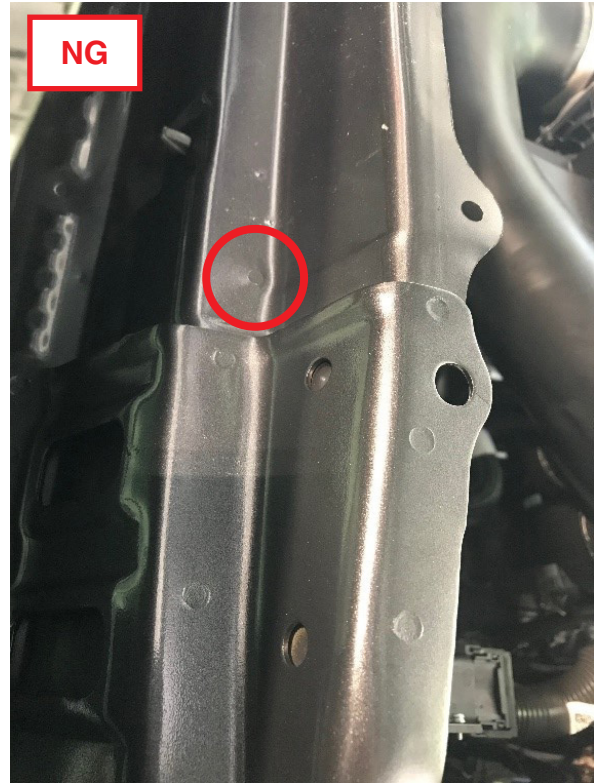
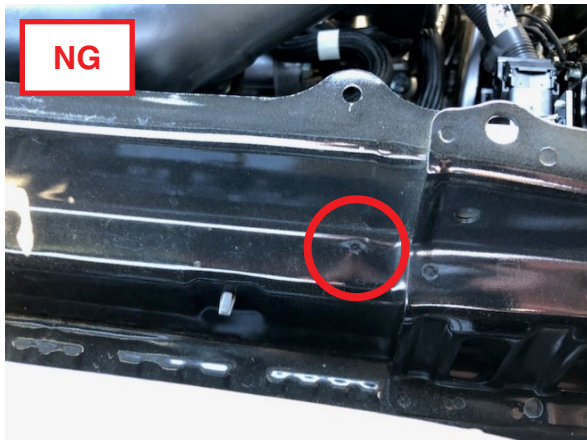
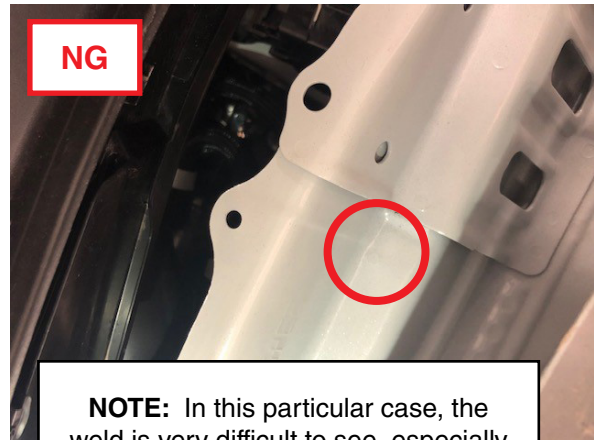
APPENDIX A: Examples of NG (“B” Jig) and OK (“A” Jig) Duct Panel Weld Inspections

NOTE: In this particular case, the weld is very difficult to see, especially in the supplied photo. Keep in mind, the vehicle's color can make the weld difficult to identify and photograph for making the OK / NG determination.
