RECALL CAMPAIGN BULLETIN

Classification: EL19-019	Reference: NTB19-053	Date: June 26, 2019
-----------------------------	-------------------------	------------------------

VOLUNTARY SAFETY RECALL CAMPAIGN 2017-2019 TITAN; GENERATOR HARNESS

CAMPAIGN ID #: PC673
APPLIED VEHICLES: 2017-2019 Titan (A61)
APPLIED ENGINE: Gasoline V8 (VK56VD)

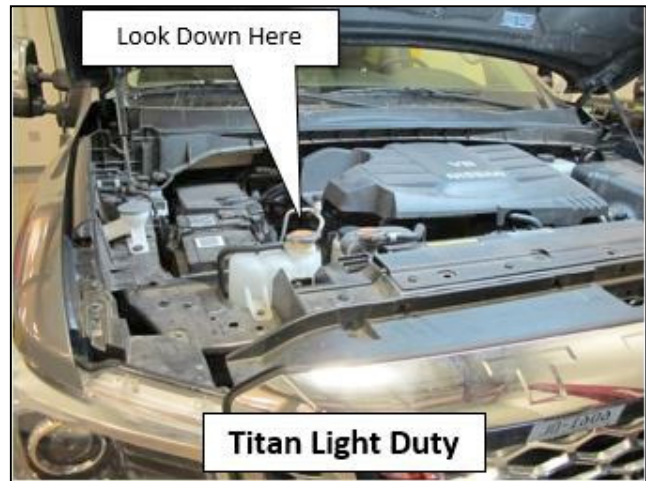
Figure 1

1. Open the hood.
2. Look down into the area referenced in Figure 1.
 - The generator harness is located between the yellow engine oil dipstick and the power steering pump.

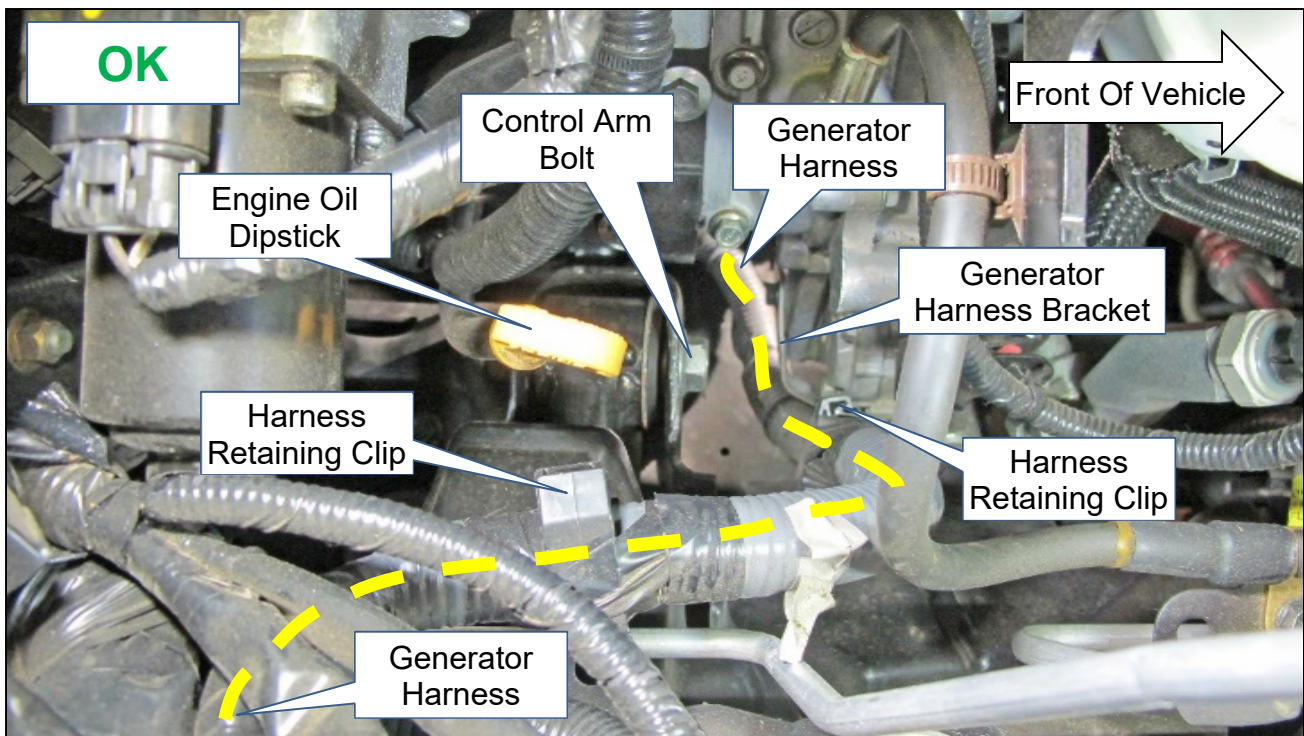
Figure 2

3. Locate the generator harness.
4. Visually inspect the generator harness routing (Figure 2 shows a properly routed generator harness).

NOTE: The generator harness is highlighted with yellow dashes.

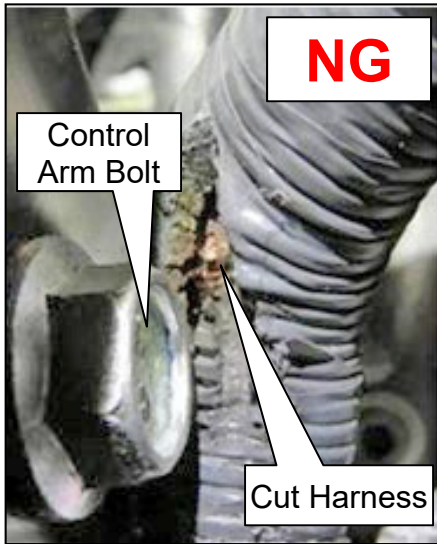
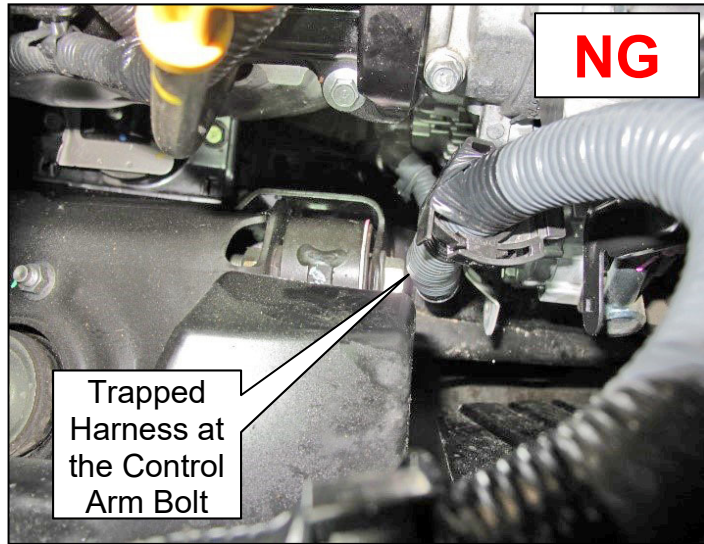
- Follow the length of the generator harness and ensure the harness is not trapped, pinched, or cut (Figure 3 and Figure 4 show an improperly routed generator harness).

- If the generator harness **IS NOT** routed correctly, go to step 5.
 - If the generator harness **IS** routed correctly, go to step 6.
5. Closely inspect the generator harness in the area where it is misrouted.
 - If there is **NO VISIBLE DAMAGE** of any kind to any of the wires within the generator harness, properly route and secure the harness, and ensure the generator harness outer covering is sufficient. Continue to step 6.
 - If there is **VISIBLE DAMAGE** to any of the individual wires within the generator harness, replace the generator harness shown in Figure 7 and highlighted in yellow. Skip to step 7.
 6. Close the hood, and submit a warranty claim using OP Code PC6730 (See **CLAIMS INFORMATION** on the last page).
 7. Close the hood and submit a warranty claim using OP Code PC6731 (See **CLAIMS INFORMATION** on the last page).

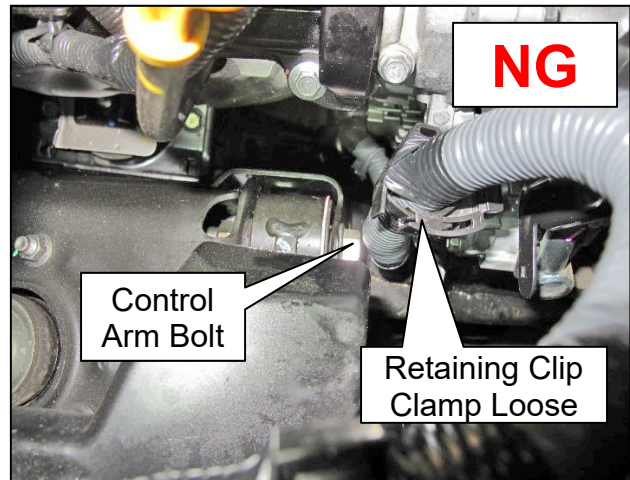
Figure 5

- The two (2) generator harness retaining clip clamps should be fully locked around the generator harness.

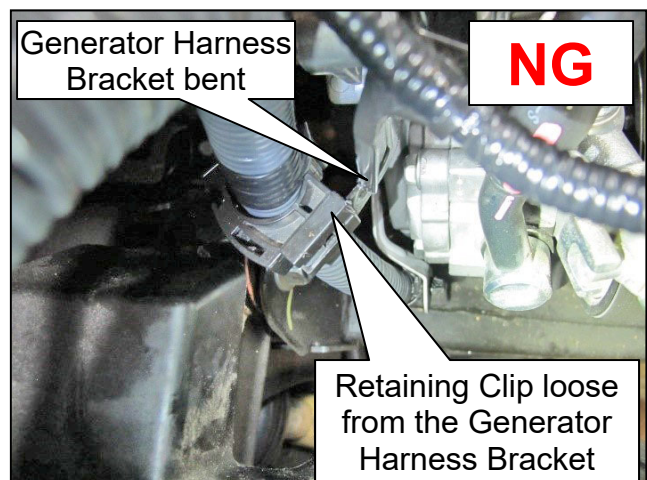
Figure 6

- The two (2) generator harness retaining clips should be fully locked into the generator harness brackets.
- Ensure the generator harness brackets are not bent which could allow the generator harness to rub on the control arm bolt.
