REPAIR PROCEDURE: PCM REPROGRAMMING by MMDS (IDS)**NOTE:**

Service Caution for Reprogramming

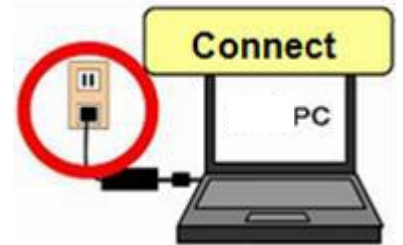
NOTE: Poor connection between the vehicle and M-MDS and/or low voltage may result in abnormal termination and/or data corruption.

- a. Make sure that the following connections are firmly connected, and then do NOT touch the VCM and DLC cable to prevent from causing noise and poor connection.
- Between the vehicle-side connector and the DLC cable
 - Between the PC-side connector and USB port of PC
