PRODUCT CAMPAIGN BULLETIN

APPLICABILITY: 2019MY Ascent **NUMBER:** WUI-94R
SUBJECT: STOP SALE: Propeller Shaft **DATE:** 07/02/19
REVISED: 07/16/19

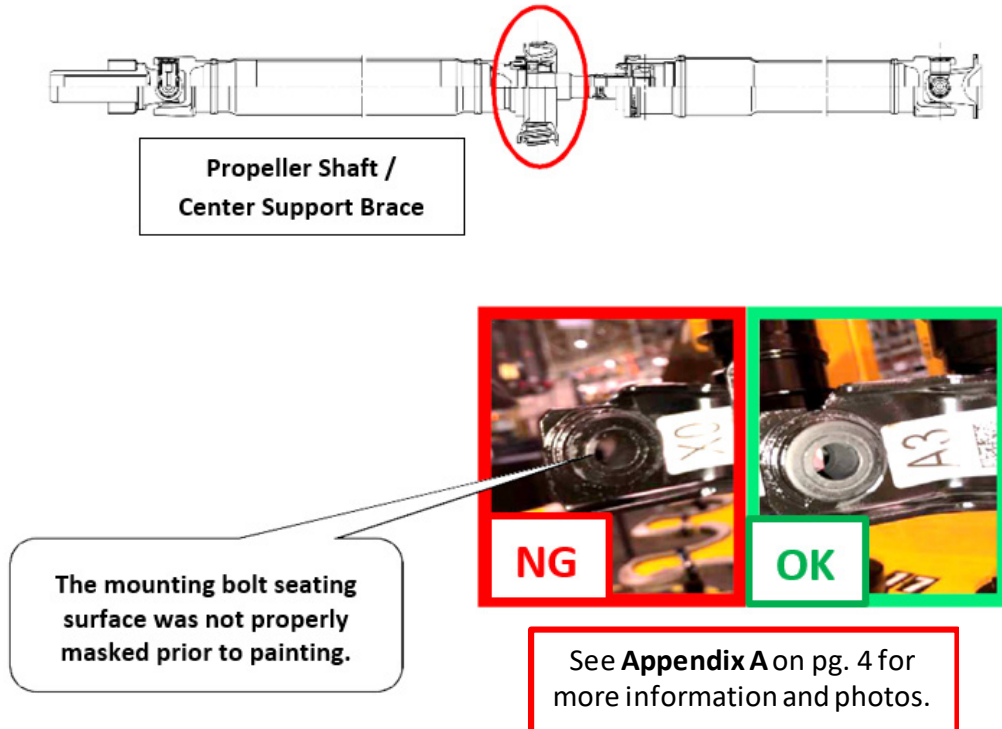
During manufacture of the propeller shaft assembly, the mounting surfaces for the two (2) center support brace bolts were inadvertently painted as shown in the **NG** example photo below. The mounting surface should be unpainted as shown in the **OK** photo. Because of this, the mounting bolt torque applied during propeller shaft installation may relax due to continued vibration. This service procedure involves replacing the propeller shaft assembly and the related hardware.

This recall involves replacement of the propeller shaft assembly.

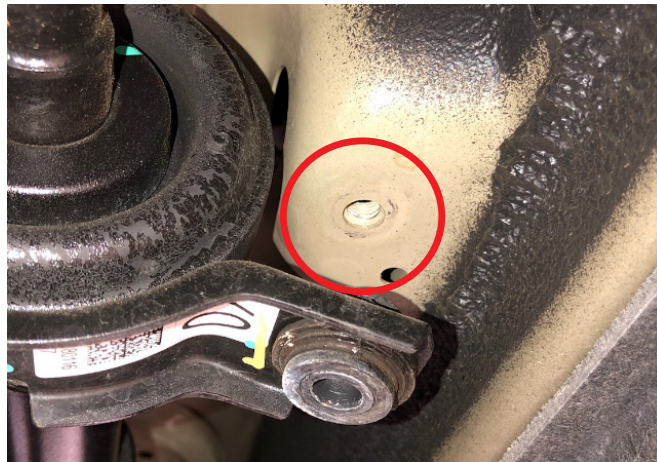
VERY IMPORTANT: After removing the original propeller shaft, confirm there is no residual **BLACK** paint remaining from the center support brace on both mounting surfaces of the body. The mounting surfaces **must be clean** as shown below. Use a mild solvent on a clean shop cloth to clean the area if necessary. **NEVER** use an abrasive disc or otherwise remove the tan-colored protective underbody finish coat. Doing so will expose bare metal making it susceptible to corrosion / rust.

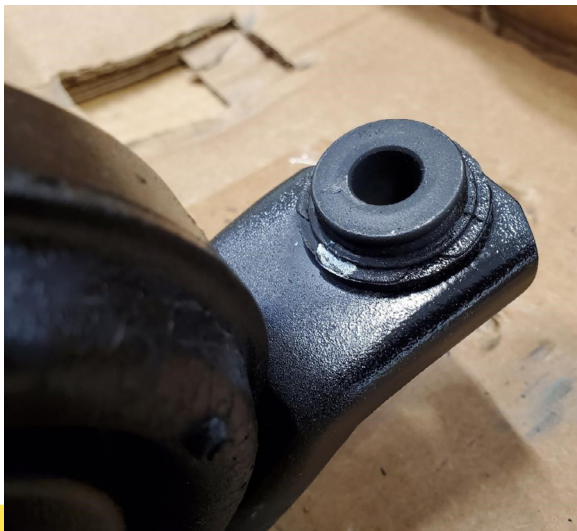
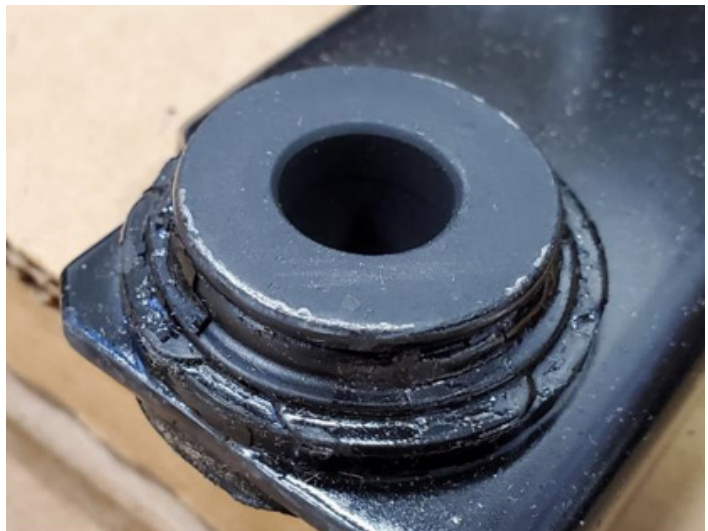
- These **OK** photos show the body side of replacement parts with a much lighter, uniform coating.

NOTE: The replacement propeller shafts for this procedure have all been confirmed to be **OK** for use. There is no need to inspect these parts for anything other than possible shipping damage and to insure the part is correct for the application.
