## Maserati Technical Bulletin

Date: July 29, 2019  
Bulletin Number: MAS001935 – MTB -1914 /A  
Recall 387 – LED Headlight Adjustment  
Supersedes: N/A  
Section: Compliance

**Model Type:** Levante (M161)

**Subject:** Vehicle Safety Recall Campaign 387, LED Headlight Adjustment

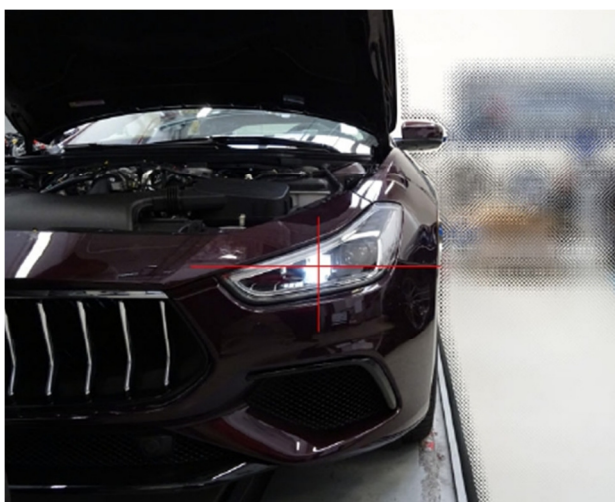
Fig.1

Maserati S.p.A., MNA and MC have determined that the above described vehicles equipped with the optional full LED headlights with Adaptive Front Lighting System ("AFLS") did not have the AFLS properly adjusted during the vehicle assembly process. Headlights adjusted above the maximum gradient allowed may impair the vision of drivers of other vehicles, and can cause a vehicle crash without prior warning. Out of an abundance of caution, Maserati has decided to initiate this Voluntary Safety Recall #387 to adjust the AFLS properly (Fig.1).

1. Check that the vehicle is included in this Recall Campaign, and that the repair has not been previously performed.
2. Perform the adjustment procedures to the "AFLS" LED Headlights as shown below and in Section 8.30.002.40 of the Workshop Manual.
3. The recall procedure is now complete.

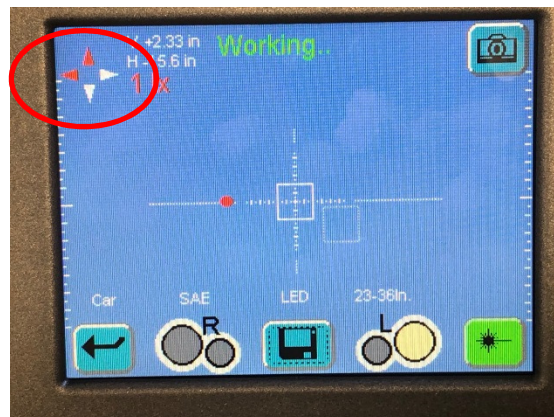
22. The screen shows the status of the headlamp: outside top tolerance, outside bottom tolerance. ►, outside right tolerance. ◄ outside left tolerance

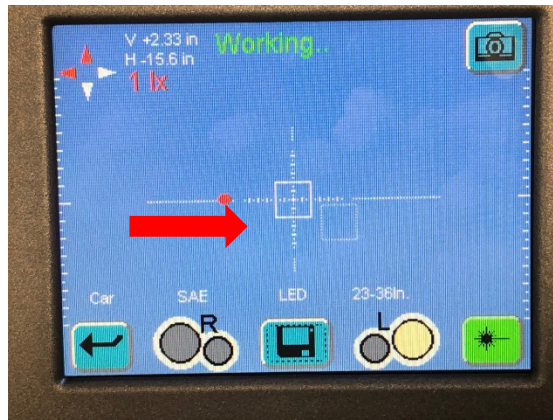
23. A red dot indicates that the headlamp is not centered correctly. Your goal is to aim the beam into the dotted square displayed on the screen.
