MMDi Corporation

Tow King Top Wind Jack Repair Instructions

Jack Nut Repair on Tow King Jacks

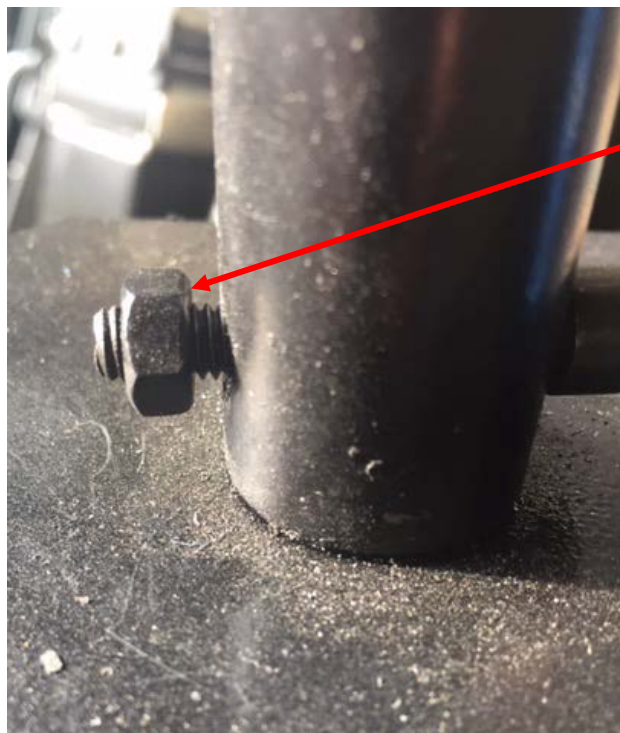
Issue - As seen in IMG 3810 (bottom left), the base of the handle was shipped with a regular nut instead of a locking nut. A locking nut would ensure the nut does not come off the handle sleeve bolt.

REGULAR NUT

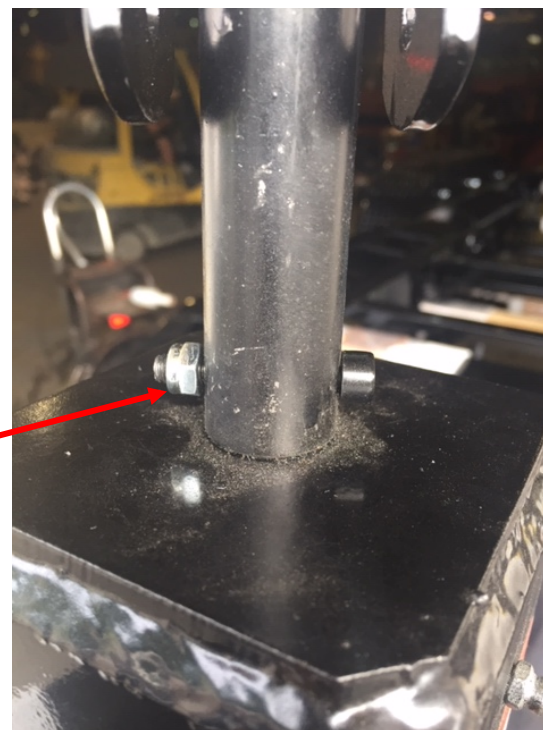
In IMG 3806 (bottom right), the regular nut is replaced with a nylon locking nut, which will not allow the nut to work its way off the handle sleeve bolt.

NYLON LOCK NUT

- 6mm x 35mm bolt
 - Fastenal Bolt Part Number 11103347 <https://www.fastenal.com/products/details/11103347>
- 6mm nylock nut
 - Fastenal Nut Part Number 1140155 <https://www.fastenal.com/product?query=1140155&fsi=1>
