Thor Motor Coach Recall Repair Instructions

| Description/Title: | MORryde Battery Tray | | |
| Affected Product Line(s): | Certain MY 2019/2020 Magnitude & Omni motorhomes | | |
| Service Campaign # : | RC000171 | Released Date: | 08/5/2019 |

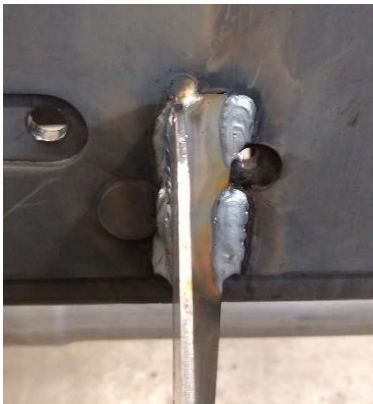
Before Repair

The battery tray that is welded onto the frame of F550 chassis could be compromised due to inadequate welds. Production run on a specific line at MORryde had inadequate weld applied. The inadequate welds have a potential of failing causing the battery tray to break free from the chassis and allowing the contents of the tray to discharge. This could potentially cause personal injury, property damage, a crash. In addition, if the battery posts or cables make contact with surrounding metal components, this could cause an electrical short, increasing the risk of a potential fire.

2. Locate the battery tray and disconnect both house batteries then wrap batteries, battery cables and fuse boxes with weld resistant blankets.
3. Weld one of the 1" X 1" angles to the inside or outside of each battery tray leg. The angle should be placed flush up against the side of the battery tray and flat up against the chassis. At least two inches of the angle should make contact to the battery tray to provide the required support. Weld all vertical seams available where the angle touches the battery tray or chassis rail. Do not weld on the chassis frame bend radius.
