Mercedes-Benz

Campaign No. 2019080005, August 2019

SUBJECT: **Model GLE-Class, GLS-Class vehicles, (167/X167 platform)  
Model Year 2020  
Check condensation drain hose at right and left of air conditioning system,  
rework if necessary**

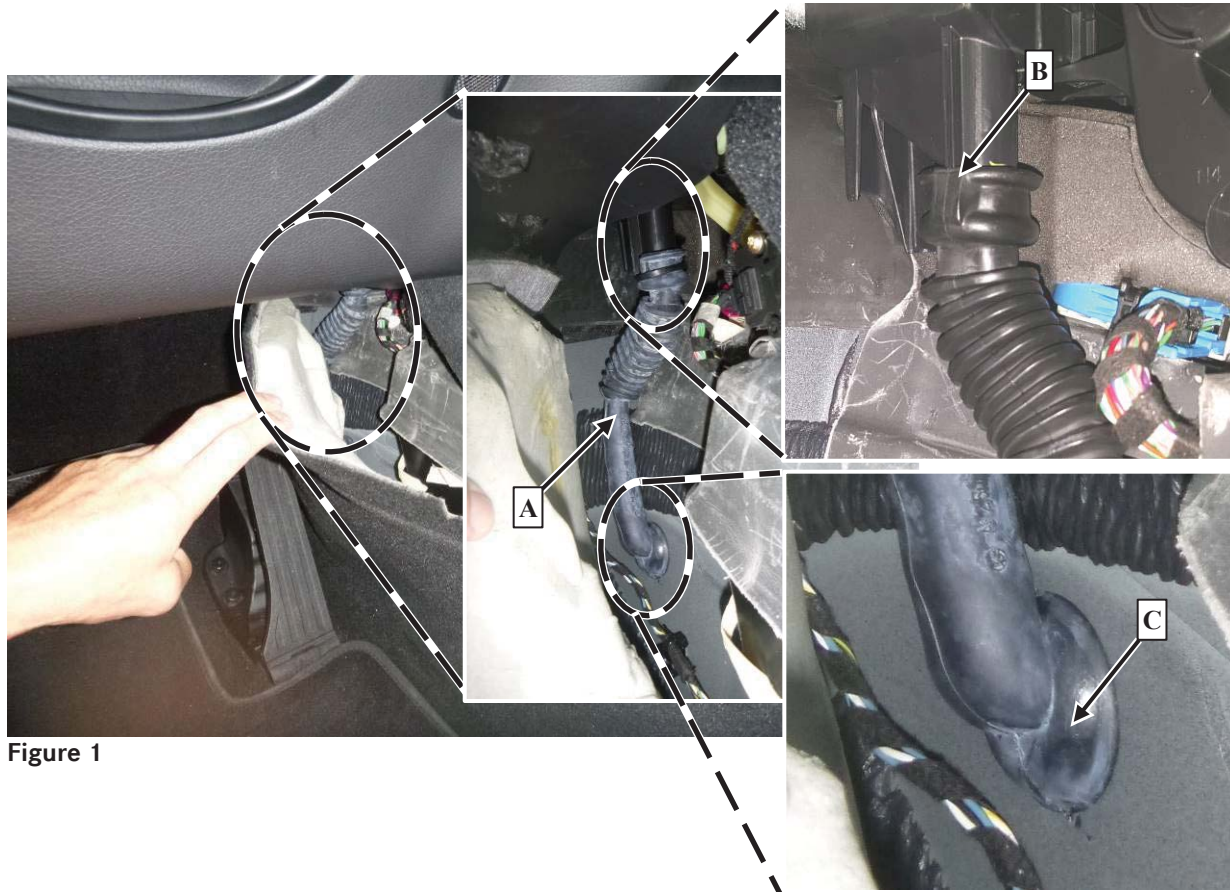
Figure 1

1. Release floor covering in footwell on driver's and front passenger side and check condensation drain hose at right and left of air conditioning system (**Figure 1**).
  - i** The condensation drain hose must be installed without creases in proper-seated position and inserted correctly on the heater box or tunnel (**C, Figure 1**).
  - i** The cutout (**B, Figure 1**) must be positioned correctly on the fitting of the heater box.
  - i** There must **not be any visible or noticeable traces of water**.

- a. Condensation drain hose **not** fastened correctly: Carry out **check/test procedure B**.
- b. Condensation drain hose fastened correctly: **End measure**.

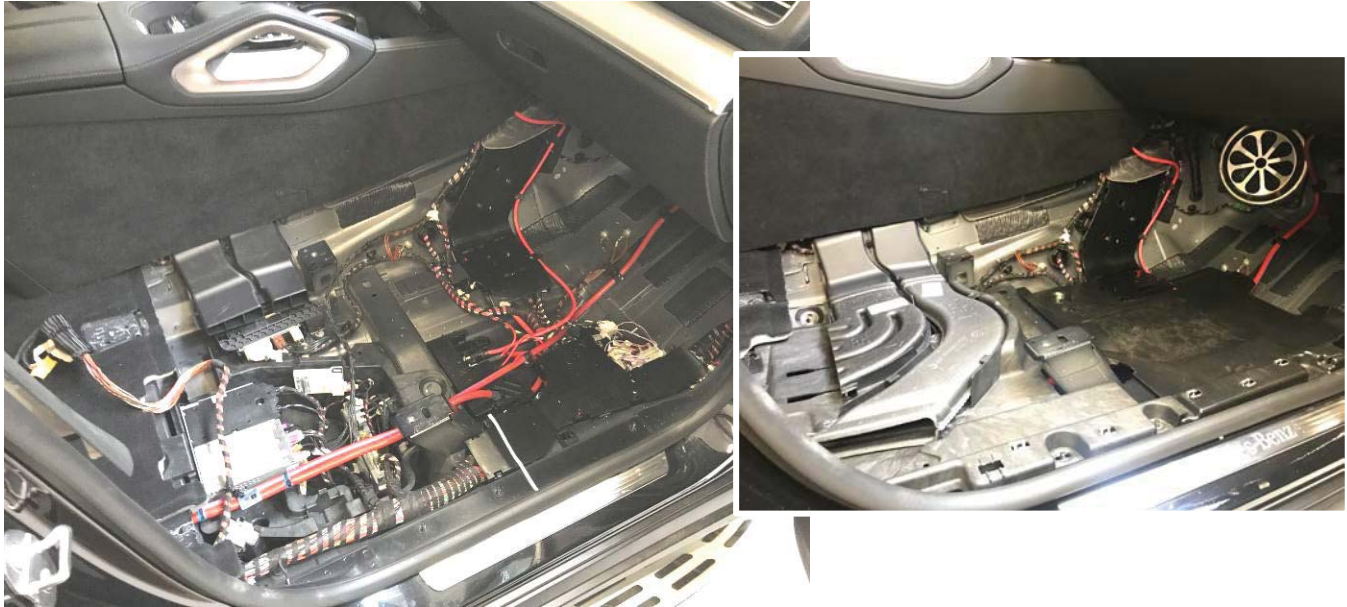
Figure 2

1. Remove front floor covering and covers above the electrical assemblies in the foot well of the incorrectly mounted drain hose.

2. Check accessible electrical connections in the moist area for moisture and corrosion.
  - a. Condensation drain hose **not** fastened correctly and **minor** traces of water present: Carry out **work procedure A**.
  - b. Condensation drain hose **not** fastened correctly and **major** traces of water present: Carry out **work procedure B**.
