SIB 32 07 19

2020-01-10

RECALL 19V-601: STEERING GEAR TIE ROD

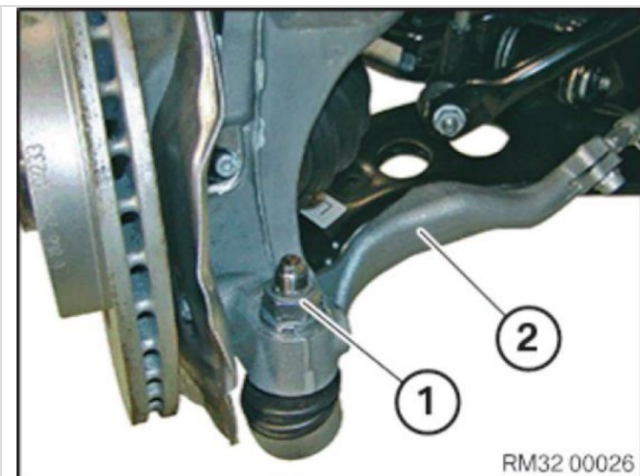
2. Loosen nut (1) on left and right swivel bearing

- Release tie rod (2) from swivel bearings

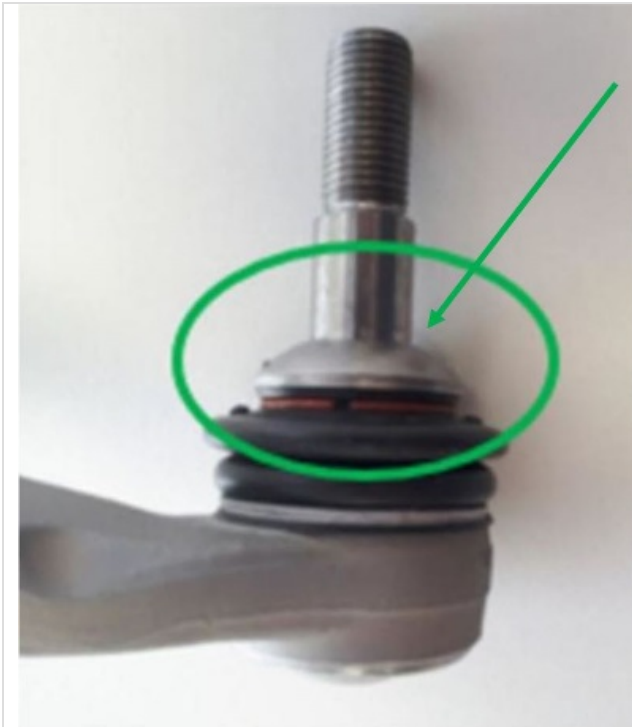
- Cone collar disc installed, knurling not visible

- Yes = No further action required. Reinstall tie rod as per repair manual **RA 32 21 151** and properly torque the **new** nut
- No = Proceed to next step

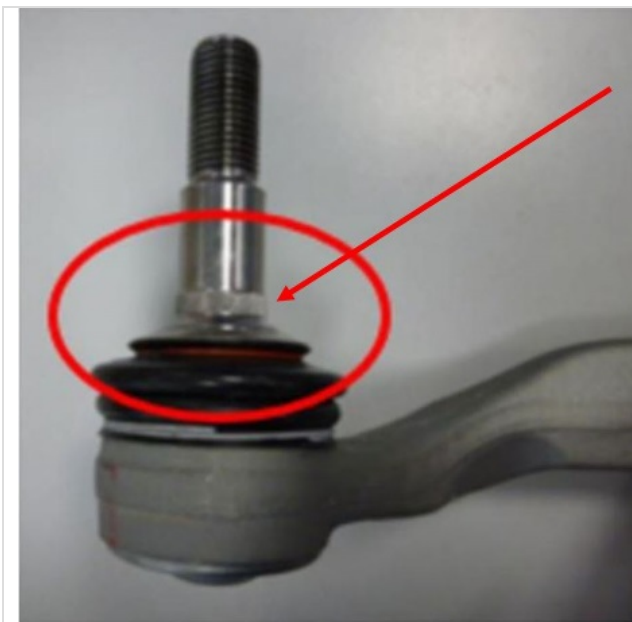
During the manufacturing process, a cone collar disc on the tie rod may not have been installed.

- Cone collar disc **not** installed, knurling visible

5. Replace the tie rod and swivel bearing as per the repair manual **RA 32 21 151** and **RA 31 21 090** and carry-out a wheel alignment procedure
