SIB 32 07 19

2019-08-21

RECALL 19V-601: STEERING GEAR TIE ROD

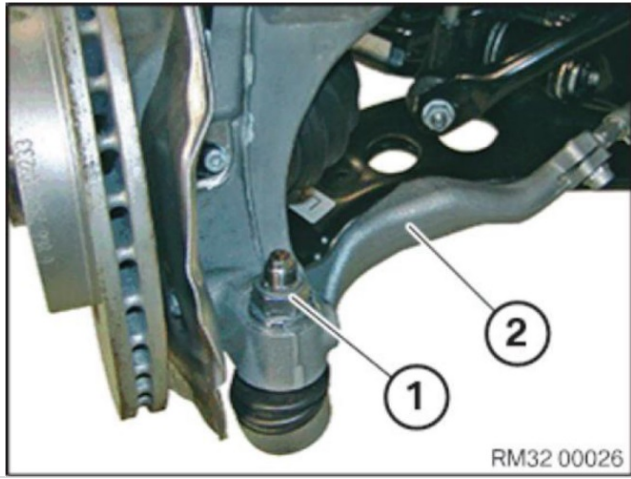
<p>2. Loosen nut (1) on left and right swivel bearing</p> <ul style="list-style-type: none"> - Release tie rod (2) from swivel bearings
--	--------------------------------------------------------------------------------------------------------------------------------------------------------

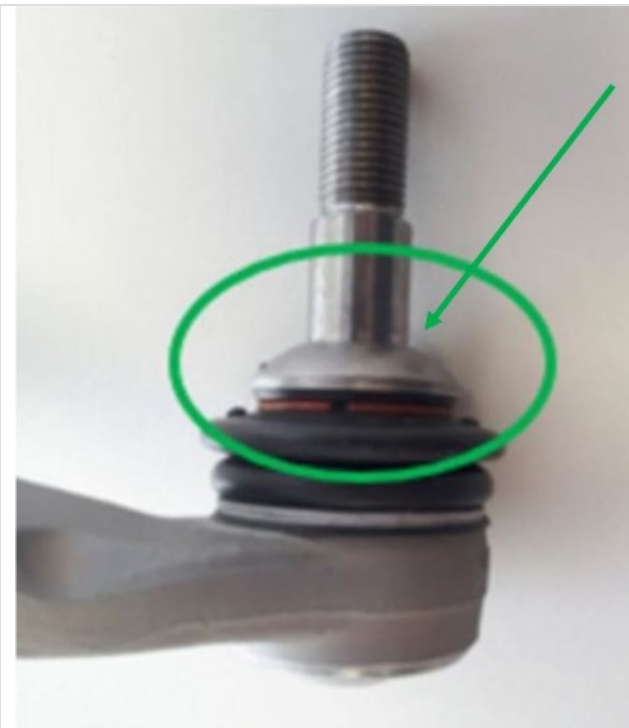
- Cone collar disc installed, knurling not visible

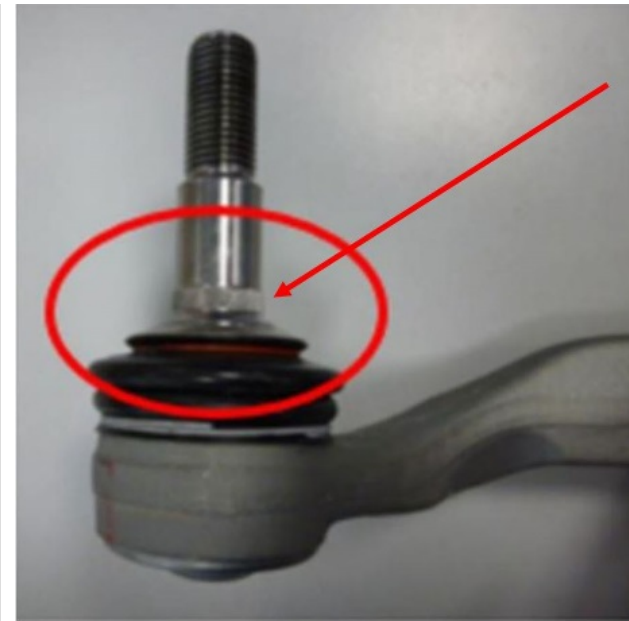
- Cone collar disc **not** installed, knurling visible

3. Inspect both tie rods for cone collar disc.
4. Is the cone collar disc installed?
 - Yes = No further action required. Reinstall tie rod as per repair manual **RA 32 21 151** and properly torque the **new** nut
 - No = Proceed to next step
5. Replace the tie rod and swivel bearing as per the repair manual **RA 32 21 151** and **RA 31 21 090** and carry-out a wheel alignment procedure
