SIM 32 01 19

RECALL CAMPAIGN 19V-601: STEERING GEAR TIE ROD

RE: Recall 19V-601: Steering Gear Tie Rod – M32 01 19

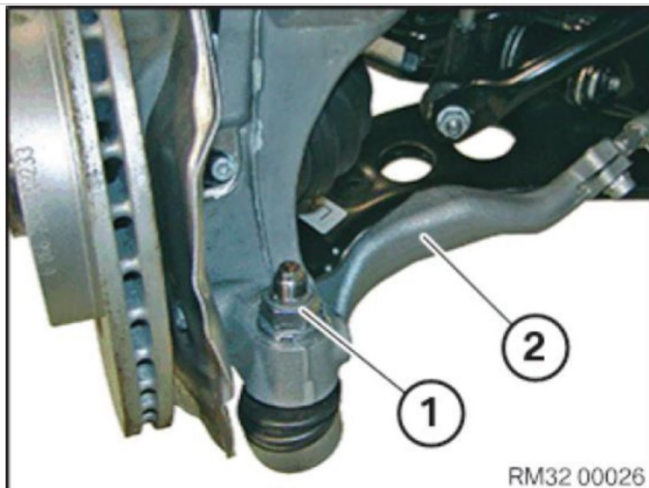
2. Remove and discard the tie rod nut (1) on left and right swivel bearing.

- Release the tie rods (2) from the swivel bearings

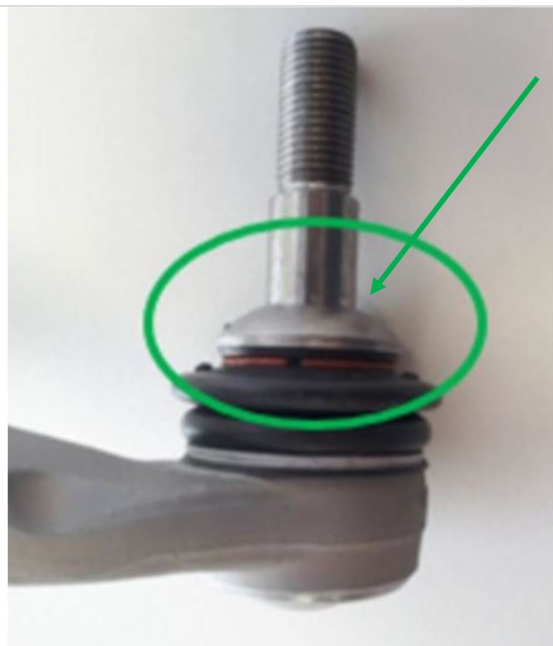
Cone collar disc installed: no knurling visible on the shank.

3. Inspect both tie rods for the presence of the cone collar disc.
4. Is the cone collar disc installed?
 - Yes = No further action required. Reinstall the tie rods as per repair manual **RA 32 21 151** and properly torque the **new** M14 nuts
 - No = Proceed to next step
5. Replace the tie rod and swivel bearing as per the repair manual **RA 32 21 151** and **RA 31 21 090**.
6. Perform a wheel alignment procedure.

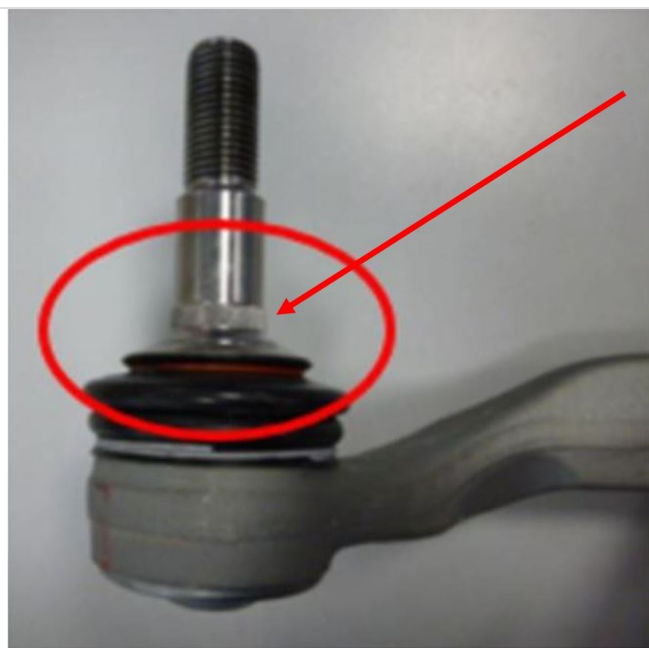
During the manufacturing process, a cone collar disc on the tie rod may not have been installed.

Cone collar disc not installed: knurling visible on the shank (arrow).
