Campaign No. 2019090019, October 2019

SUBJECT: **Model CLS-Class vehicles (257 platform)**
Model Year 2019
Wiring Harness for Electric Coolant Pump

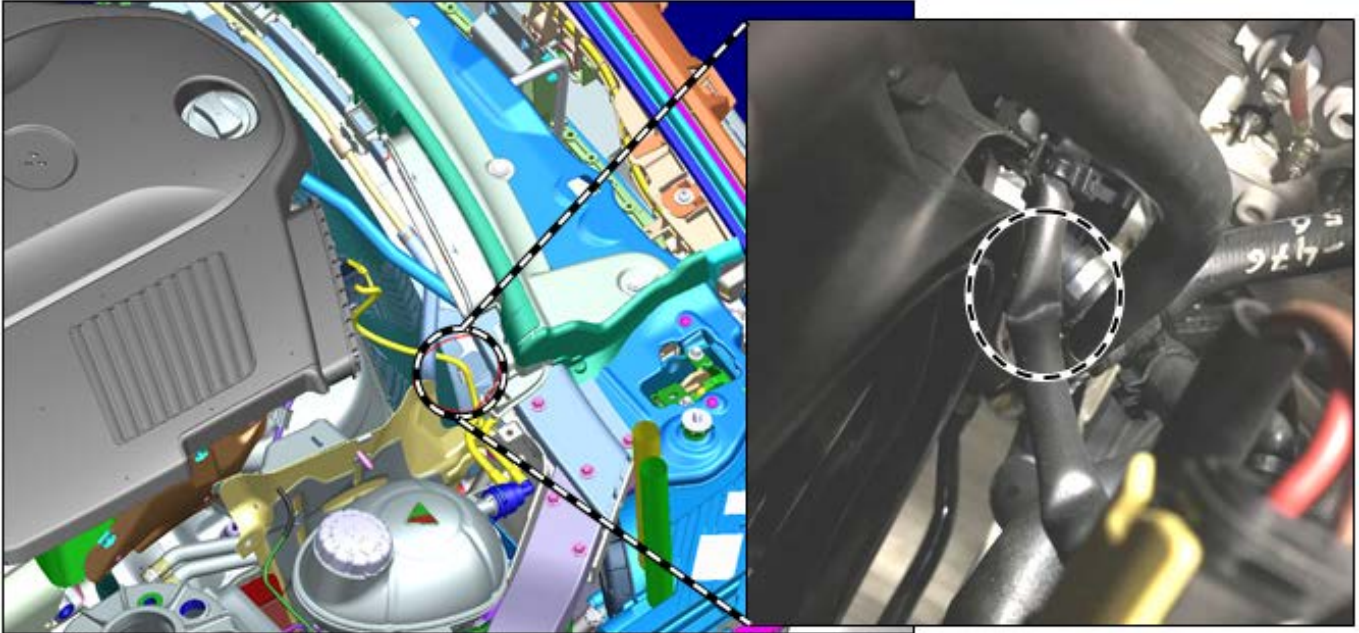
Figure 1

1. Check electrical wiring harness of electric coolant pump in area of fan for damage (figure 1).

- a. **Line insulation and protective hose of electrical wiring harness damaged:**
Perform **work procedures A and B and C.**
- b. **Only Protective hose of electrical wiring harness damaged and line insulation NOT damaged:**
Perform **work procedures B and C.**
- c. **Line insulation and protective hose of electrical wiring harness Both NOT damaged:** Perform **work procedure C.**

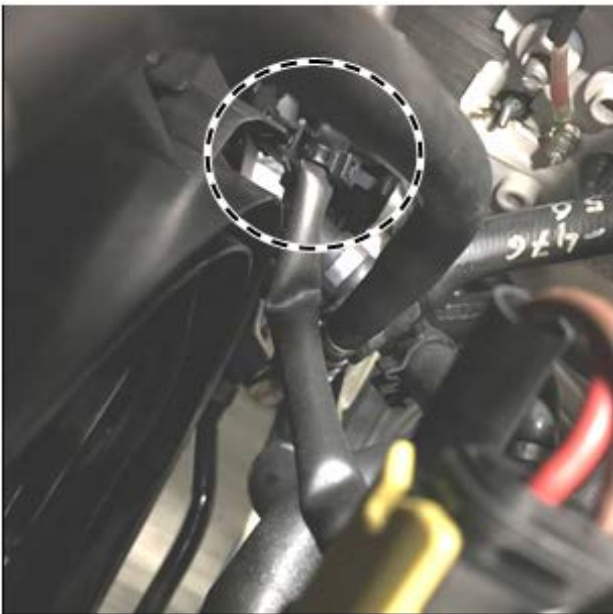
Figure 2

1. Replace mounting clip of electrical wiring harness at attachment rib of fan housing.
 - i** **Figure 2** shows old mounting clip!
 - i** **Figure 3** shows new mounting clip!
 - i** Distance (**A, figure 3**) between electrical wiring harness and fan should be approx. 15 mm.
