Compliance Recall

Code: 37M2

Subject Shift Lever Micro Switch

Release Date November 19, 2019

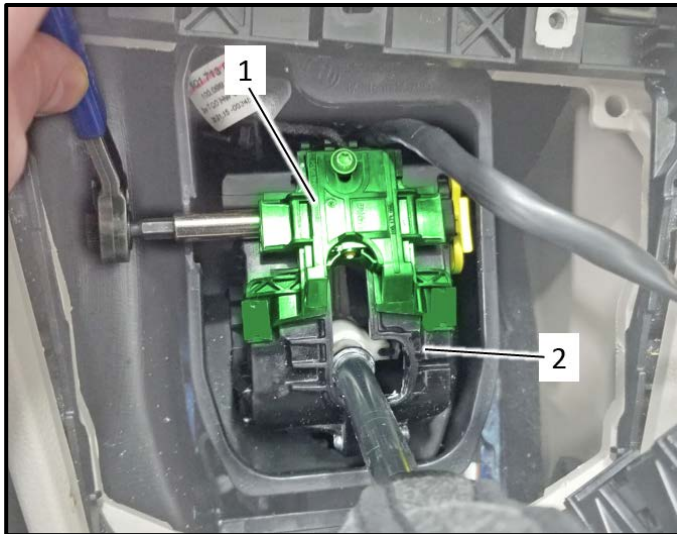
Repair Overview

Over time, a build-up of silicate on the shift lever micro switch contacts can result in an isolation-like layer that may be interpreted as an open micro switch. This open switch normally indicates that the shift lever is in "P" park position. If the build-up happens, it may be possible to remove the key from the ignition switch without the shift lever being in the "P" park position because the system is unable to recognize that the vehicle is not in "P" park. This makes the vehicle noncompliant with FMVSS and CMVSS 114; *Theft protection and rollaway prevention*.

- Install an external micro switch <1> to the selector mechanism <2>.
