RECALL CAMPAIGN BULLETIN

Classification: EL19-030a	Reference: NTB19-078a	Date: October 28, 2019
------------------------------	--------------------------	---------------------------

VOLUNTARY RECALL CAMPAIGN 2018-2019 ROGUE AND ROGUE HYBRID; AV CONTROL UNIT (INFOTAINMENT) SOFTWARE UPDATE

CAMPAIGN ID #: R1911
NHTSA #: 19V-654
APPLIED VEHICLES: 2018-2019 Rogue (T32)
2018-2019 Rogue Hybrid (T32H)

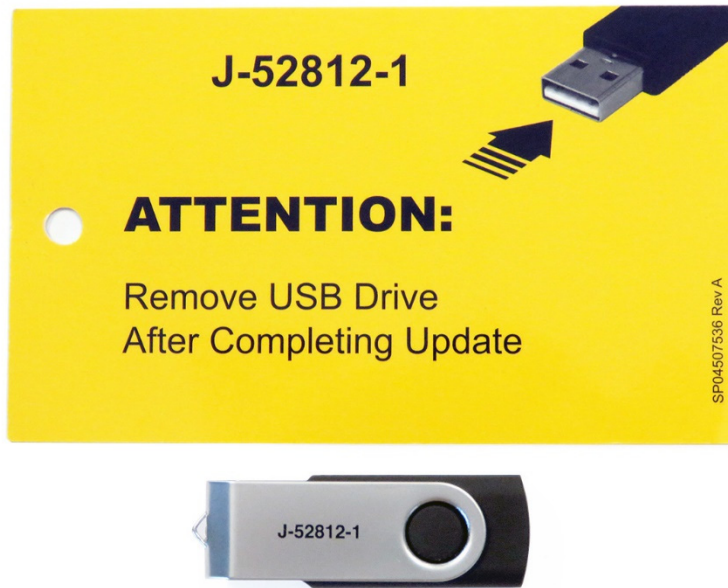
Figure 1

- Special tool USB drive J-52812-1 has been shipped to each dealer (see Figure 1).
- Additional USB drives are available from Tech•Mate: nissantechmate.com or 1-800-662-2001.
