RECALL CAMPAIGN BULLETIN

Classification: AN19-029a	Reference: NTB19-086a	Date: February 9, 2021
------------------------------	--------------------------	---------------------------

VOLUNTARY RECALL CAMPAIGN 2019 MURANO; AV CONTROL UNIT (INFOTAINMENT) SOFTWARE UPDATE

CAMPAIGN ID #: R1911
NHTSA #: 19V-654
APPLIED VEHICLES: 2019 Murano (Z52)

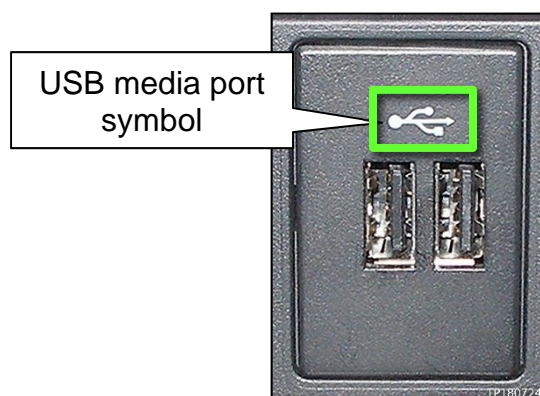
Figure 2

4. Turn the audio system OFF.
5. Insert special tool USB drive J-52812-1 into the vehicle's USB media port (see Figure 2).
 - DO NOT remove the USB drive during the software update until instructed.

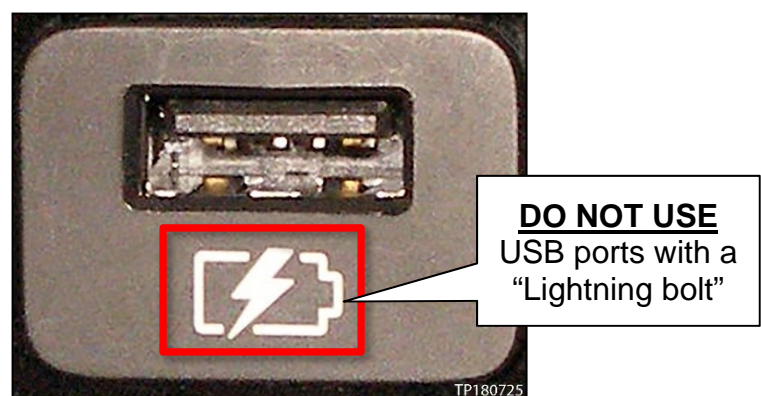
Figure 3

DO NOT insert the USB drive into a charging port (see Figure 3). Charging ports are marked in the vehicle with a “lightning bolt” symbol. If used, the software update and/or USB drive may become damaged. Only insert the USB drive in a USB media port.
