RECALL CAMPAIGN BULLETIN

Classification: AN19-041e	Reference: NTB19-090e	Date: February 8, 2021
------------------------------	--------------------------	---------------------------

VOLUNTARY RECALL CAMPAIGN 2019 FRONTIER; AV CONTROL UNIT (INFOTAINMENT) SOFTWARE UPDATE

CAMPAIGN ID #: R1911
NHTSA #: 19V-654
APPLIED VEHICLES: 2019 Frontier (D40)

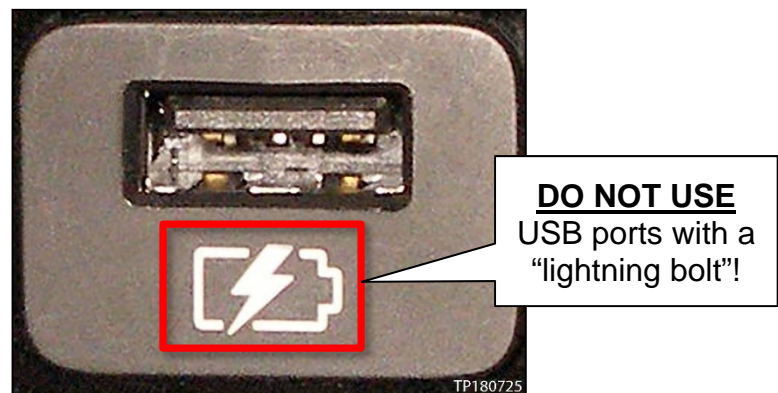
Figure 7

DO NOT insert the USB drive into a charging port (see Figure 7). Charging ports are marked in the vehicle with a “lightning bolt” symbol. If used, the software update and/or USB drive may become damaged. Only insert the USB drive in a USB media port.

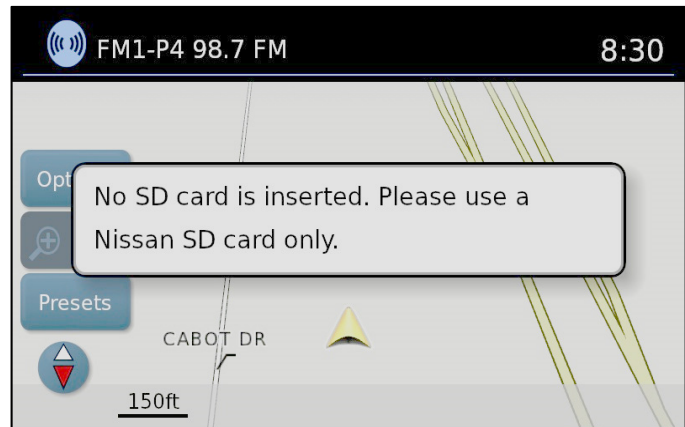
Figure 13

- If the message “No SD card is inserted. Please use a Nissan SD card only” is displayed (Figure 13), proceed to step 17 on page 8.

17. Remove and reinsert the map SD card from the card slot.
- After the map SD card is reinserted, the **APPLICATION** screen will display (Figure 15).

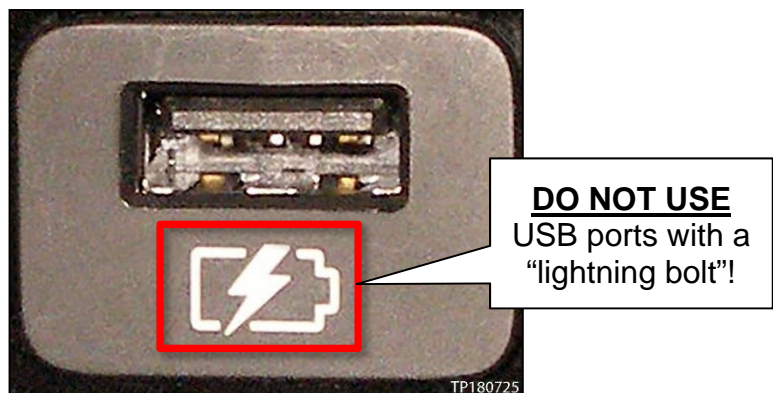
Figure 20

DO NOT insert the USB drive into a **charging port** (see Figure 20). Charging ports are marked in the vehicle with a "lightning bolt" symbol. If used, the software update and/or USB drive may become damaged. Only insert the USB drive in a USB media port.
