RECALL CAMPAIGN BULLETIN

Classification: EL19-028	Reference: NTB19-077	Date: October 14, 2019
-----------------------------	-------------------------	---------------------------

VOLUNTARY RECALL CAMPAIGN 2019 ALTIMA; AV CONTROL UNIT (INFOTAINMENT) SOFTWARE UPDATE

CAMPAIGN ID #: R1911
NHTSA #: 19V-654
APPLIED VEHICLES: 2019 Altima (L34)

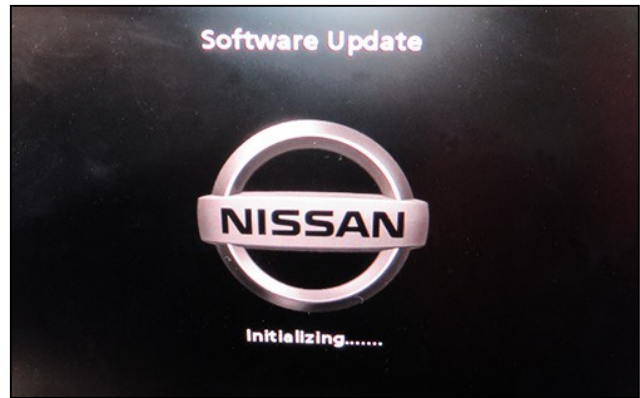
6. Wait approximately 10-30 seconds for the screen in Figure 4 to appear.

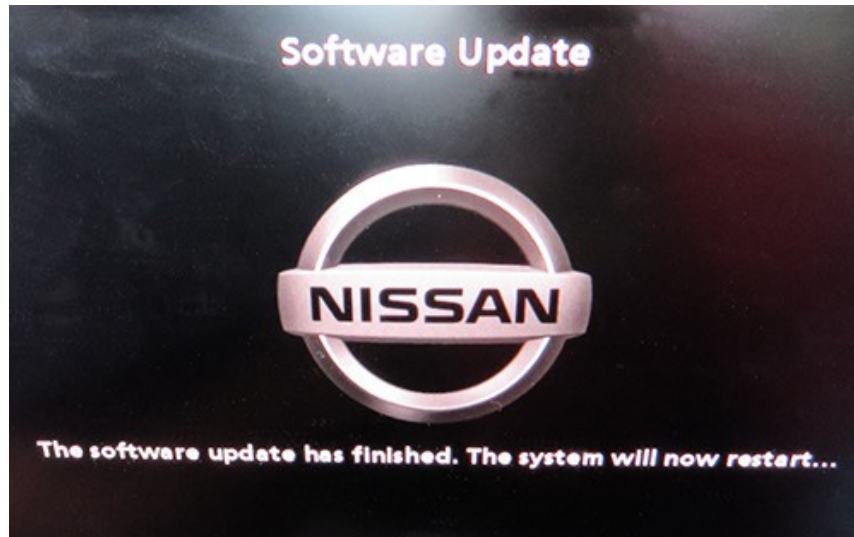
Figure 7

8. Once the software update is complete (Figure 7), remove the USB drive. The system will then reboot (restart).

IMPORTANT: The system will not reboot until the USB drive is removed.
