RECALL CAMPAIGN BULLETIN

Classification: AN19-035c	Reference: NTB19-096c	Date: February 8, 2021
------------------------------	--------------------------	---------------------------

VOLUNTARY RECALL CAMPAIGN 2018-2019 VERSA SEDAN; AV CONTROL UNIT (INFOTAINMENT) SOFTWARE UPDATE

CAMPAIGN ID #: R1911
NHTSA #: 19V-654
APPLIED VEHICLES: 2018 – 2019 Versa Sedan (N17)

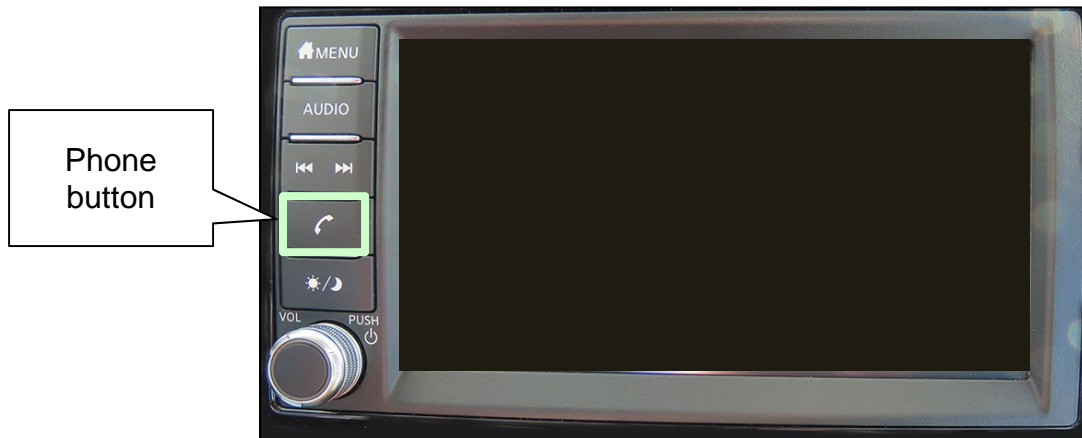
1. Determine which audio unit the vehicle is equipped with.
 - If there is a **Phone** button as shown in Figure 1 then continue to step 2 on the next page.
 - If there is a **Back** button as shown in Figure 2 then skip to step 16 on page 8.

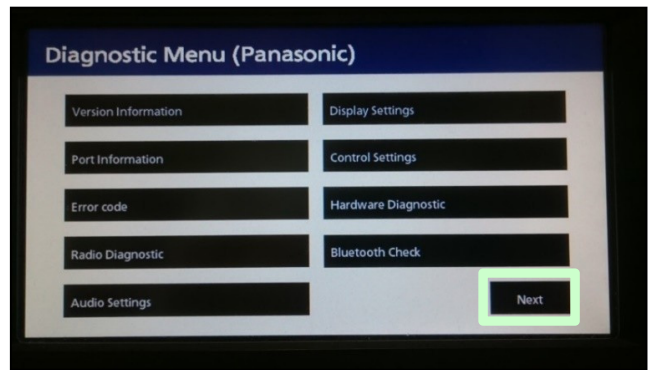
HINT: A screen similar to the one in Figure 9 will appear.

13. Perform audio unit initialization.
 - a. Press and hold the “Menu” button.
 - b. Press and hold the “Audio” button.
 - c. Press the “Seek right” button 3 times.

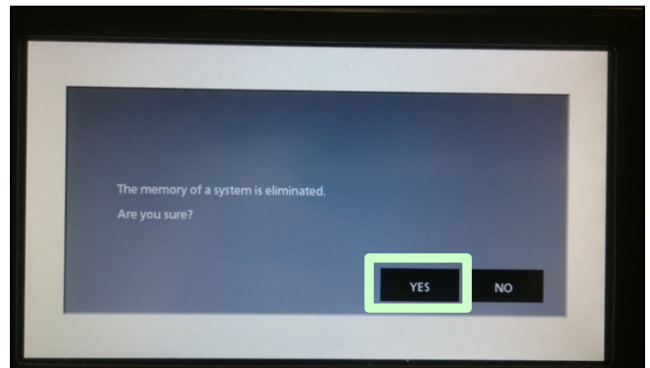
Figure 10

- d. Select **Next** at the bottom right side of the screen.
- e. On the second page of the menu screen, press “**Factory Cold Start.**” (Screen not shown).
- f. Select **YES** on the confirmation screen shown in Figure 10.

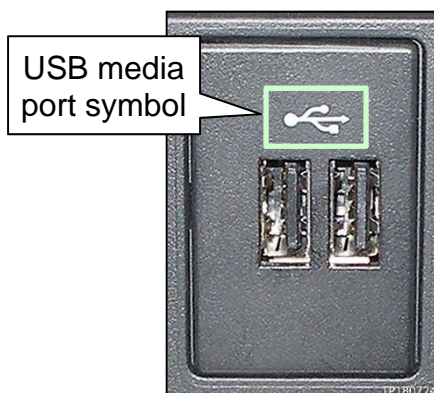
Figure 12

16. Set the parking brake.
17. Start the engine, and then wait 60 seconds for the system to load.
HINT: The engine needs to idle for the duration of the update to retain battery charge.
18. Turn the audio OFF.
19. Insert the special USB drive J-52812-15 into the vehicle's USB media port.
(see Figure 12).
 - Do not remove the USB drive during the update to the vehicle until instructed to.

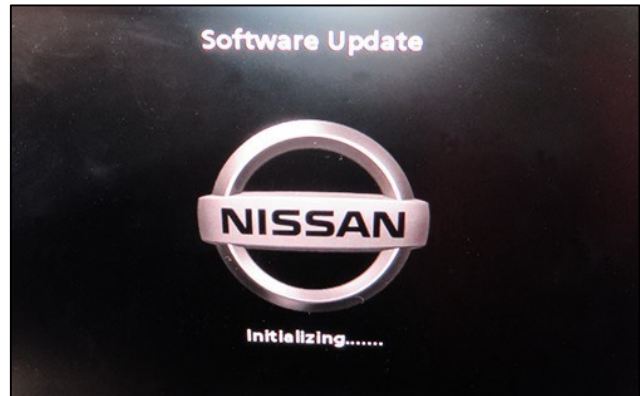
20. Wait approximately 10-30 seconds for the screen in Figure 14 to appear.

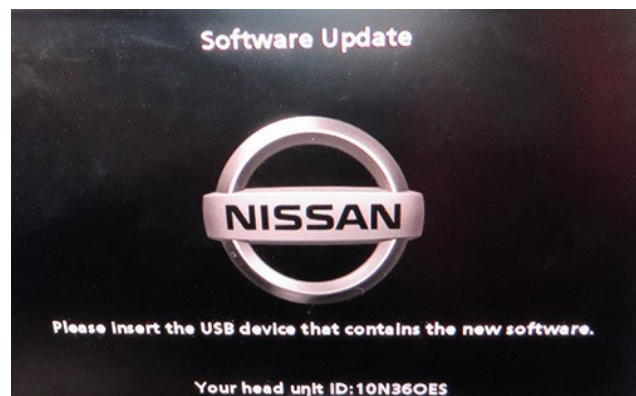
- The screen in Figure 15 may briefly appear. **Do not remove the USB.** The audio system will detect the USB and continue the update.

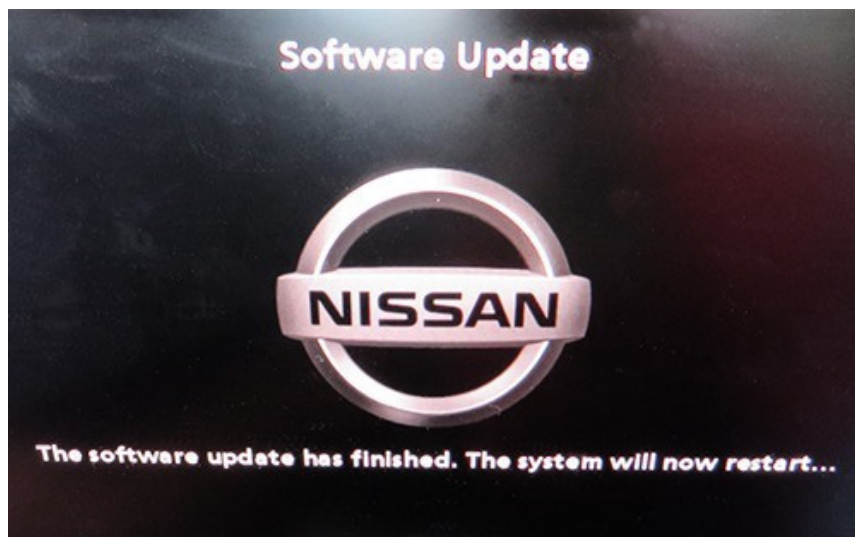
Figure 17

22. Once the update is complete (Figure 17), remove the USB drive; the system will reboot (restart).
