RECALL CAMPAIGN BULLETIN

Classification: EL19-062	Reference: NTB19-109	Date: December 5, 2019
-----------------------------	-------------------------	---------------------------

VOLUNTARY RECALL CAMPAIGN 2018 MAXIMA; AV CONTROL UNIT (INFOTAINMENT) SOFTWARE UPDATE

CAMPAIGN ID #: R1911
NHTSA #: 19V-654
APPLIED VEHICLE: 2018 Maxima (A36)

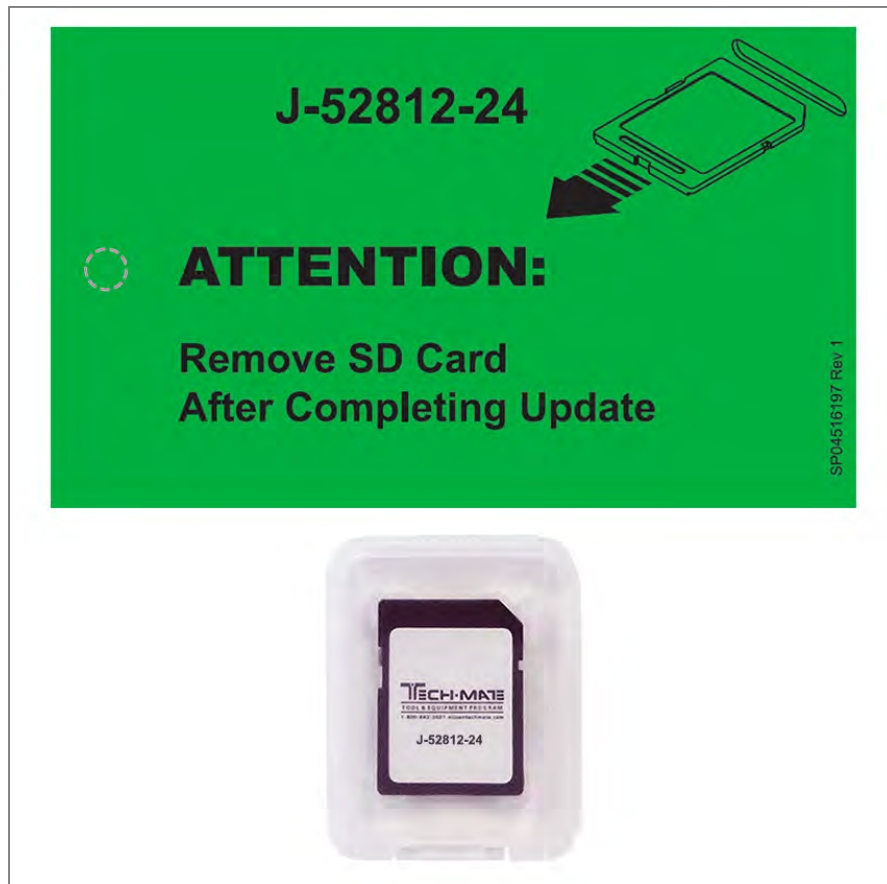
Figure 1

- Special tool SD Card J-52812-24 has been shipped to each dealer (see Figure 1).
- Additional SD cards are available from Tech•Mate: nissantechmate.com or 1-800-662-2001.

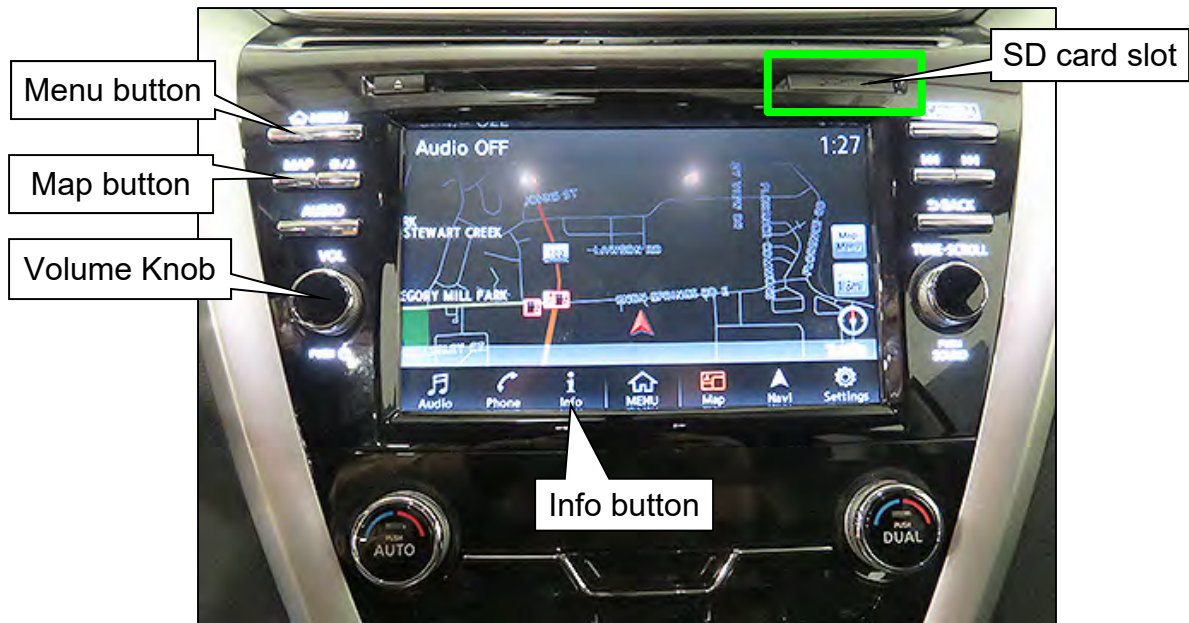
NOTE: Refer to Figure 2 below for location of controls and SD card slot.

1. Make sure the MAP SD card (not the software update card) is inserted in the SD card slot before starting the software update procedure.
2. Turn the ignition to ON/ACC.
3. Turn the hazard warning lamps ON to prevent the BCM from entering battery saver mode.
4. Ensure the map is displayed on the screen by pressing the MAP button.
5. Ensure the audio system is OFF (Audio OFF should be displayed in the top left corner of the MAP screen as shown in Figure 2).
