RECALL CAMPAIGN BULLETIN

Classification: EL19-037a	Reference: NTB19-089a	Date: November 5, 2019
------------------------------	--------------------------	---------------------------

VOLUNTARY RECALL CAMPAIGN 2018-2019 NV; AV CONTROL UNIT (INFOTAINMENT) SOFTWARE UPDATE

CAMPAIGN ID #: R1911
NHTSA #: 19V654
APPLIED VEHICLES: 2018-2019 NV (F80)

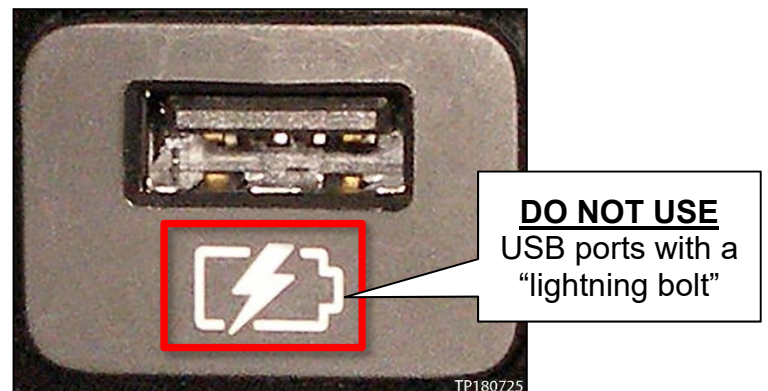
Figure 7

DO NOT insert the USB drive into a charging port (see Figure 7). Charging ports are marked in the vehicle with a “lightning bolt” symbol. If used, the software update and/or USB drive may become damaged. Only insert the USB drive in a USB media port.

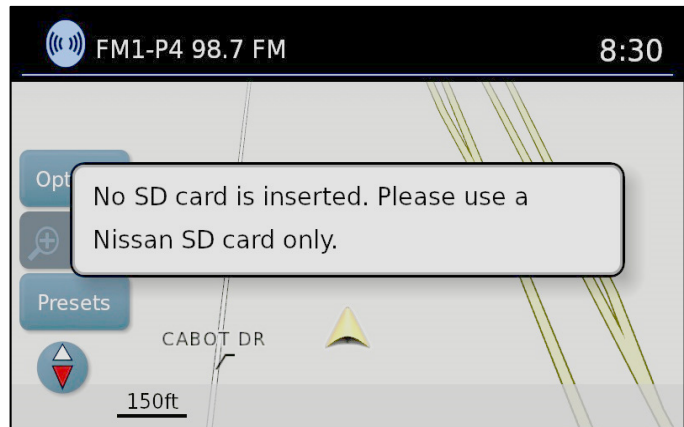
Figure 13

- If the message “No SD card is inserted. Please use a Nissan SD card only” is displayed (Figure 13), proceed to step 17 on page 8.

17. Remove and reinsert the map SD card from the card slot.
- After the map SD card is reinserted, the **APPLICATION** screen will display (Figure 15).

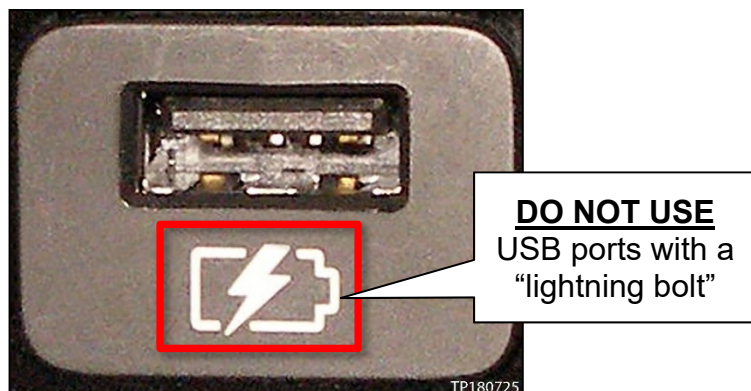
Figure 20

DO NOT insert the USB drive into a **charging port** (see Figure 20). Charging ports are marked in the vehicle with a "lightning bolt" symbol. If used, the software update and/or USB drive may become damaged. Only insert the USB drive in a USB media port.
