RECALL CAMPAIGN BULLETIN

Classification: EL19-041c	Reference: NTB19-090c	Date: November 22, 2019
------------------------------	--------------------------	----------------------------

VOLUNTARY RECALL CAMPAIGN 2018-2019 FRONTIER; AV CONTROL UNIT (INFOTAINMENT) SOFTWARE UPDATE

CAMPAIGN ID #: R1911
NHTSA #: 19V654
APPLIED VEHICLES: 2018-2019 Frontier (D40)

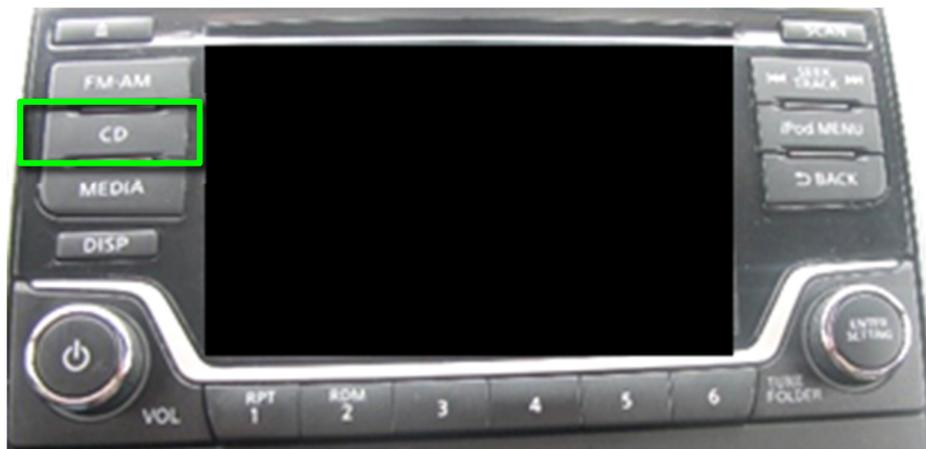
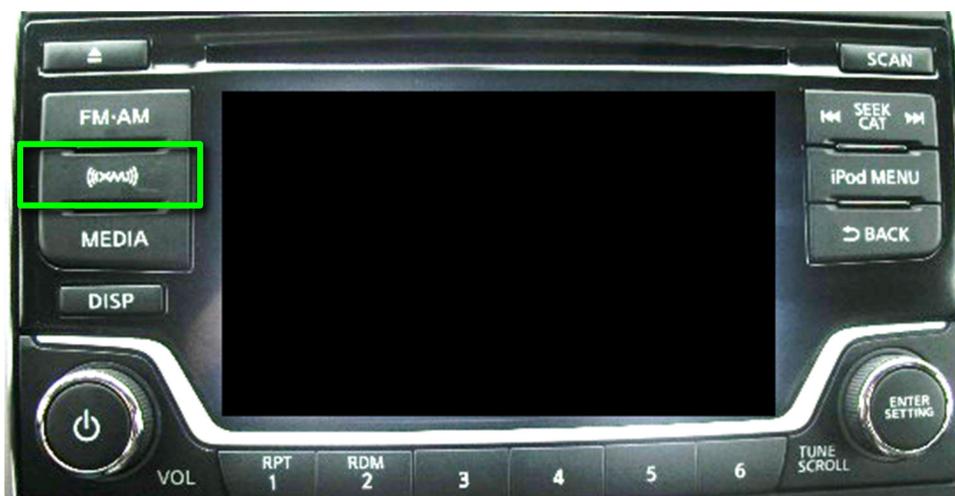
1. Determine if the audio system present in the vehicle is the type shown in Figure 1 or Figure 2.
 - If the audio system **is NOT** shown in Figure 1 or Figure 2, proceed to step 2 on page 4.
 - If the audio system **is** shown in Figure 1 or Figure 2, **this bulletin does not apply**. Software and repair procedures will be available in December 2019. **DO NOT** submit any claims on these vehicles.

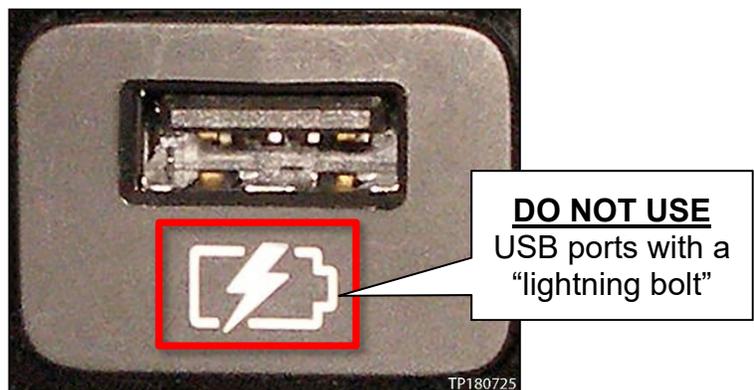
Figure 9

DO NOT insert the USB drive into a charging port (see Figure 9). Charging ports are marked in the vehicle with a "lightning bolt" symbol. If used, the software update and/or USB drive may become damaged. Only insert the USB drive in a USB media port.

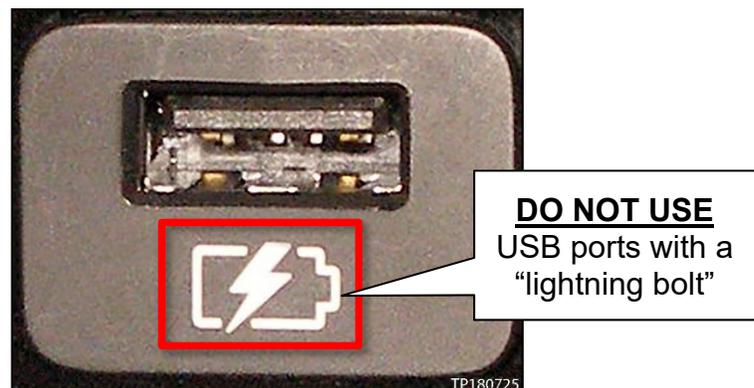
Figure 22

DO NOT insert the USB drive into a **charging port** (see Figure 22). Charging ports are marked in the vehicle with a "lightning bolt" symbol. If used, the software update and/or USB drive may become damaged. Only insert the USB drive in a USB media port.
