RECALL CAMPAIGN BULLETIN

VOLUNTARY RECALL CAMPAIGN 2018-2019 PATHFINDER; DISPLAY CONTROL UNIT (INFOTAINMENT) SOFTWARE UPDATE

CAMPAIGN ID #: R1911
NHTSA #: 19V654
APPLIED VEHICLE: 2018-2019 Pathfinder (R52)

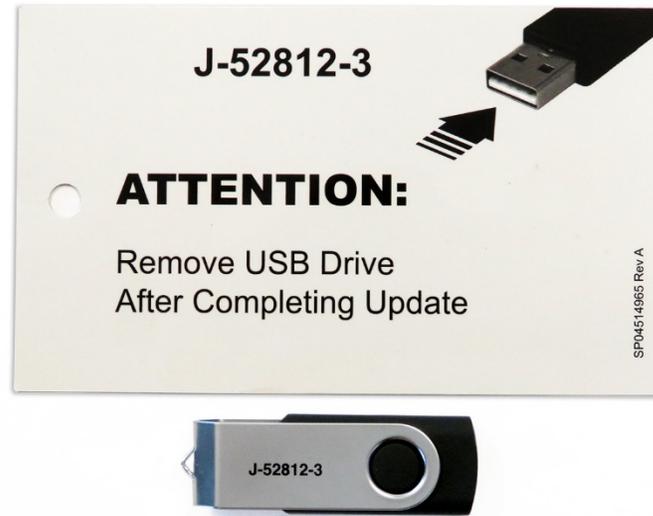
Figure 1

- One special tool USB drive J-52812-3 with ID card has been shipped to each dealer (see Figure 1).
- Additional USB drives are available from Tech•Mate: nissantechmate.com or 1-800-662-2001.

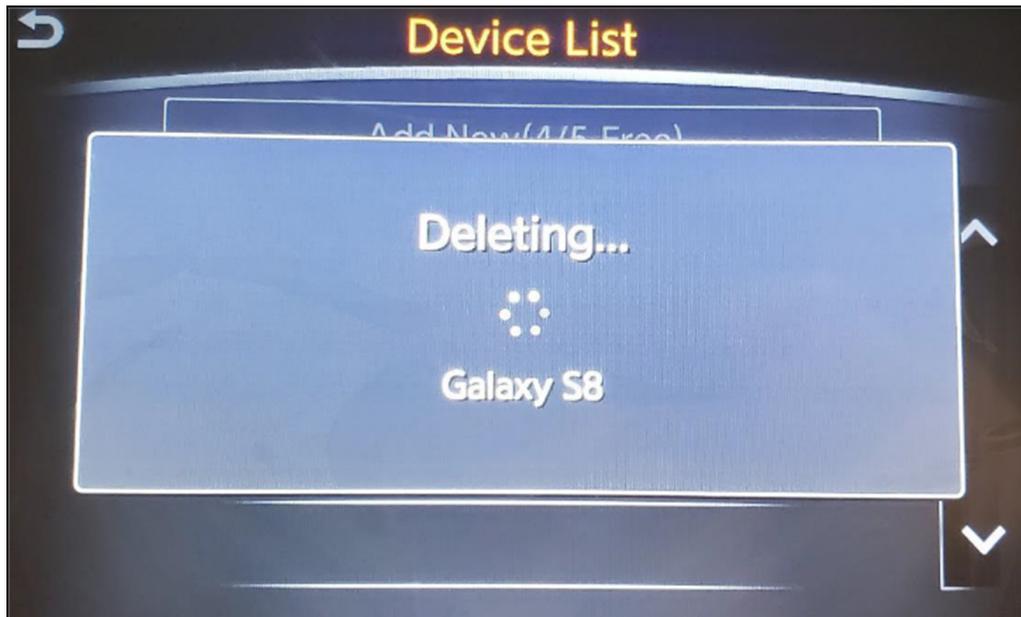
Figure 6

- The first screen will show “Deleting...” followed by the device name.

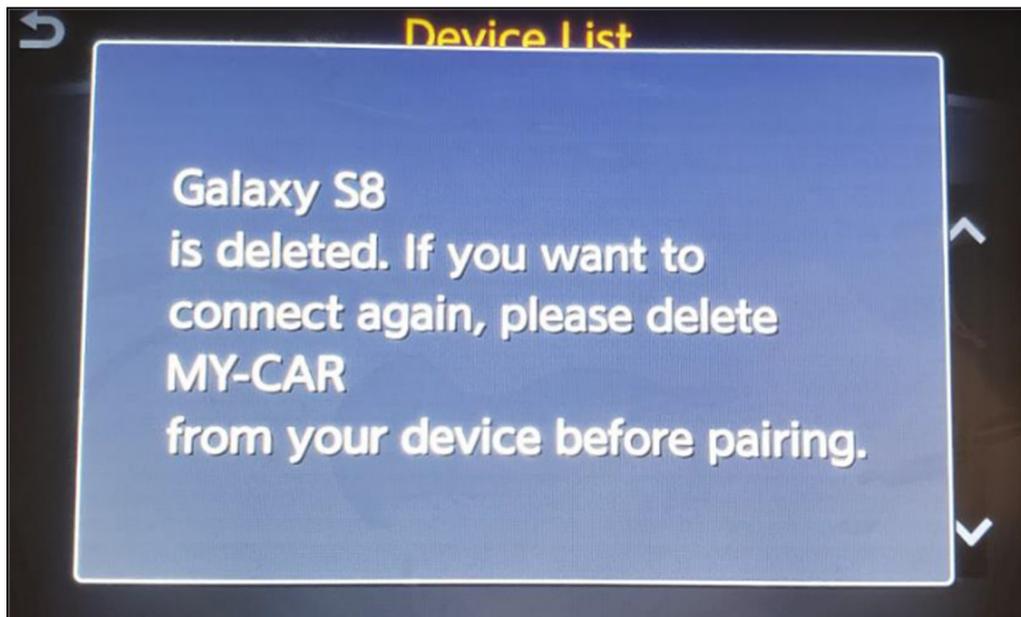
Figure 7

- The second screen will show information regarding repairing the Bluetooth® device.

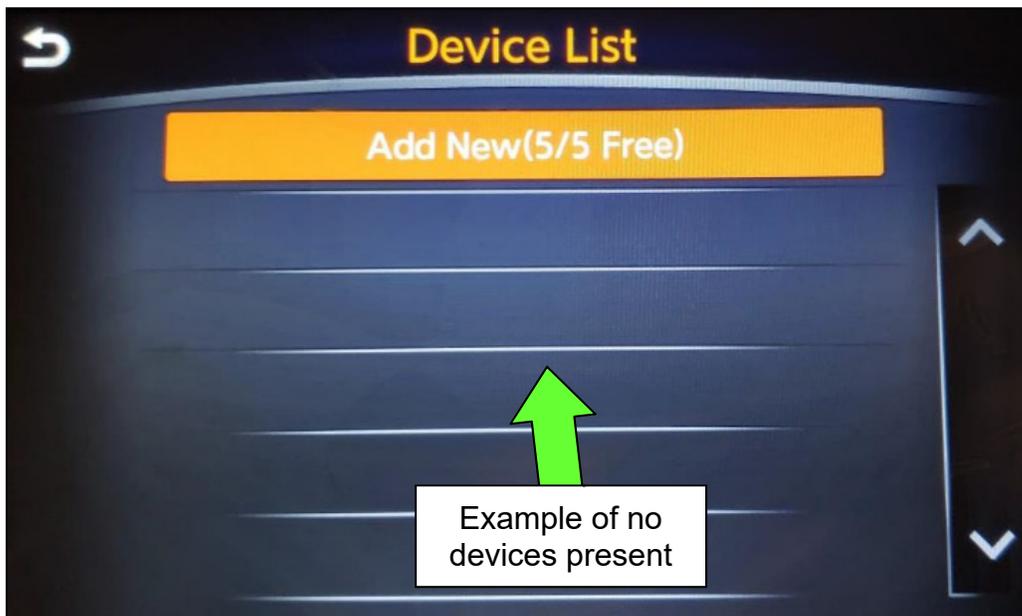
- Figure 9 will be displayed when all listed devices have been deleted.

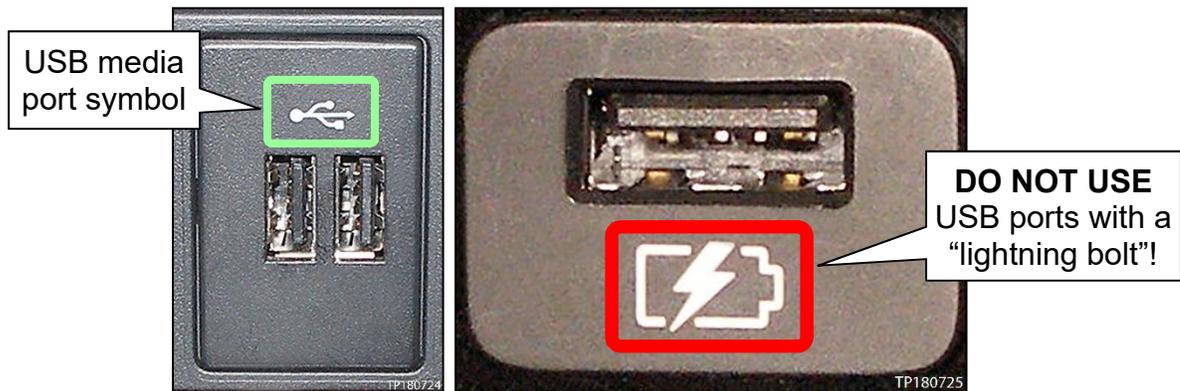
Figure 10

Do not insert the USB drive into a charging port. If used, the update software and/or USB drive may become damaged. Only insert the USB drive in a USB media port.

7. Insert special tool J-52812-3 into the vehicle's USB media port (see Figure 10).

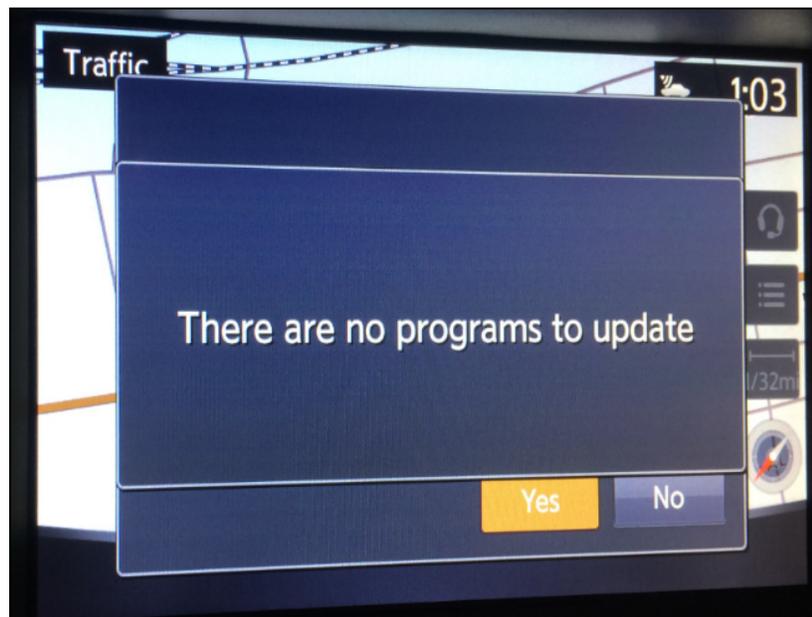
8. Wait approximately 10-30 seconds for the screen in Figure 12 or Figure 13 to appear.
 - a. If the screen shown in Figure 12 appears, proceed to step 9 below.
 - b. If the screen shown in Figure 13 appears, then no software update is available. Remove special tool J-52812-3, and then go to step 15.
