RECALL CAMPAIGN BULLETIN

Classification: AN19-031a	Reference: NTB19-088a	Date: February 9, 2021
------------------------------	--------------------------	---------------------------

VOLUNTARY RECALL CAMPAIGN 2018-2019 ROGUE SPORT; AV CONTROL UNIT (INFOTAINMENT) SOFTWARE UPDATE

CAMPAIGN ID #: R1911
NHTSA #: 19V-654
APPLIED VEHICLES: 2018-2019 Rogue Sport (J11)

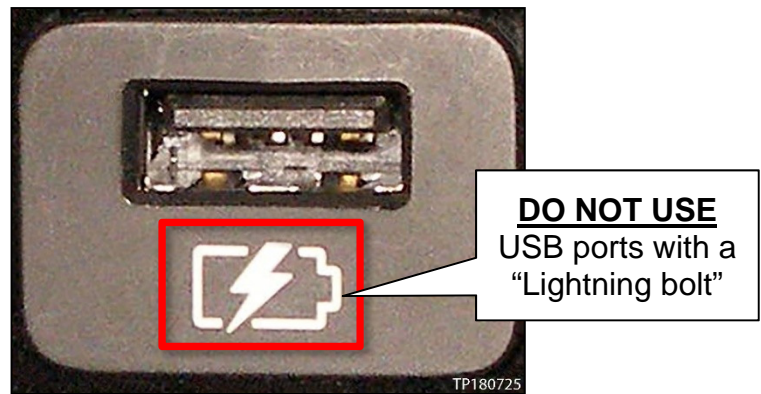
Figure 7

DO NOT insert the USB drive into a charging port (see Figure 7). Charging ports are marked in the vehicle with a “lightning bolt” symbol. If used, the software update and/or USB drive may become damaged. Only insert the USB drive in a USB media port.

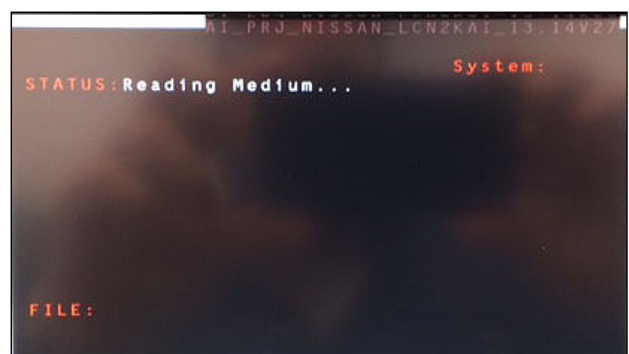
- The screen in Figure 10 will be displayed during the update.
- Figure 11 may display before the update begins. **DO NOT** remove the USB drive during the update.

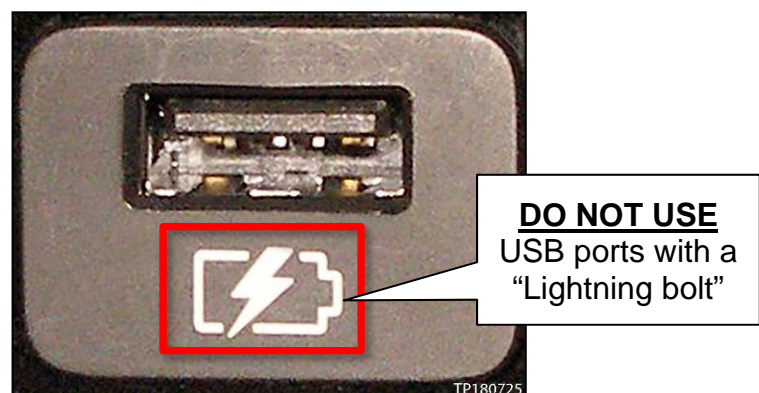
Figure 20

DO NOT insert the USB drive into a charging port (see Figure 20). Charging ports are marked in the vehicle with a “lightning bolt” symbol. If used, the software update and/or USB drive may become damaged. Only insert the USB drive in a USB media port.

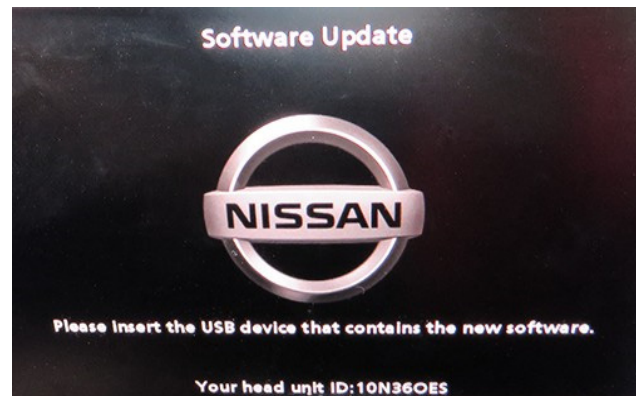
- The screen in Figure 22 may briefly appear. **DO NOT** remove the **USB drive**. The audio system will detect the USB drive and continue the software update.
