RECALL CAMPAIGN BULLETIN

Classification: EL19-037c	Reference: NTB19-089c	Date: December 5, 2019
------------------------------	--------------------------	---------------------------

VOLUNTARY RECALL CAMPAIGN 2019 NV; AV CONTROL UNIT (INFOTAINMENT) SOFTWARE UPDATE

CAMPAIGN ID #: R1911
NHTSA #: 19V-654
APPLIED VEHICLES: 2019 NV (F80)

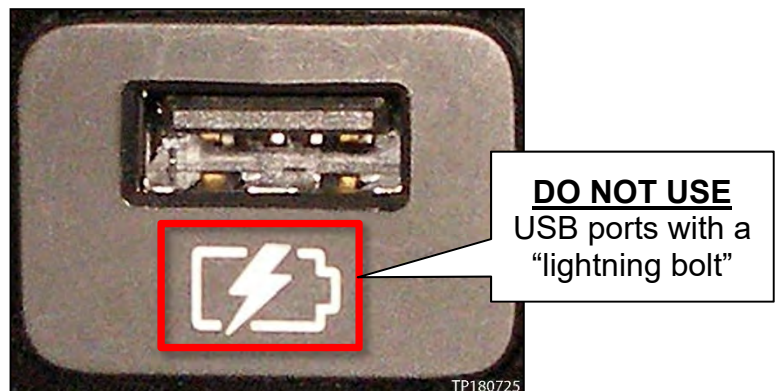
Figure 7

DO NOT insert the USB drive into a charging port (see Figure 7). Charging ports are marked in the vehicle with a “lightning bolt” symbol. If used, the software update and/or USB drive may become damaged. Only insert the USB drive in a USB media port.

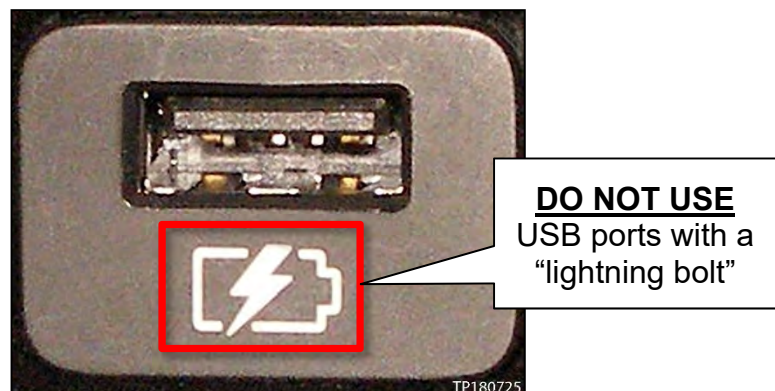
Figure 20

DO NOT insert the USB drive into a **charging port** (see Figure 20). Charging ports are marked in the vehicle with a "lightning bolt" symbol. If used, the software update and/or USB drive may become damaged. Only insert the USB drive in a USB media port.
