RECALL CAMPAIGN BULLETIN

Classification: AN19-030b	Reference: NTB19-078b	Date: February 9, 2021
------------------------------	--------------------------	---------------------------

VOLUNTARY RECALL CAMPAIGN 2018-2019 ROGUE AND ROGUE HYBRID; AV CONTROL UNIT (INFOTAINMENT) SOFTWARE UPDATE

CAMPAIGN ID #: R1911
NHTSA #: 19V-654
APPLIED VEHICLES: 2018-2019 Rogue (T32)
2018-2019 Rogue Hybrid (T32H)

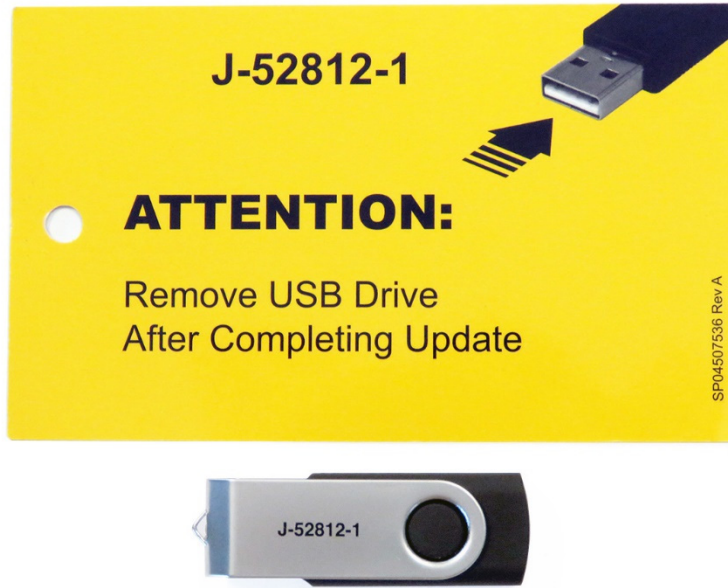
Figure 1

- Special tool USB drive J-52812-1 has been shipped to each dealer (see Figure 1).
- Additional USB drives are available from TechMate: nissantechmate.com or 1-800-662-2001.

It is highly recommended that the provided campaign USB drive, J-52812-1, be used.

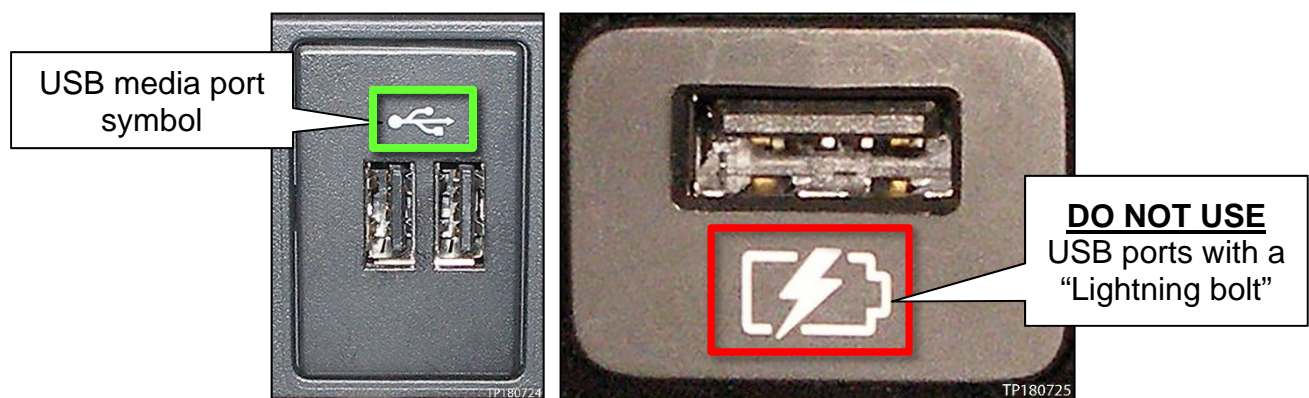
Figure 2

DO NOT insert the USB drive into a charging port (see Figure 3). Charging ports are marked in the vehicle with a “lightning bolt” symbol. If used, the software update and/or USB drive may become damaged. Only insert the USB drive in a USB media port.

4. Turn the audio system OFF.
5. Insert the USB drive with infotainment software update into the vehicle's USB media port (see Figure 2).
 - DO NOT remove the USB drive during the software update until instructed.

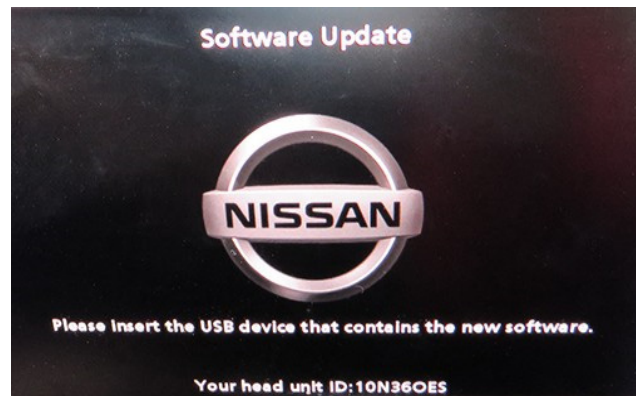
- The screen in Figure 5 may briefly appear. **DO NOT** remove the **USB drive**. The audio system will detect the USB drive and continue the software update.
