# RECALL CAMPAIGN BULLETIN

Classification: EL19-030	Reference: NTB19-078	Date: October 14, 2019
-----------------------------	-------------------------	---------------------------

## VOLUNTARY RECALL CAMPAIGN 2018-2019 ROGUE AND ROGUE HYBRID; AV CONTROL UNIT (INFOTAINMENT) SOFTWARE UPDATE

**CAMPAIGN ID #:** R1911  
**NHTSA #:** 19V-654  
**APPLIED VEHICLES:** 2018-2019 Rogue (T32)  
2018-2019 Rogue Hybrid (T32H)

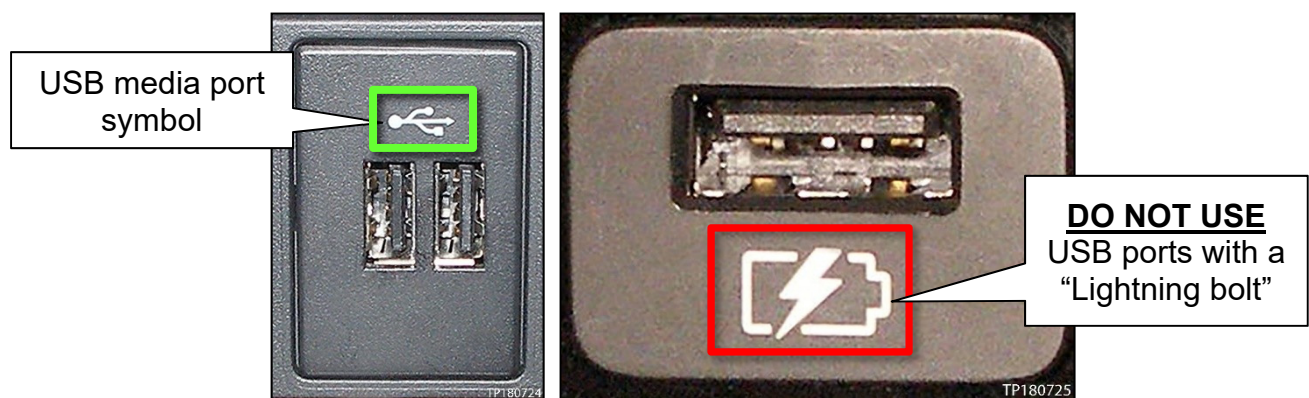
Figure 2

**DO NOT** insert the USB drive into a charging port (see Figure 3). Charging ports are marked in the vehicle with a “lightning bolt” symbol. If used, the software update and/or USB drive may become damaged. Only insert the USB drive in a USB media port.

4. Turn the audio system OFF.
5. Insert the USB drive with infotainment software update into the vehicle's USB media port (see Figure 2).
  - DO NOT remove the USB drive during the software update until instructed.
