PRODUCT CAMPAIGN BULLETIN

APPLICABILITY: 2020MY Legacy & Outback

NUMBER: WUL-97R

SUBJECT: Brake Pedal Bracket Mounting Bolt Inspection

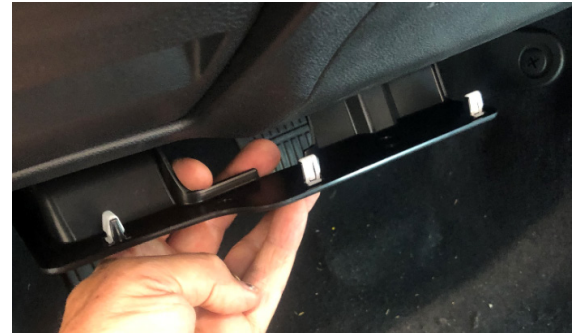
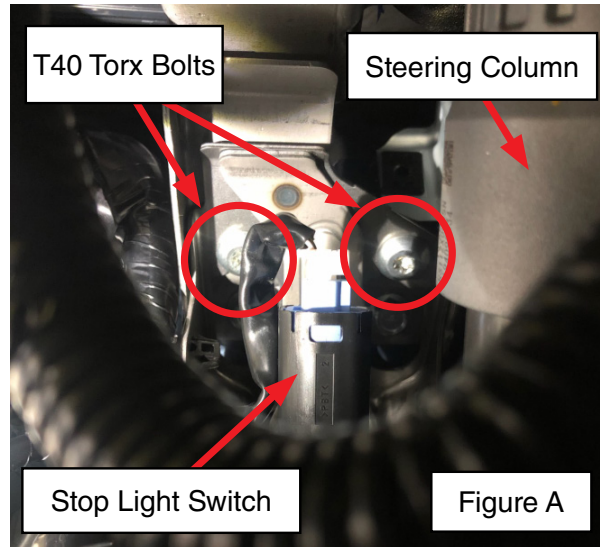
IMPORTANT NOTE: The picture (**Figure A**) below shows the mounting bolt area of the brake pedal assembly with the lower dash under-cover removed. When performing this initial inspection, **only** the bottom cover shown above needs to be removed.

There are 2 bolts used to secure the front (closest to the driver) portion of the brake pedal assembly to the mounting bracket. The T-40 Torx bolts are secured with a 12 mm flanged hex nut.

- Assemble the torque wrench, necessary extension(s) and the T40 Torx bit. If the torque wrench is digital, Set it to 5 Nm (3.7 ft. lbs. or **44.3 inch-pounds**).
- Confirm both T40 Torx bolts are present as shown in **Figure A** above.
- Check the bolt torque while paying close attention for any movement (using a clockwise/ tightening motion) of the bolt prior to the specified value being reached. **NOTE:** The plastic foot ventilation duct can be easily moved backward enough to gain sufficient access to check the bolt torque

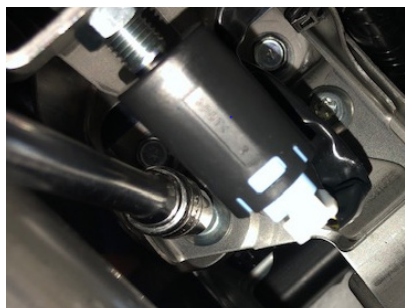
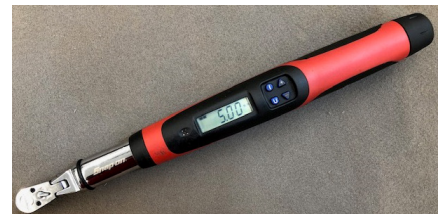
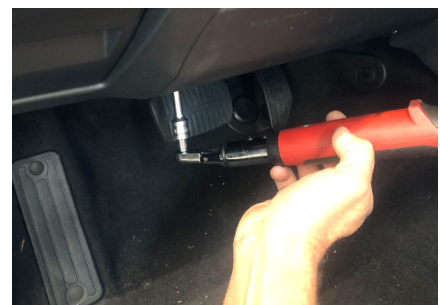
Use caution to not move the duct any more than necessary. If it becomes loose, it must be replaced as it is a **one-time use** part.
