Mercedes-Benz

Campaign No. 2019090008 October 2019

SUBJECT: **Model E-Class Station Wagon vehicles (213 platform)**  
**Model Year 2017-2019**  
**Check threaded connection of roof spoiler, rework if necessary**

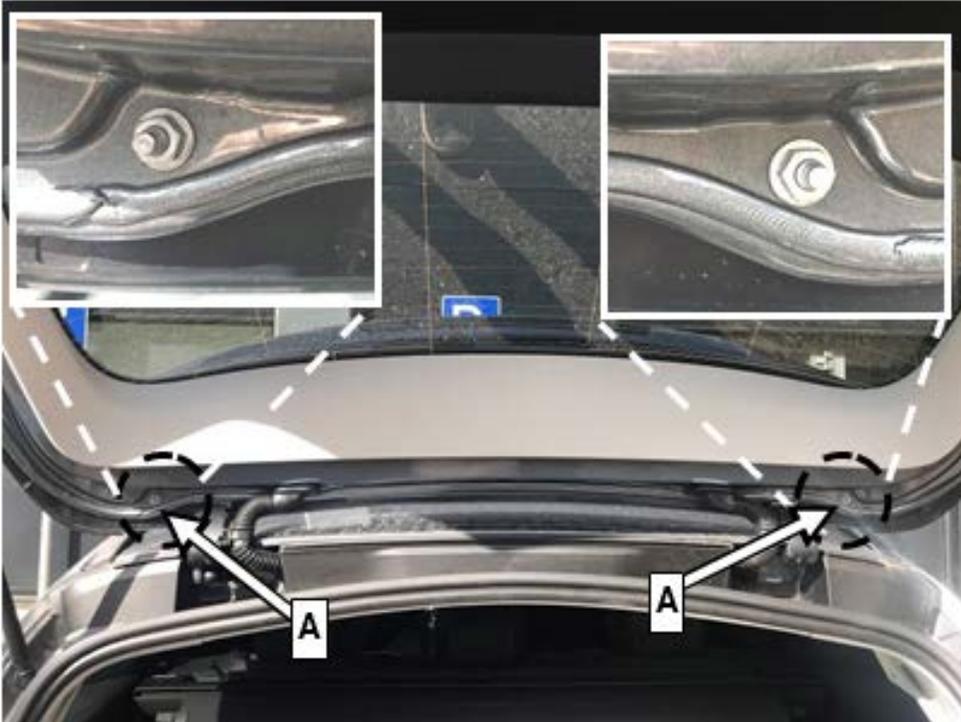
Figure 1

Daimler AG ("DAG"), the manufacturer of Mercedes-Benz vehicles, has determined that on certain Model Year ("MY") 2017-2019 E-Class Station Wagon vehicles (213 platform), the spoiler on the tailgate may not have been fastened according to current production specification. At higher speeds, the spoiler might completely detach from the vehicle, increasing the risk of a crash for following traffic. An authorized Mercedes-Benz dealer will check the fastening of the tailgate spoiler, and rework, if necessary.

1. Open liftgate.
2. Check that all four mounting nuts (**A, figure 1**) of roof spoiler threaded connection are present.
  - i** Check by hand that mounting nuts are firmly seated.

- a. If the mounting nuts are **not** present: Perform **work procedure**.
- b. If the mounting nuts are **present**: **End measure**.

1. Remove top liftgate trim.
  - i** For basic data, see **AR72.20-P-6631LWS**.
  - i** There are two mounting nuts located under the liftgate trim.
2. Retighten existing and/or loose mounting nuts of roof spoiler threaded connection to specified torque and retrofit missing mounting nuts.
  - i** Roof spoiler is installed with **four** mounting nuts!
  - i** For basic data, see **AR72.20-P-4000LW**.
  - Hm** Nut of rear spoiler at liftgate **8 Nm**
