L73X-R.02.19.

Engine and Gearbox sw update.

Aventador S.

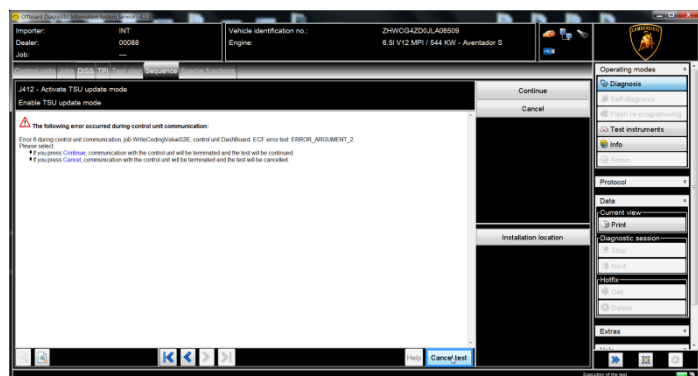
- i. If the following error screen is displayed, abort the guided function by clicking on "Cancel Test" and contact Technical Support.

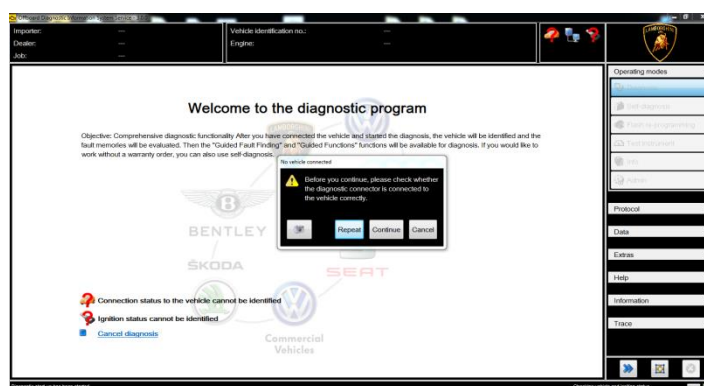
- ii. If an error is displayed that regards the hardware interface, and the "connection to vehicle" and "key state" icons appear as shown in the figure below:

- Click "Cancel"
- Repeat installation of the interface VAS5054/6154/6154A per the instructions in procedure (\*) "VCI Manager v2.0", selecting the right-hand "Extras" menu in ODIS and clicking on the "Diagnostic interface" button.

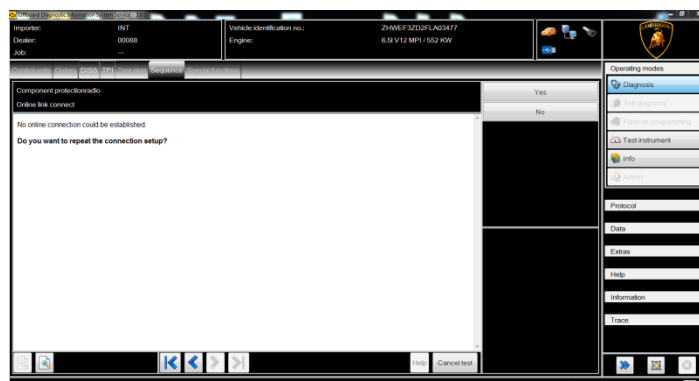
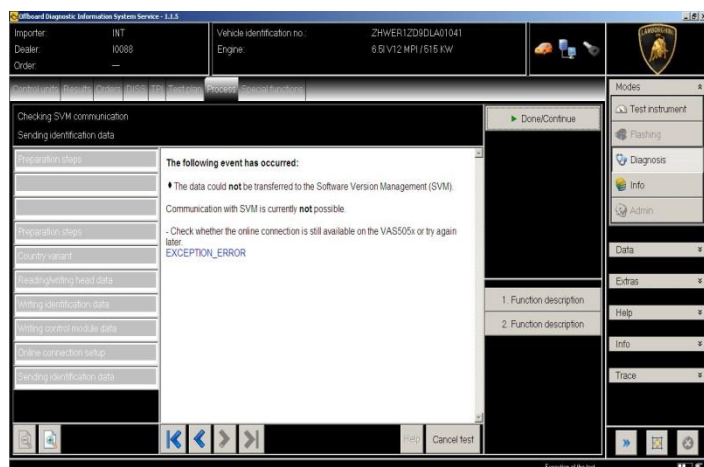
- iii. If one of the following connection errors is displayed like in the following example screenshots:

- It is not possible to connect to the central server; check that your laptop is correctly connected to the Internet and retry by clicking on "Yes" or "Done/Continue", as appropriate.

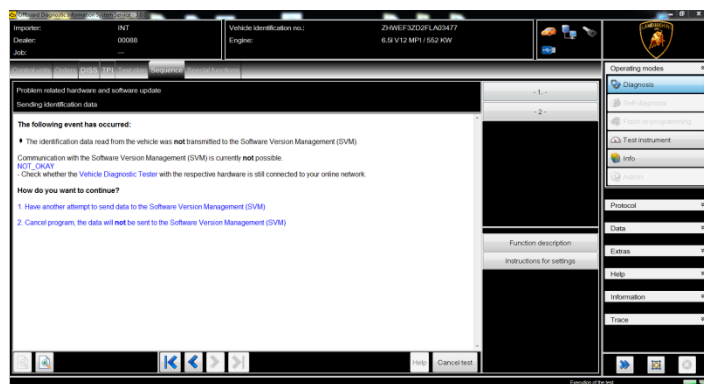
iv. If the connection is dropped during the course of the target/actual comparison during the SVM procedure:

- It is not possible to connect to the central server; check that your laptop is correctly connected to the Internet and retry by clicking on "1".

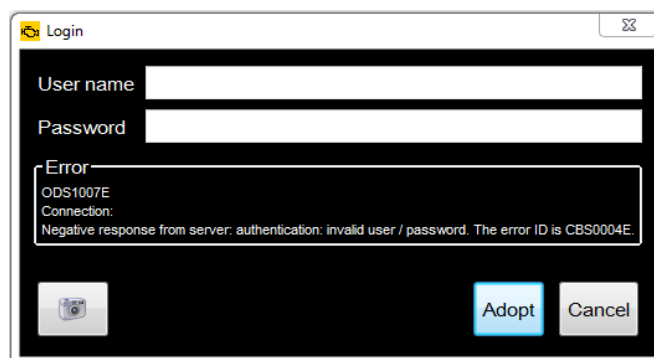
v. If the authentication error as shown in the following screenshot is displayed (error code: ODS1007E):

- Ensure you have a valid GeKo user account;
- Ensure that the "Geko" label is printed on the token you are using;
- Ensure you have entered the correct password;

- Click on "Cancel" and run the application test (see document "ODIS\_ControlloConnessione\_Server\_SVM\_2.0" (\*)).

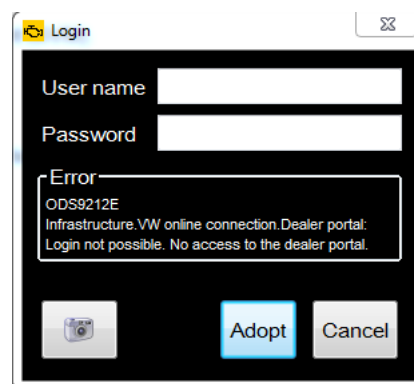
vi. If the infrastructure error as shown in the following screenshot is displayed (error code: ODS9212E):

- Ensure you have a valid GeKo user account;
- Ensure that the "Geko" label is printed on the token you are using;
- Check that the Internet is set in ODIS settings and not CPN (see document "Set-up\_Iniziale\_ODIS\_2.0" (\*));
- Click on "Cancel" and run the application test (see document "ODIS\_ControlloConnessione\_Server\_SVM\_2.0" (\*)).
