L73X-R.02.19.

Engine and Gearbox sw update.

Aventador S.

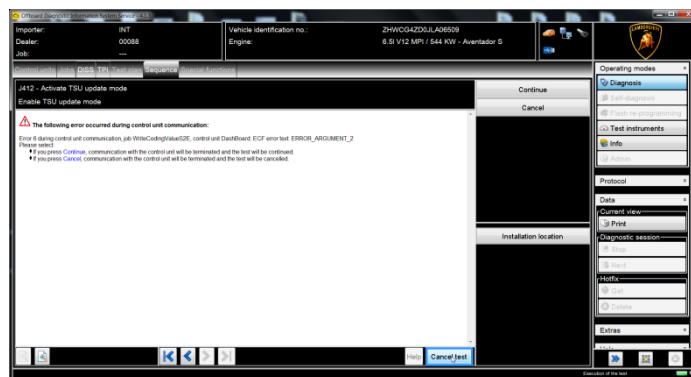
i. If the following error screen is displayed, abort the guided function by clicking on "Cancel Test" and contact Technical Support.

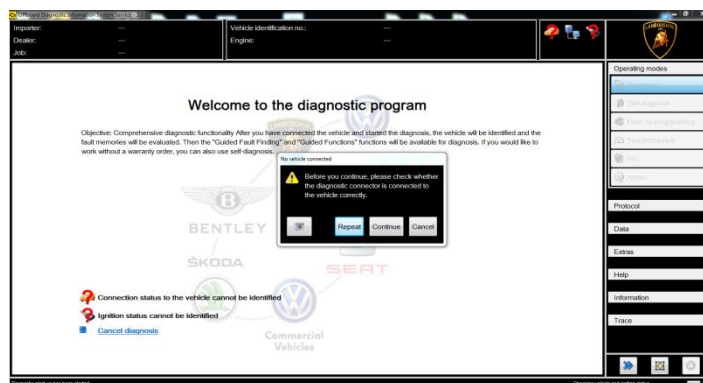
ii. If an error is displayed that regards the hardware interface, and the "connection to vehicle" and "key state" icons appear as shown in the figure below:

- Click "Cancel"
- Repeat installation of the interface VAS5054/6154/6154A per the instructions in procedure (\*) "VCI Manager v2.0", selecting the right-hand "Extras" menu in ODIS and clicking on the "Diagnostic interface" button.

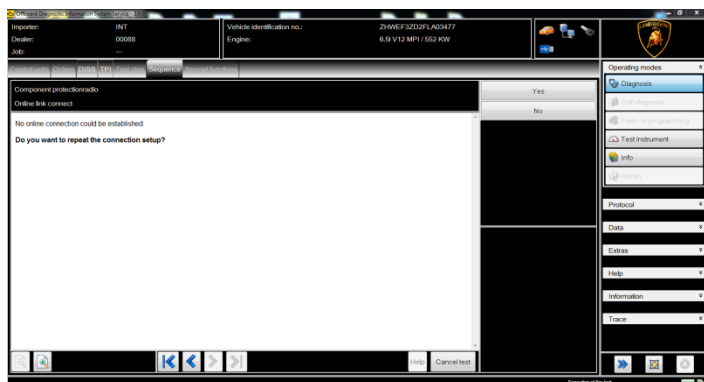
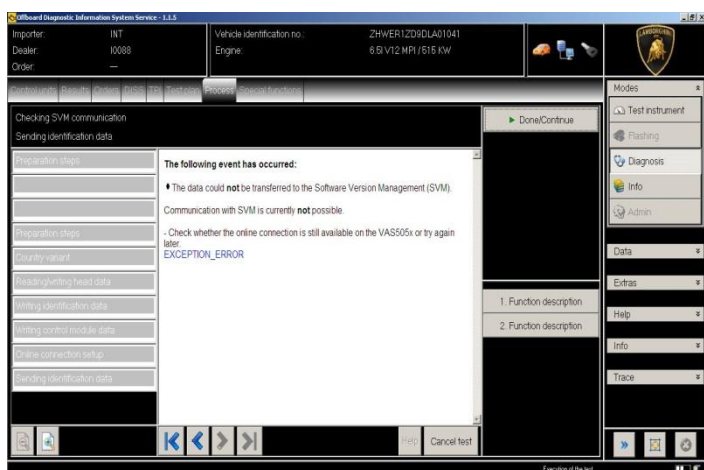
iii. If one of the following connection errors is displayed like in the following example screenshots:

- It is not possible to connect to the central server; check that your laptop is correctly connected to the Internet and re-

try by clicking on "Yes" or "Done/Continue", as appropriate.

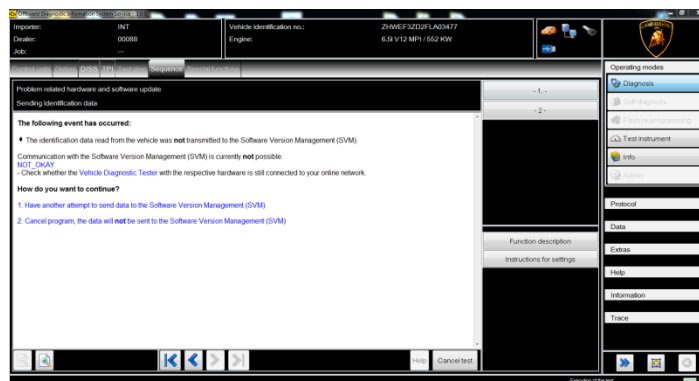
iv. If the connection is dropped during the course of the target/actual comparison during the SVM procedure:

- It is not possible to connect to the central server; check that your laptop is correctly connected to the Internet and retry by clicking on "1".

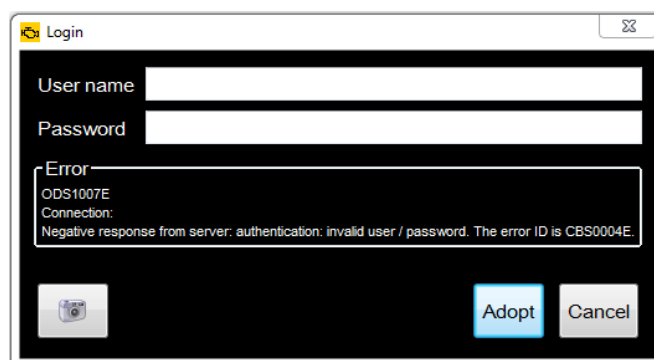
v. If the authentication error as shown in the following screenshot is displayed (error code: ODS1007E):

- Ensure you have a valid GeKo user account;
- Ensure that the "Geko" label is printed on the token you are using;
- Ensure you have entered the correct password;
- Click on "Cancel" and run the application test (see document "ODIS\_ControlloConnessione\_Server\_SVM\_2.0"(\*)).

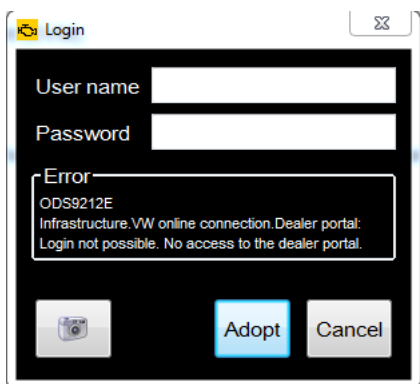
vi. If the infrastructure error as shown in the following screenshot is displayed (error code: ODS9212E):

- Ensure you have a valid GeKo user account;
- Ensure that the "Geko" label is printed on the token you are using;

- Check that the Internet is set in ODIS settings and not CPN (see document "Set-up\_Iniziale\_ODIS\_2.0" (\*));
- Click on "Cancel" and run the application test (see document "ODIS\_ControlloConnessione\_Server\_SVM\_2.0" (\*)).
