SIB 65 20 19

## RECALL CAMPAIGN 19V-698: DRIVER'S FRONT AIR BAG MODULE – PRIOR PARTS REPLACEMENT

This Service Information Bulletin (Revision 4) replaces SI B65 20 19 **dated February 2022**.

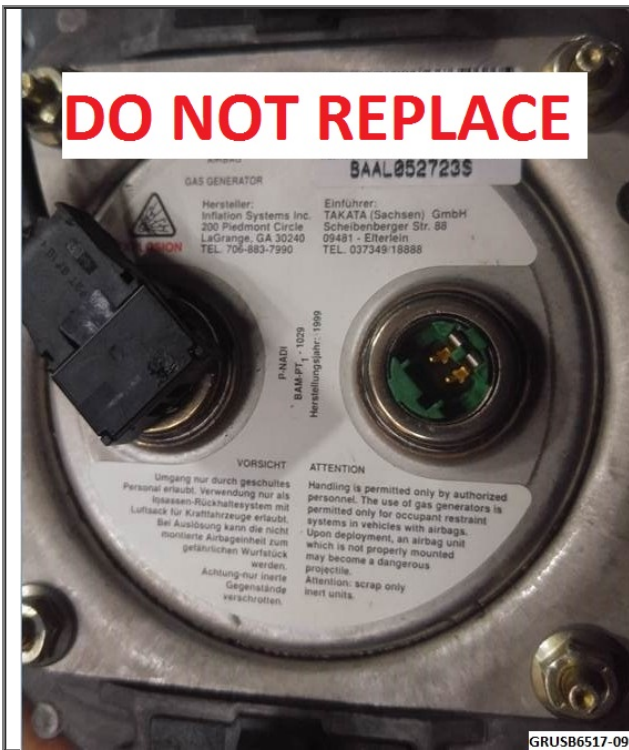
2. Check the label on the back of the driver's air bag.

Is the label yellow with a white number sticker with printed serial number **BAM PT1-1085** (as shown on left) printed below the bar code?

**YES**- replace air bag

**NO** - the driver's air bag is not affected.

**Reinstall the driver's air bag.**

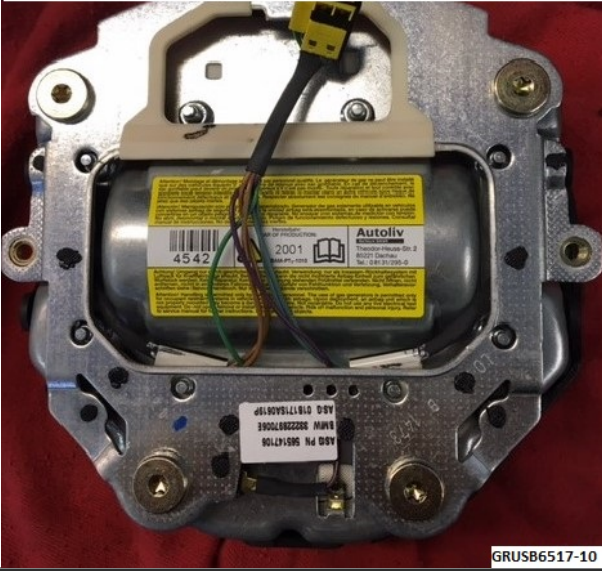
Air bags from other manufacturers (non-Takata), or Takata air bags with different chemical compositions (white label) are not affected by this recall and **DO NOT** need to be replaced.

**DO NOT REPLACE**
