Subject: BMW Recall 19V-698 : Driver's Front Air Bag Module – Prior Parts Replacement

SIB 65 20 19

RECALL CAMPAIGN 19V-698: DRIVER'S FRONT AIR BAG MODULE – PRIOR PARTS REPLACEMENT

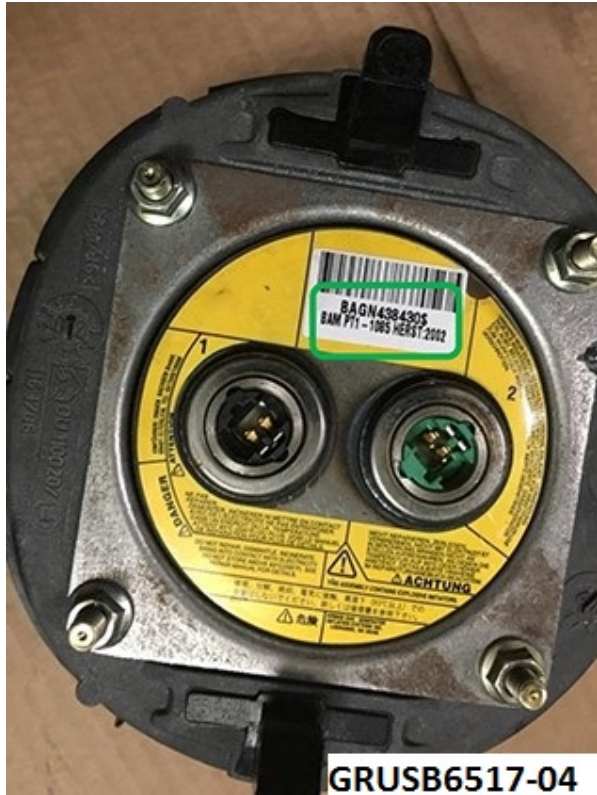
NO - the driver's air bag is not affected.

Reinstall the driver's air bag.

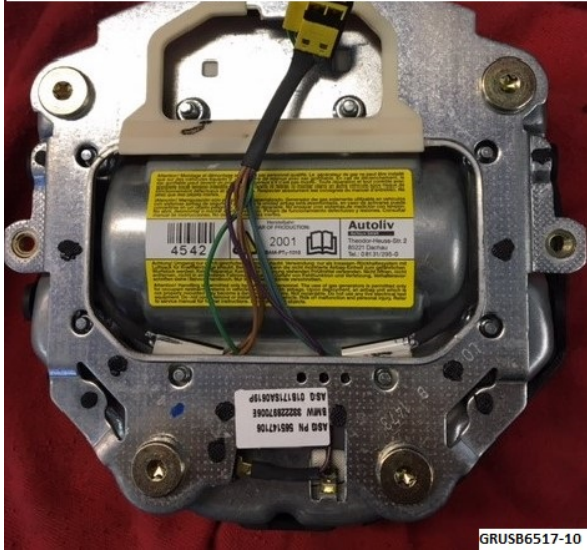
DO NOT REPLACE

Air bags from other manufacturers (non-Takata), or Takata air bags with different chemical compositions (white label) are not affected by this recall and DO NOT need to be replaced.
