**SIB 65 20 19**

2022-02-04

**RECALL CAMPAIGN 19V-698: DRIVER'S FRONT AIR BAG MODULE – PRIOR PARTS REPLACEMENT**This Service Information Bulletin (Revision 2) replaces SI B65 20 19 **dated March 2020**.**What's New** (Specific text highlighted):

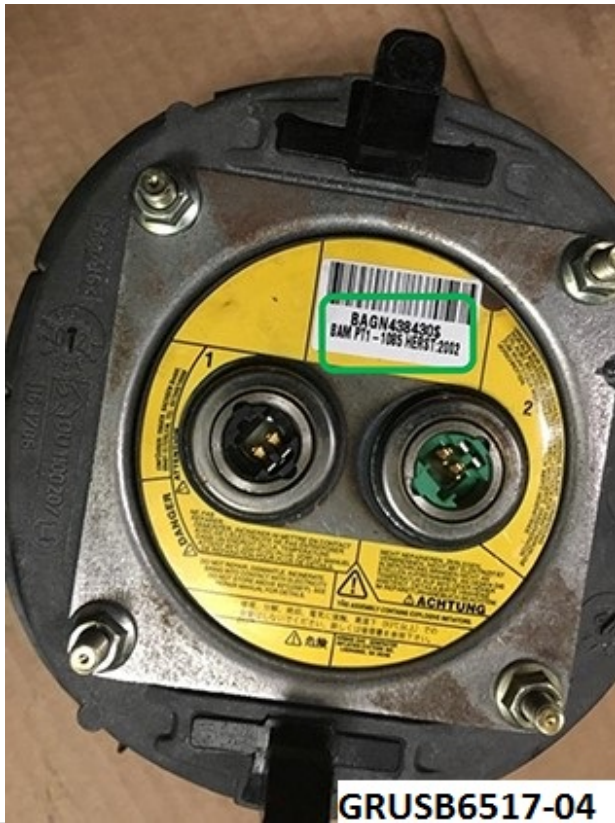
1. Remove the driver's air bag in accordance with repair instructions <b>REP 32 34 020</b> "Removing and installing/replacing air bag units".
	2. Check the label on the back of the driver's air bag.

Is the label yellow with a white number sticker with printed serial number **BAM PT1-1085** (as shown on left) printed below the bar code?

**YES-** replace air bag

**NO** - the driver's air bag is not affected.

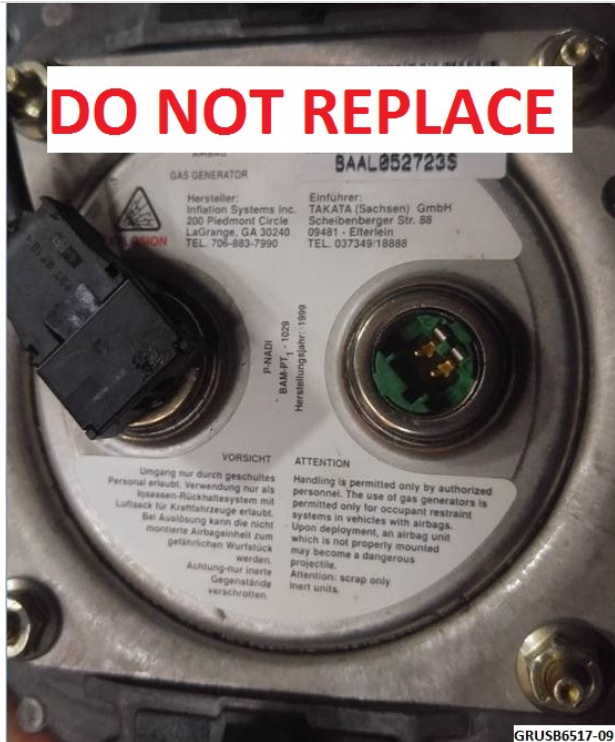
**Note:**  
Air bags from other manufacturers (non-Takata), or Takata air bags with different chemical compositions (white label) are not affected by this recall and **DO NOT** need to be replaced.

**Reinstall the driver's air bag.**

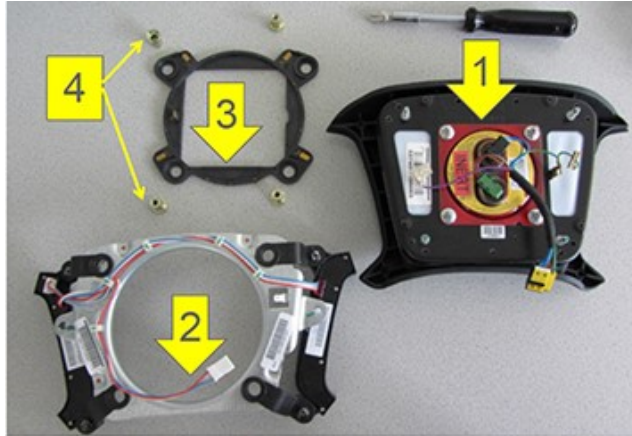
On vehicles with a basic steering wheel, the horn ring must be remounted to the new part.

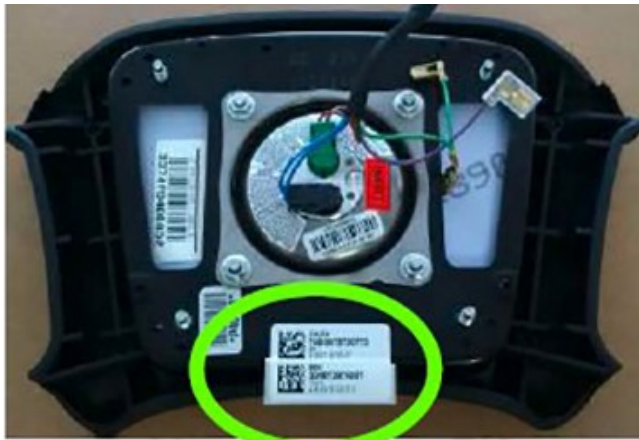
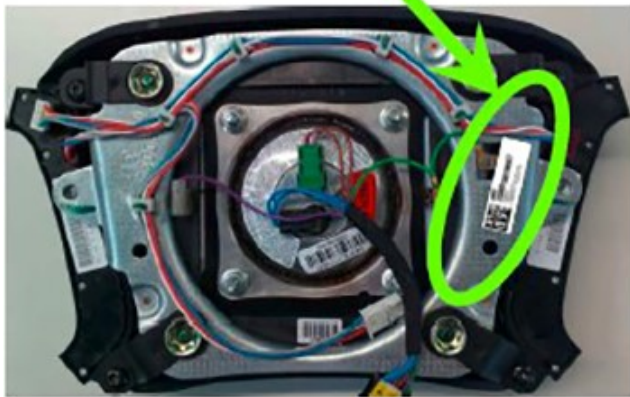
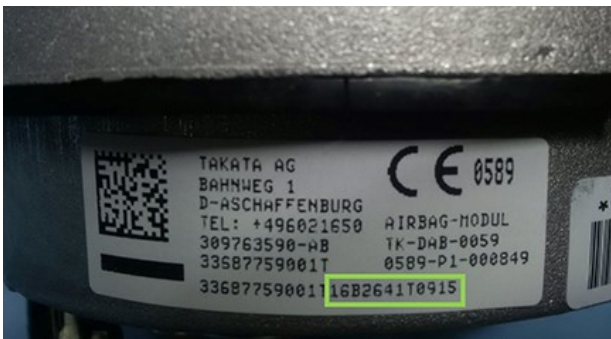
Have the new airbag module ready and remove one of the two stickers with the barcode and the serial number of the airbag module.

This must be glued on the horn ring after assembly.
