SIB 65 20 19

RECALL CAMPAIGN 19V-698: DRIVER'S FRONT AIR BAG MODULE – PRIOR PARTS REPLACEMENT

This Service Information Bulletin (Revision 5) replaces SI B65 20 19 **dated March 2023**.

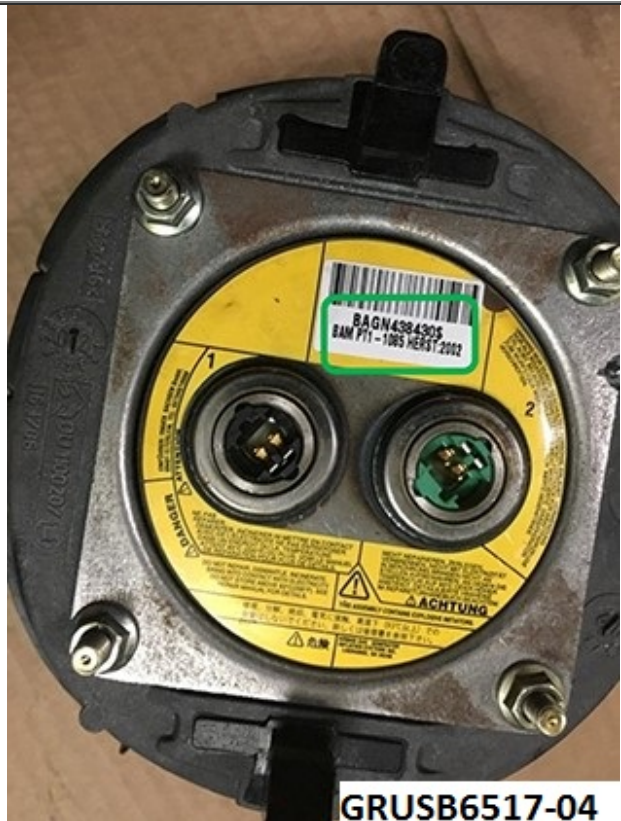
<p>1. Remove the driver's air bag in accordance with repair instructions REP 32 34 020 "Removing and installing/replacing air bag units".</p>

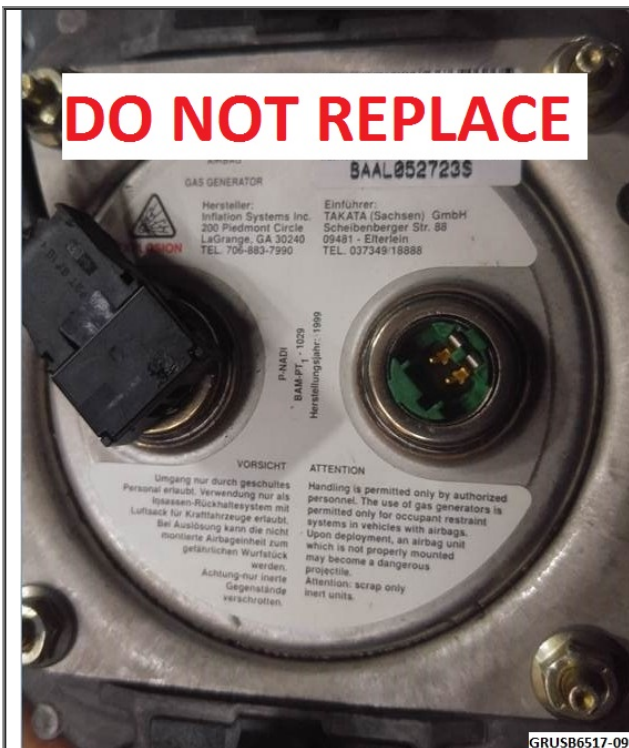
<p>2. Check the label on the back of the driver's air bag.</p> <p>Is the label yellow with a white number sticker with printed serial number BAM PT1-1085 (as shown on left) printed below the bar code?</p> <p>YES- replace air bag</p> <p>NO - the driver's air bag is not affected.</p> <p>Reinstall the driver's air bag.</p>

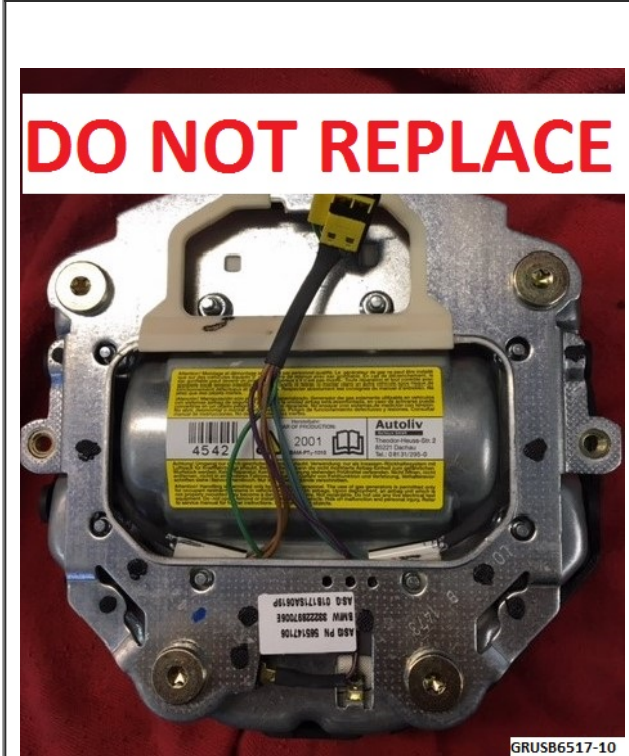
Note:
 Air bags from other manufacturers (non-Takata), or Takata air bags with different chemical compositions (white label) are not affected by this recall and **DO NOT** need to be replaced.

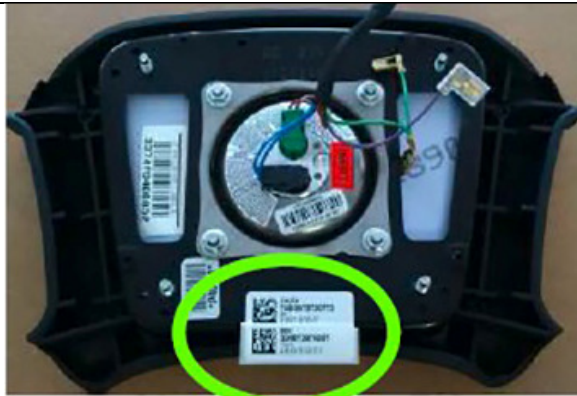
<p>1. Remove horn ring.</p> <ul style="list-style-type: none"> • Unplug the connector for the grounding cable (see the green arrow in the figure) • Remove the nuts (see the blue mark in the figure, Torx 55).
	<ul style="list-style-type: none"> • Take off the horn ring, making sure that the springs remain in place. • Remove the horn contact plate. • Separate components after disassembly: <ol style="list-style-type: none"> 1 - Air bag module 2 - Horn ring 3 - Horn contact plate 4 - Torx nuts

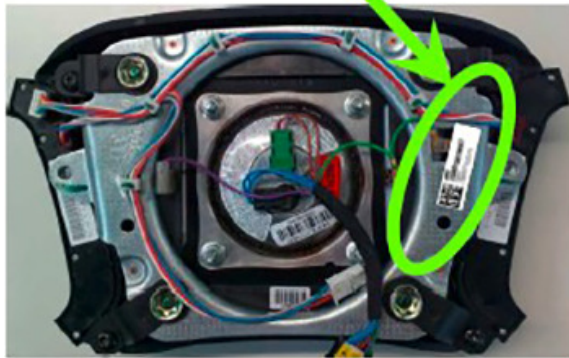
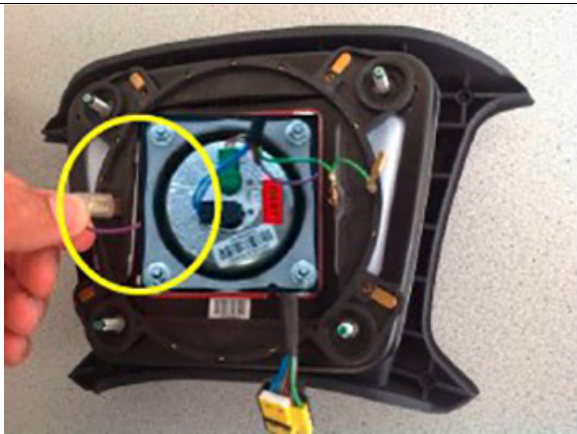
2. Prepare the new air bag module and pull off one of the two labels with the barcode and serial number of the air bag module.

This must be applied to the horn ring **after** installation.

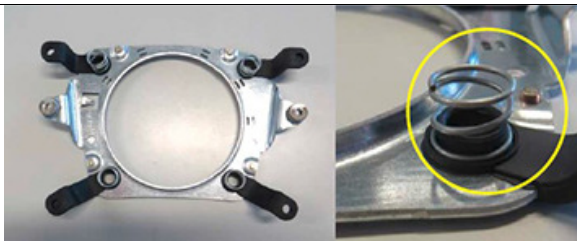
3. Place the horn contact plate on the new air bag module and plug in the connector.

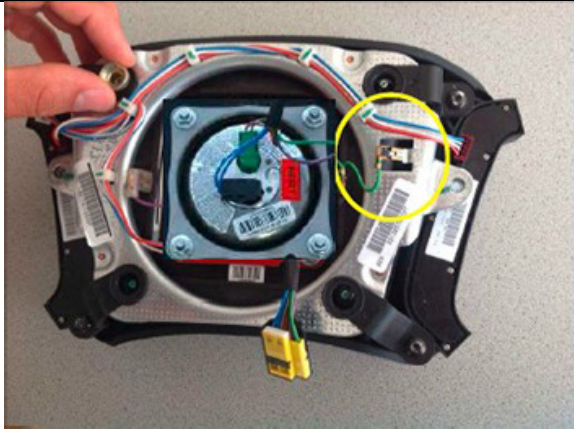
4. Place the horn ring on the air bag module. Make sure the springs are seated correctly.
