PRODUCT CAMPAIGN BULLETIN

APPLICABILITY: 2015-18MY Forester **NUMBER:** WUM-98
SUBJECT: Occupant Detection Wiring Harness Inspection **DATE:** 10/14/19
NHTSA ID: 19V-701

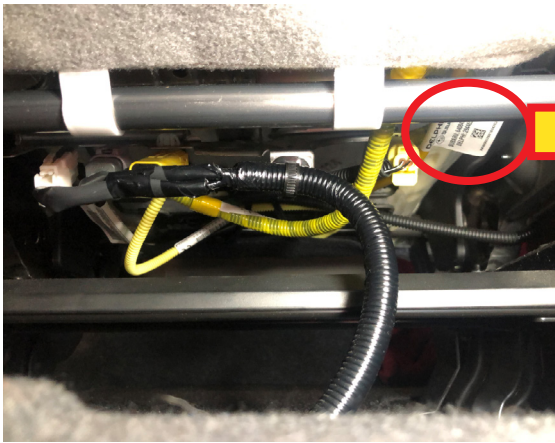
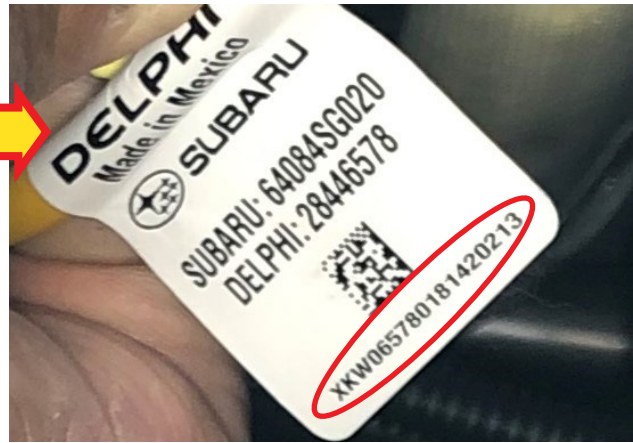
- There is enough room under the seat to access the harness label and perform the date / supplier code inspection without removing the seat assembly.
- Do not pull on the sensor mat harness with excessive force. There is enough flexibility and slack in the harness available to access the label for this inspection.

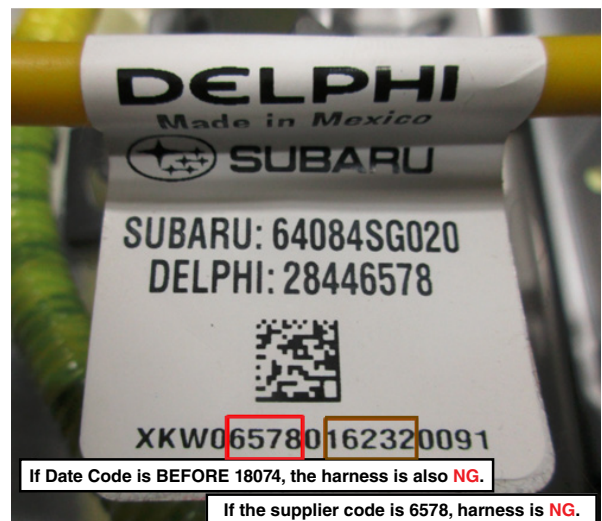
Step 1. If the date code (**BROWN** box in photo) on the label is **AFTER 18074** AND has a supplier code other than **6578** (**RED** box in photo) on it, harness is **OK**. See additional ****NOTE** below.

Step 2. If the date code is **18074** or **BEFORE** AND has the supplier code **6578** (**RED** box in photo) on it, the harness is **NG** and the seat cushion assembly must be replaced. Always order the most up-to-date part number seat cushion assembly for the VIN being repaired. Follow the Service Procedure in the applicable Service Manual for the repair.

- “6578” identifies the bad terminal supplier.
- “16” is the year (2016) and “232” is the 232nd day of the year: “16232”.

IMPORTANT: The original part’s supplier code AND date code MUST be recorded on the document(s) submitted for claim reimbursement. Use the following example: **6578-18074**.
