**PRODUCT CAMPAIGN BULLETIN**

**APPLICABILITY:** 2015-18MY Forester **NUMBER:** WUM-98R  
**SUBJECT:** Occupant Detection Wiring Harness Inspection **NHTSA ID:** 19V-701  
**DATE:** 10/14/19  
**REVISED:** 11/20/19

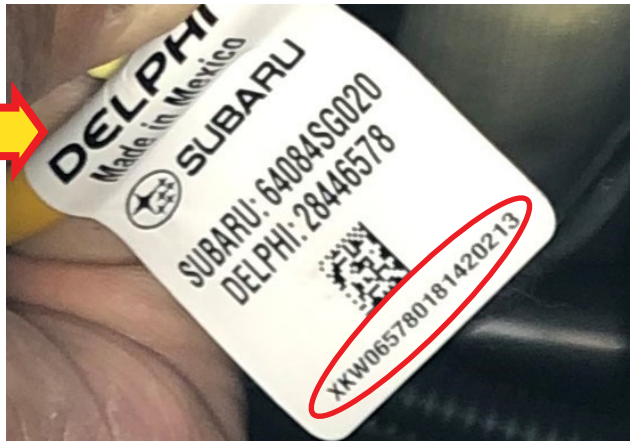
## INSPECTION:

- There is enough room under the seat to access the harness label and perform the date / supplier code inspection without removing the seat assembly.
- Do not pull on the sensor mat harness with excessive force. There is enough flexibility and slack in the harness available to access the label for this inspection.

**TIP:** Take a photo of the label with a phone then review the image to get the necessary information.

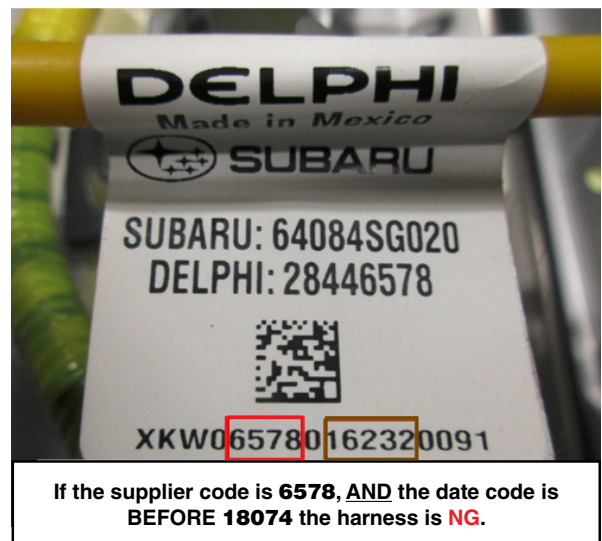
**Step 1.** If the date code (**BROWN** box in photo) on the label is **AFTER 18074**, the harness is **OK**. See additional **\*\*NOTE** below.

**Step 2.** If the date code is **18074** or **BEFORE AND** has the supplier code **6578** (**RED** box in photo) on it, the harness is **NG** and the seat cushion assembly must be replaced. Always order the most up-to-date part number seat cushion assembly for the VIN being repaired. Follow the Service Procedure in the applicable Service Manual for the repair.

- “16” is the year (2016) and “232” is the 232nd day of the year: “16232”.

**IMPORTANT:** The Repair Order must include the Original **AND** (if the seat bottom assembly was replaced) the replacement part’s supplier code and date information as outlined above. Use the following example: **6578-18074**.
