Mercedes-Benz

Campaign No. 2019100011, October 2019

SUBJECT: **Model GLE-Class (167 platform) and GLS-Class (X167 platform)
Model Year 2020****Check window divider on right and left rear doors, Rework if necessary.**

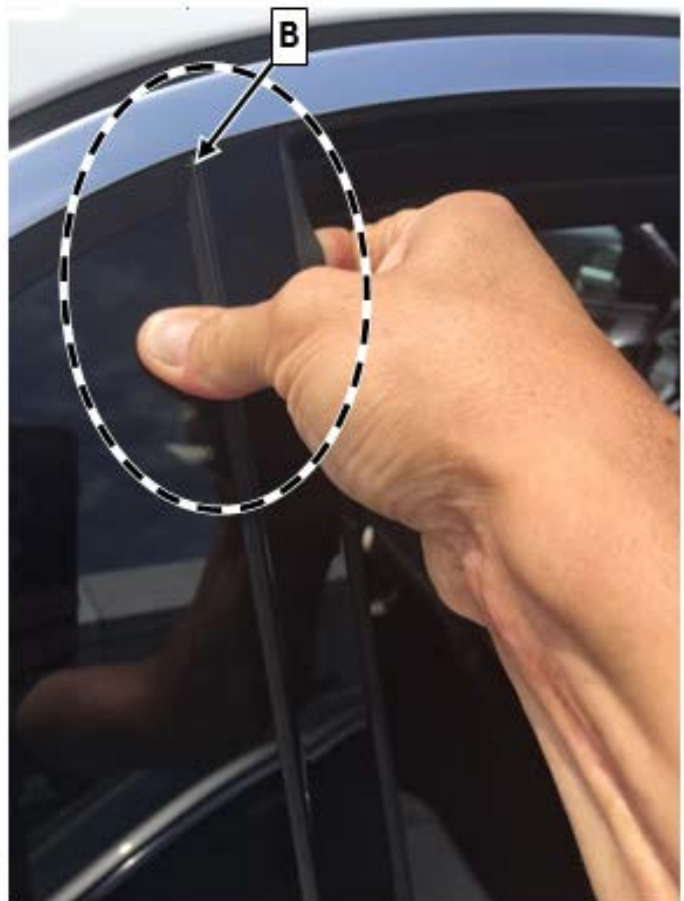
Figure 2

i The window divider should not detach due to the minor force. Ensure that there is at least a 1mm clearance between the chrome trim strip (**B, Figure 2**) and window divider (**A, Figure 2**), and that the window divider does not jam under the chrome trim strip of the window frame (**B**). If the window divider jams under the chrome strip, the test results in a false positive.

- a. Window divider (A) detaches due to slight tractive force: Carry out work procedure.
- b. Window divider (A) does not loosen due to slight tractive force: **End measure.**
