Technical Service Bulletin

NUMBER
19-01-032H

MODEL(S)
Elantra (ADa)

SUBJECT: BALL JOINT FASTENER TORQUE (RECALL CAMPAIGN 185)

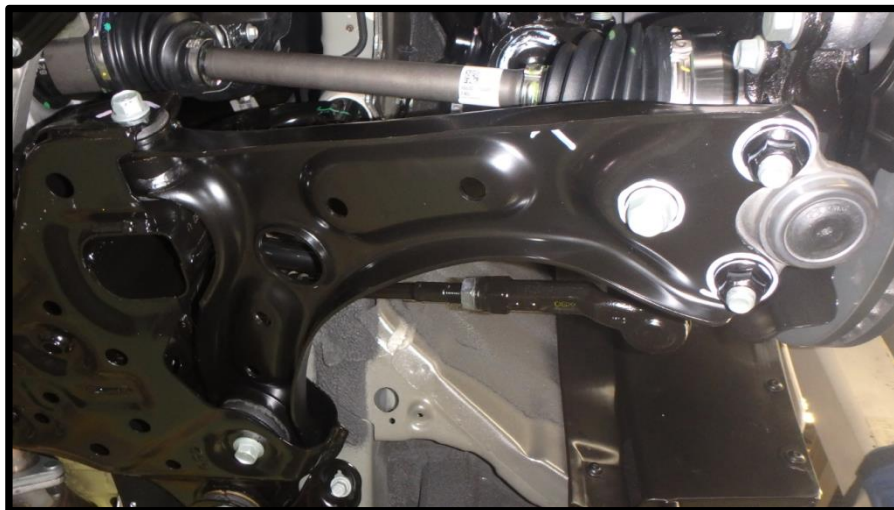
Description: On certain 2020 model year Elantra (ADa) vehicles, the fasteners securing the lower control arm ball joints may not have been properly tightened during assembly. Loose ball joint fasteners may allow the ball joint to separate from the lower control arm, increasing the risk of a crash. This bulletin describes the procedure to confirm lower control arm ball joint fastener torque, and correct if needed.

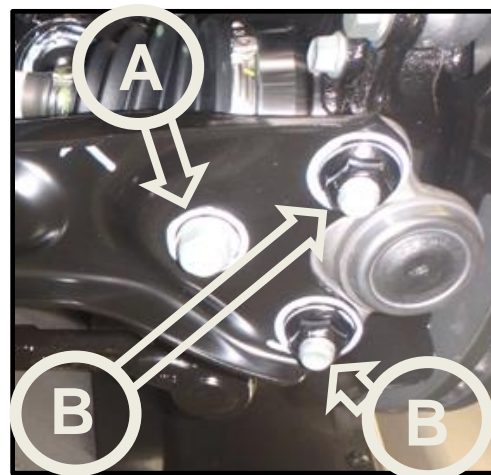
2. Verify the bolt (A) and two nuts (B) that secure the ball joint to the lower control arm are tightened to specification.

Tightening Torque:

98.1 ~ 117.7 N.m

(10.0 ~ 12 kgf.m, 72.3 ~ 86.6 lb-ft)

Repeat the procedure for the opposite side of the vehicle.
